Timber Bridge Best Practices and the State of the Industry in Atlantic Canada

PREPARED AND PRESENTED BY:

Christopher Legg, Timber Structures Designer, Senior CAD Technician

Wood Research and Development

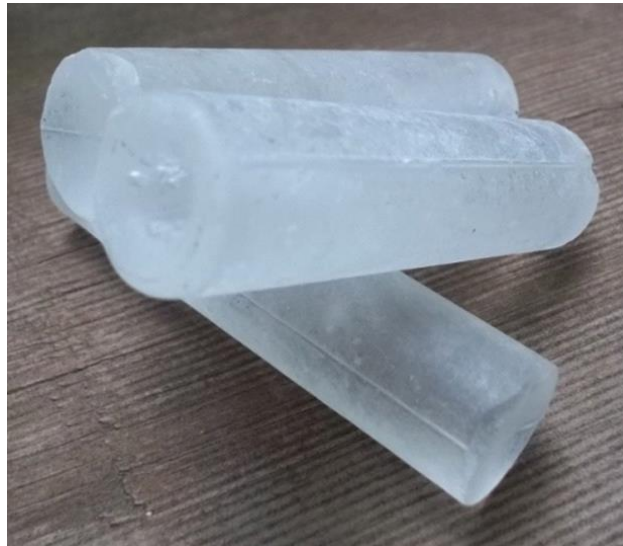
Figure 1-3: Diffuser Rods

Diffusers are similar to fumigants, except they do not begin to vaporise until the moisture content of the wood rises above approximately 20%. This allows the diffusers be utilised more efficiently, as they will remain intact until conditions reach the point where decay may begin. Diffusers are solid rods which

typically consist of borate salts. In contrast to fumigants, these salts have low toxicity. Rather than killing the fungi directly, they function by neutralizing the PH wave that is created by fungi hyphae secreting acidic enzymes that break down the wood. This makes the wood no longer a suitable food source for the fungi, preventing continued decay.

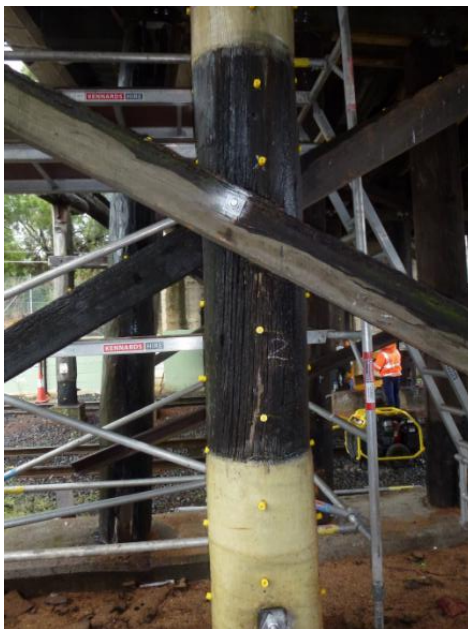
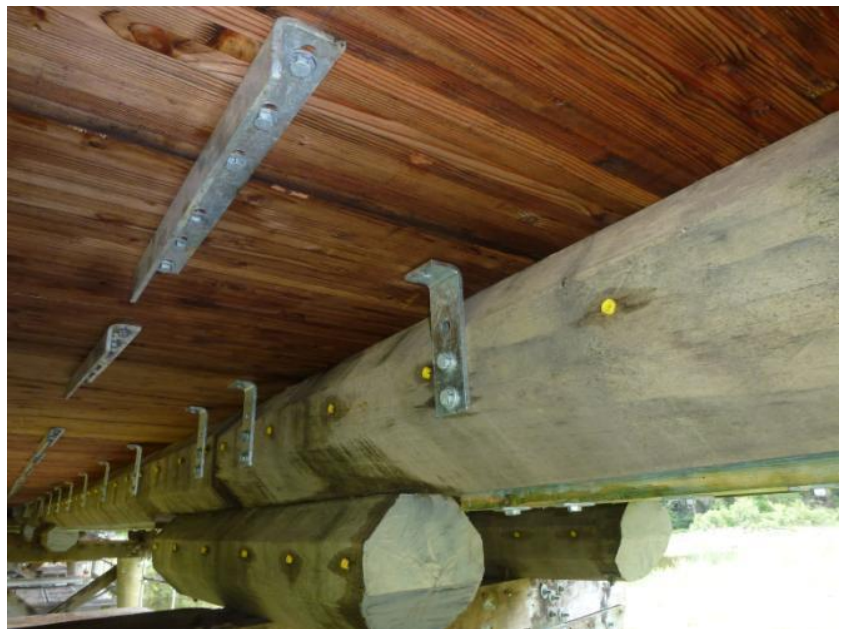
Figure 1-4: Diffuser rod installation in bridge piles (left) and girders (right). The yellow plastic bungs are the locations of diffuser rods.

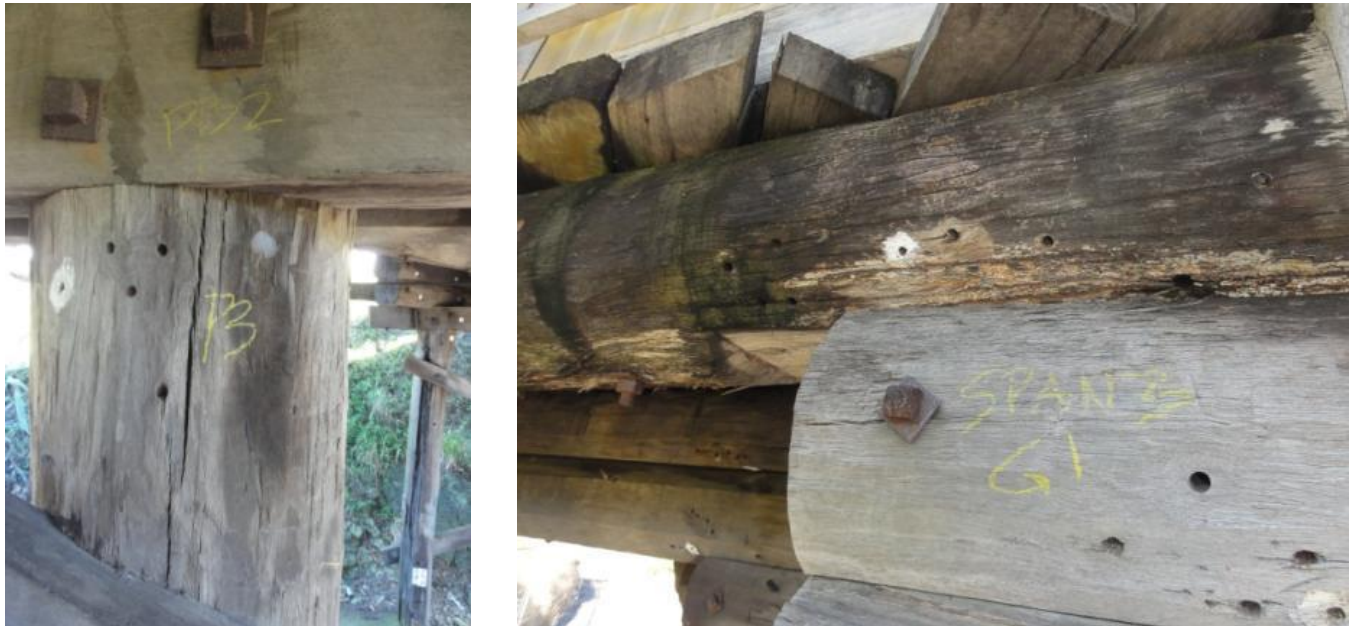
Figure 2-1: Repeated bore sounding on this road-over-rail bridge in Queensland has created a path for water and insects to enter the timber elements, and eventually destroyed the elements' integrity.

The traditional method for identifying and assessing internal decay in timber bridges has been bore-sounding, in which a small hole is drilled into a member, and a probe is inserted to measure the cavity size. This testing method is damaging to the timber, and it creates a path for water to enter the member. When this test is repeated in subsequent inspections, the damage can be substantial as shown in Figure 2-1. Furthermore, because of the destructive nature of this test its use must be limited to relatively few locations on the bridge and significant areas of decay can easily be missed.

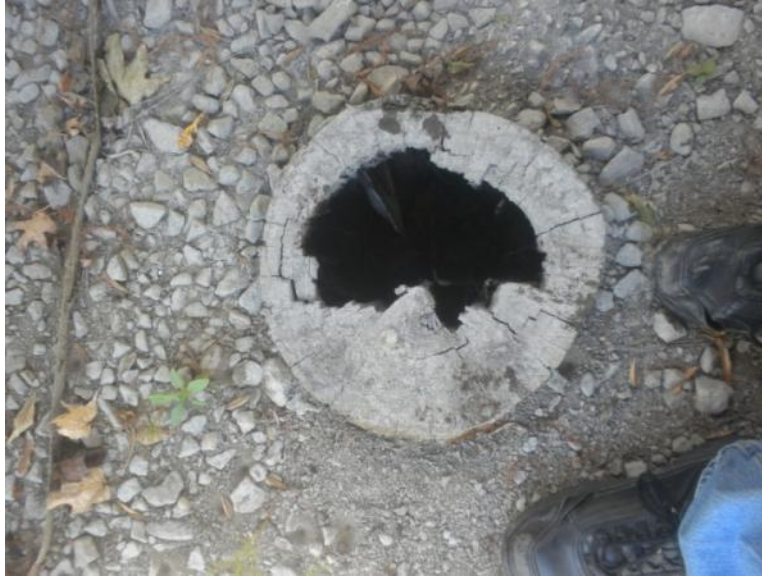
Figure 2-2: This photo demonstrates the danger of using bore sounding to locate decay. The pile was tested with a sounding hole from the wrong side of the pile and the cavity, caused by the track spike visible at the top left, was not detected.

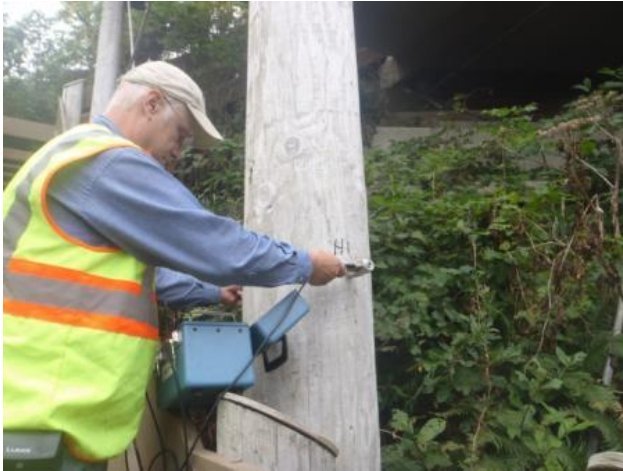
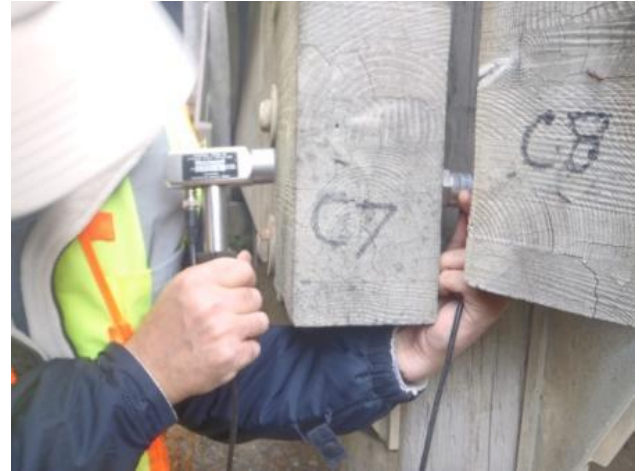
Figure 2-3: Taking readings with the stress wave timer

Advanced non-destructive testing methods exist that can be more effective in locating decay without damaging the timber. One of these test methods is Stress Wave Timing (SWT). Degraded wood or cavities caused by decay can be found by measuring the velocity of a sound wave traveling through the timber. The sound wave is introduced by striking the member with a hammer which contains one half of a transducer pair, which also starts a timer. When the wave reaches a receiver containing the other half of a transducer pair held on the opposite side of the member, the timer is stopped. See Figure 2-3. The velocity of this wave is related to the Modulus of Elasticity and the density of the timber, and can be used to identify where the timber has been degraded by decay. Because this test is non-destructive, it can be used in more locations throughout the bridge as shown in Figure 2-4. This method also has the advantage that it can detect decay before a cavity has formed. As little as 10% reduction in density due to decay can cause as much as a 75% loss of strength, so detecting decay before a cavity has formed is clearly important.

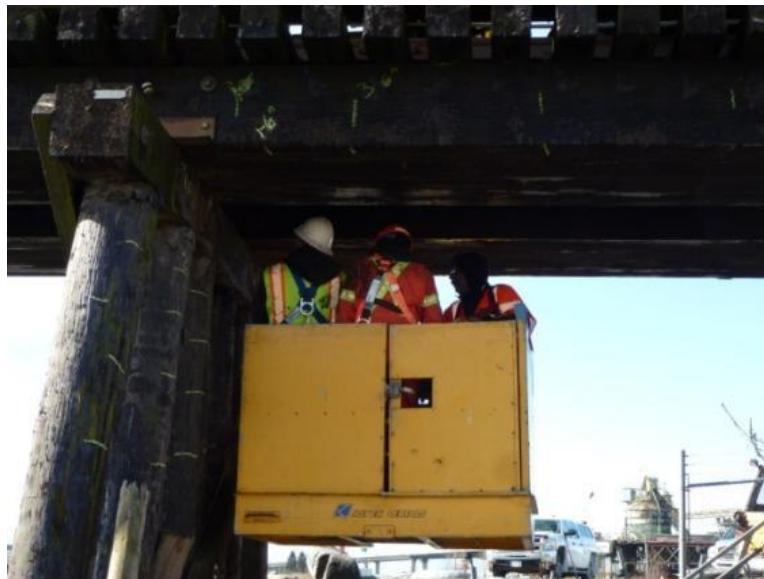
Figure 2-4: A crew inspects a railroad bridge. Yellow chalk marks indicate where SWT readings will be taken. This frequency of testing would be impractical with destructive methods such as bore sounding.

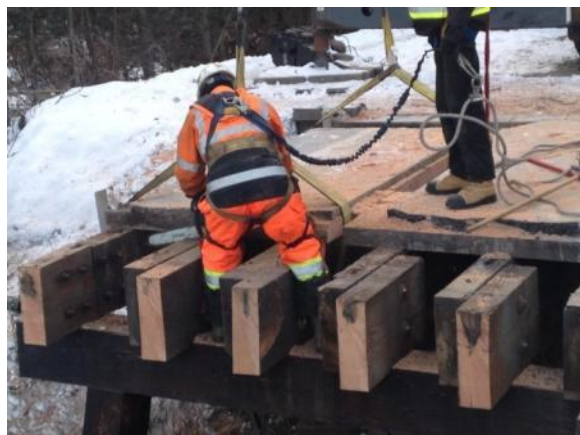
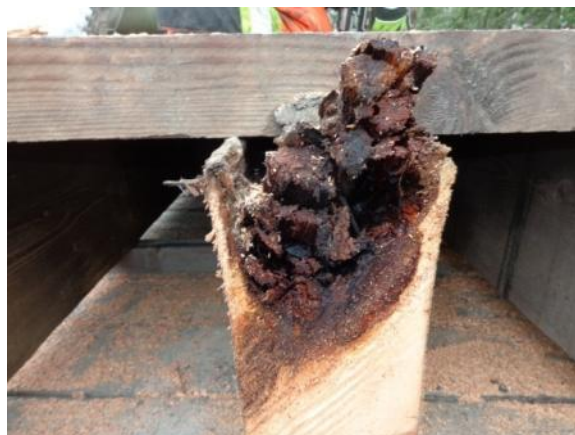
Figure 2-6: Deck and stringers being removed from a bridge in Ontario. There is clear decay at the top of each stringer, originating around the vertical deck spikes.

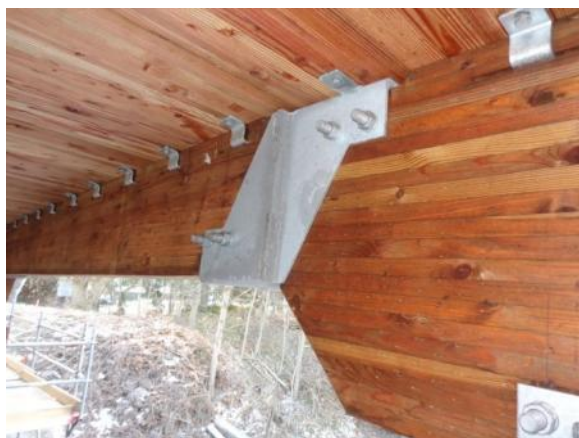
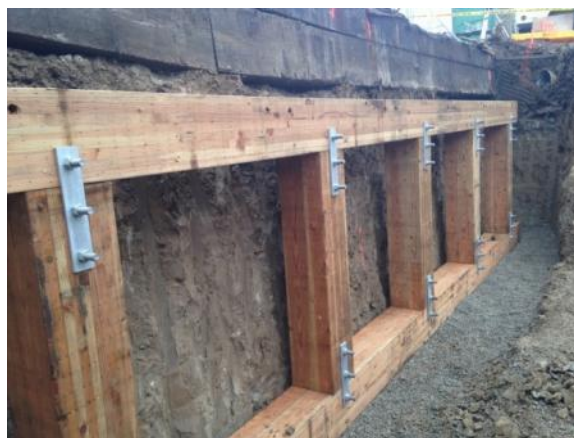
Figure 2-7: In this replacement bridge in Ontario, the deck is secured using z-clips which fit into pre-cut horizontal slots in the girders and lag screws that do not penetrate the top of the deck. The posts are fastened to the caps and sills using steel face plates and horizontal bolts.

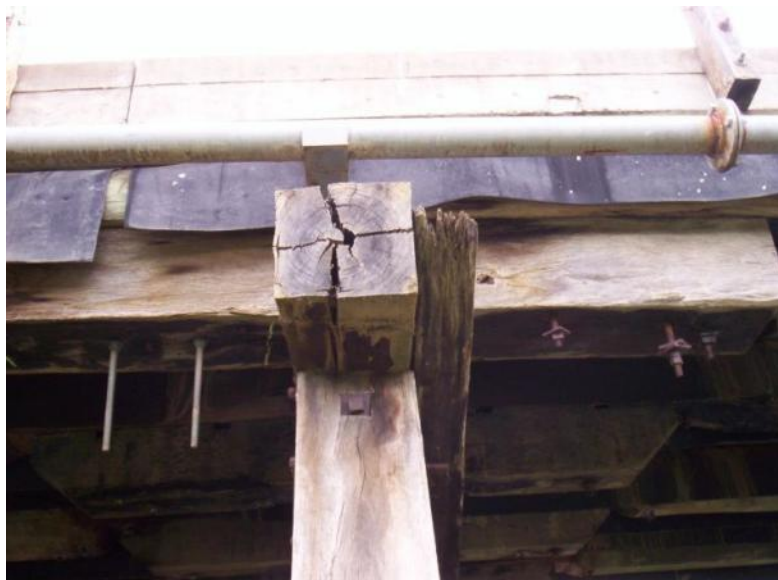
Figure 2-8: Waterproof coverings such as these are ineffective at keeping the timber dry, especially where they are penetrated by fasteners or subjected to flooding. Instead they limit air flow and cause the moisture content to remain elevated.

Waterproof barriers such as roofing felt and tin flashing are often used in timber construction in an attempt to protect timber elements from exposure to moisture. Unfortunately, these barriers often have the opposite effect. If space is not provided for sufficient air flow between the barrier and the wood elements, as shown in Figure 2-8, moisture will become trapped and be unable to evaporate. This elevates the moisture content and accelerates decay. In many cases the barriers should simply be eliminated from the design. In cases where protection is necessary, a better solution would be sheet-metal flashing; however, care must be taken to ensure that enough air space is provided between the metal and the timber to allow sufficient air flow and drying of the timber.

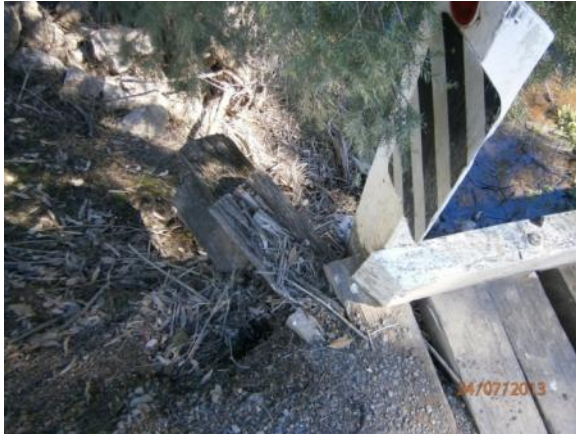
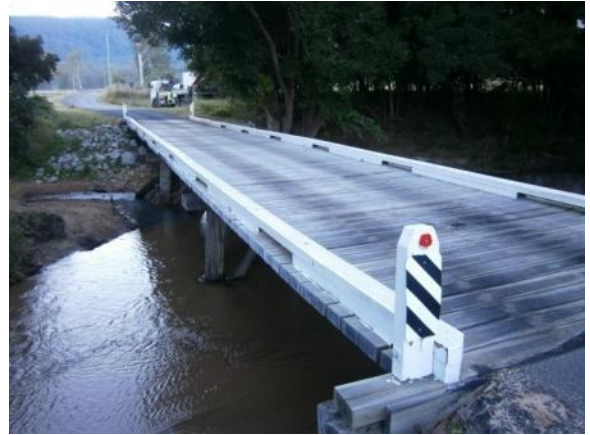
Figure 2-9: Examples of painted curbs on two bridges in Australia. Water will inevitably enter these members – through cracks and chips in the paint, as well as through fastener holes – and the paint will slow the drying process.

Timber elements with a minimum dimension of 50mm or greater should not be coated with paints containing more than 29% solids. Alternatives include preservative treatments and low-solids wood-stains. Paraffin-based sealants designed for use on end grain help reduce the speed of moisture travel through the end grain; this allow more uniform drying throughout the piece, and thus reduces end checking and feathering. These products do not pose the same problems and should be used instead of paint on large timbers.

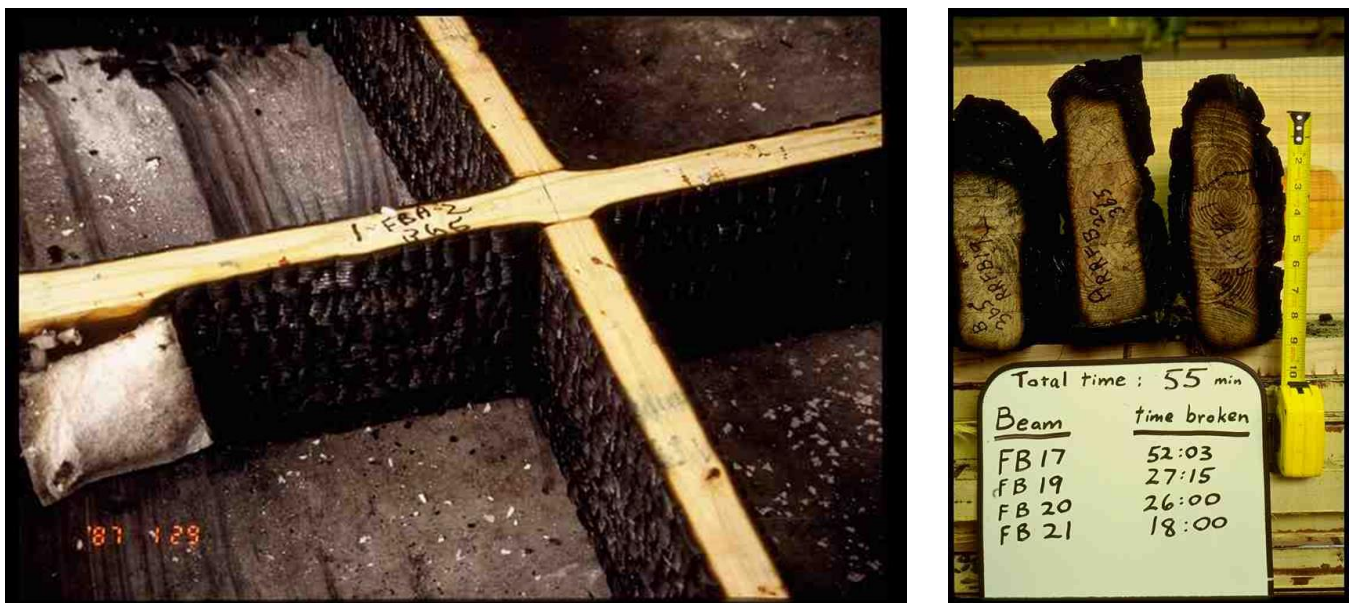
Figure 2-11: Timber beams following fire resistance testing. The charred layers progress from the surfaces that are exposed to fire, while the interiors of the members remain sound.

By contrast, steel loses strength rapidly when exposed to high temperature. Steel has higher thermal conductivity, so when the surface is exposed to high surface temperatures, that heat quickly spreads through the whole member. As temperature rises, the strength of steel decreases; at a temperature of 800° C, the yield strength of steel can be as little as 20% of the room temperature strength. This can lead to rapid collapse of a structure when unprotected steel members are exposed to fire.

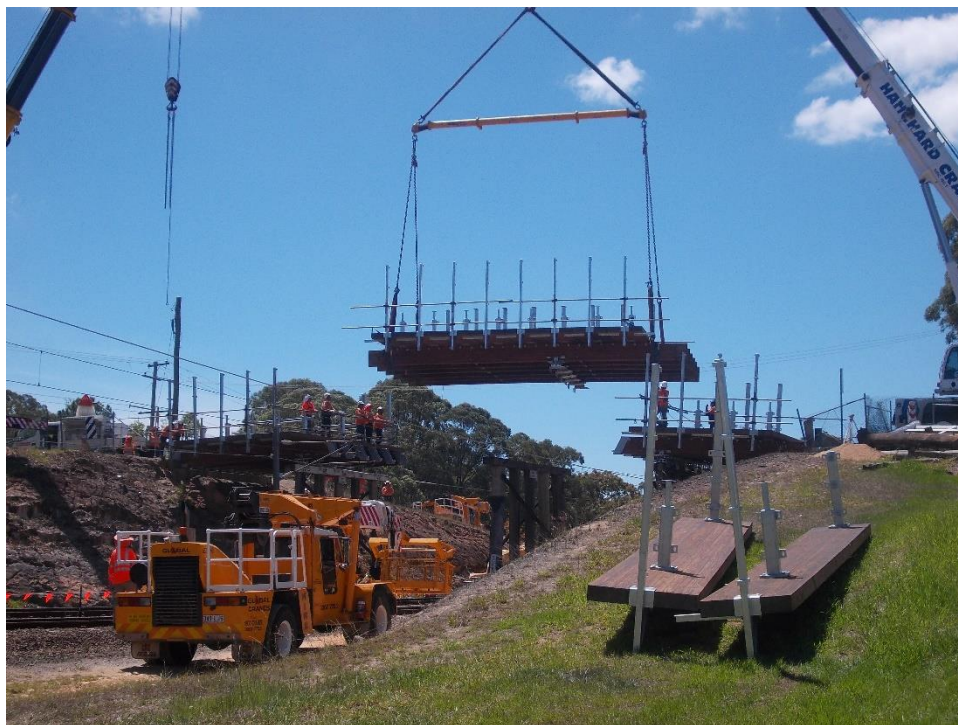
Figure 3-1: Installation of a railroad overpass in Queensland. The center span, over the railroad tracks, was pre-assembled alongside the approach road and installed by crane. The light weight of the timber structure allowed this installation to be completed quickly, without interrupting rail traffic.

Thanks to its light weight and the ability to pre-fabricate components off-site, timber bridges can often be installed very rapidly, with much less time spent on-site. This means lower labor costs and fewer interruptions to traffic. This can be especially beneficial on railroad overpasses, where interrupting rail traffic is often quite costly. Additionally, installation can often be completed with less specialized labor and less heavy equipment compared to steel or concrete structures. (Moses, et al., 2017)

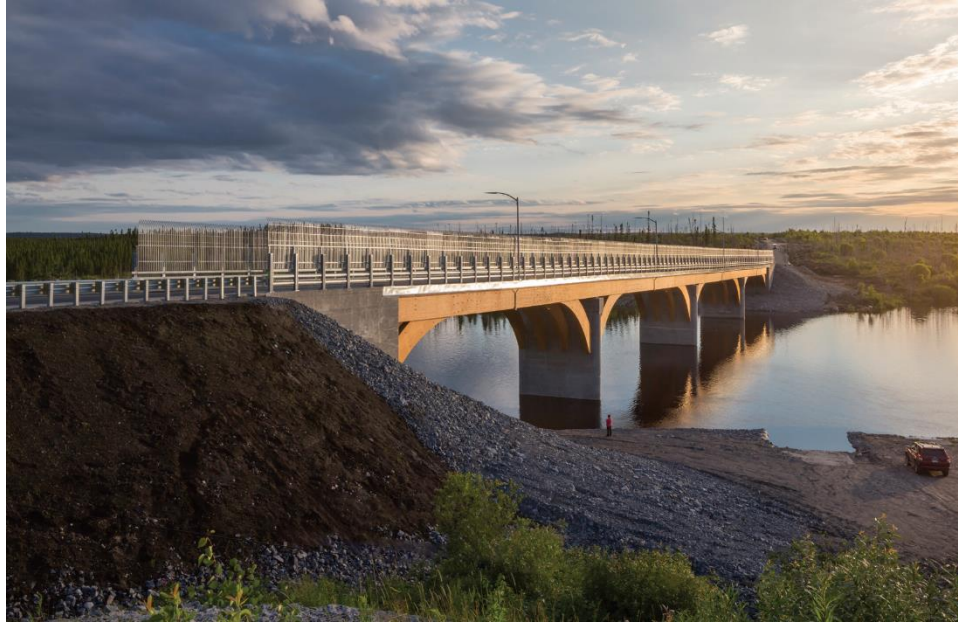
Figure 3-3: Mistissini Bridge, a 160 metre glulam bridge in Quebec, designed by Stantec. A carbon footprint analysis conducted by Stantec found that this bridge sequestered 497 tonnes of carbon (Lefebvre & Richard, 2014).

A recent example is the Mistissini Bridge, a 160 meter glulam girder bridge in Quebec. The design team, at Stantec in Quebec, conducted a life cycle carbon analysis for the timber design along with an alternative design utilizing steel girders and a concrete deck. The analysis found that the timber superstructure and deck had net negative emissions of -981 tonnes of CO₂. This more than offset the emissions from the concrete, steel, and asphalt used in the substructure and elsewhere in the bridge. The total project emissions came to -497 tonnes. By comparison the steel and concrete design would have generated 969 tonnes of CO₂ emissions. Thus, the timber design resulted in a total carbon emission reduction of 1466 tonnes compared to the steel and concrete alternative (Lefebvre & Richard, 2014).

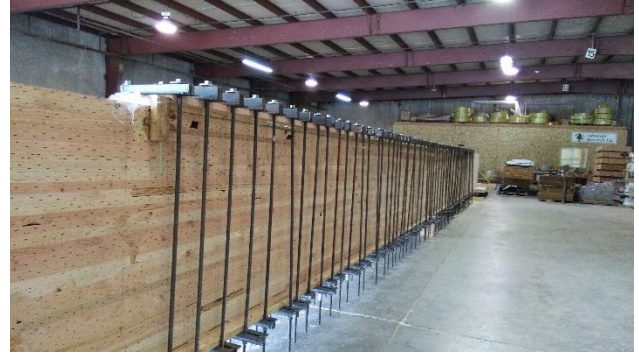
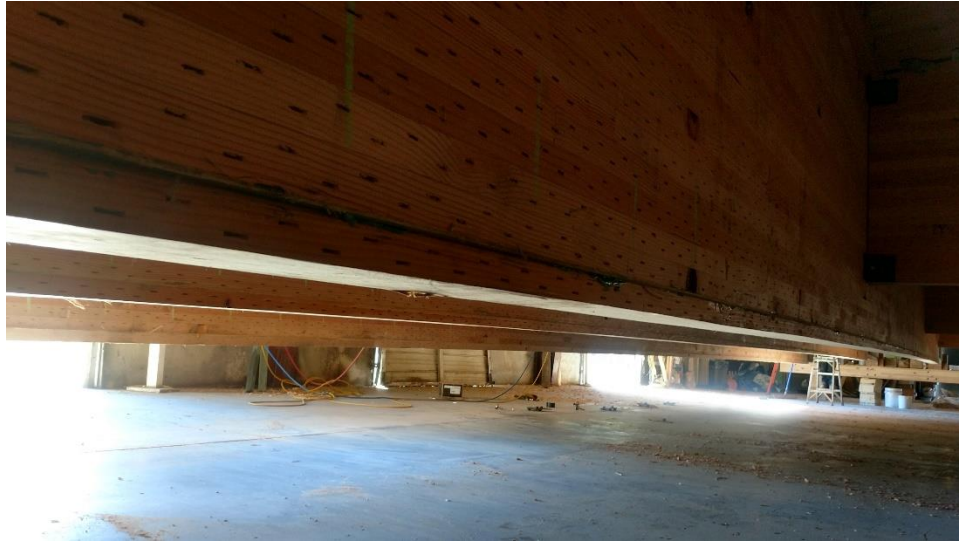
Figure 3-6: Moment reinforcing being installed on a bridge girder. The fibre-reinforce polymer (FRP) panels are glued to the tension face of the glulam beam, and a final lumber lamination is installed to protect the FRP from impact.

A common application of FRP reinforcing is on the tension face of girders to resist bending stresses. Tension reinforcing panels consists of longitudinal glass, aramid, and/or carbon fibres. These panels are bonded to the tension face of the beam, or sandwiched between the bottom laminations of a glulam beam. In addition to providing its own tensile capacity, the FRP transitions tension and other applied stresses across localized defects, such as knots and splits, in the timber. This gives the composite section significantly increased bending capacity. On a long span structure, use of FRP reinforced timber can significantly reduce the overall depth of the structure. This can be an important advantage, for example where flood clearances over a river are an important requirement.

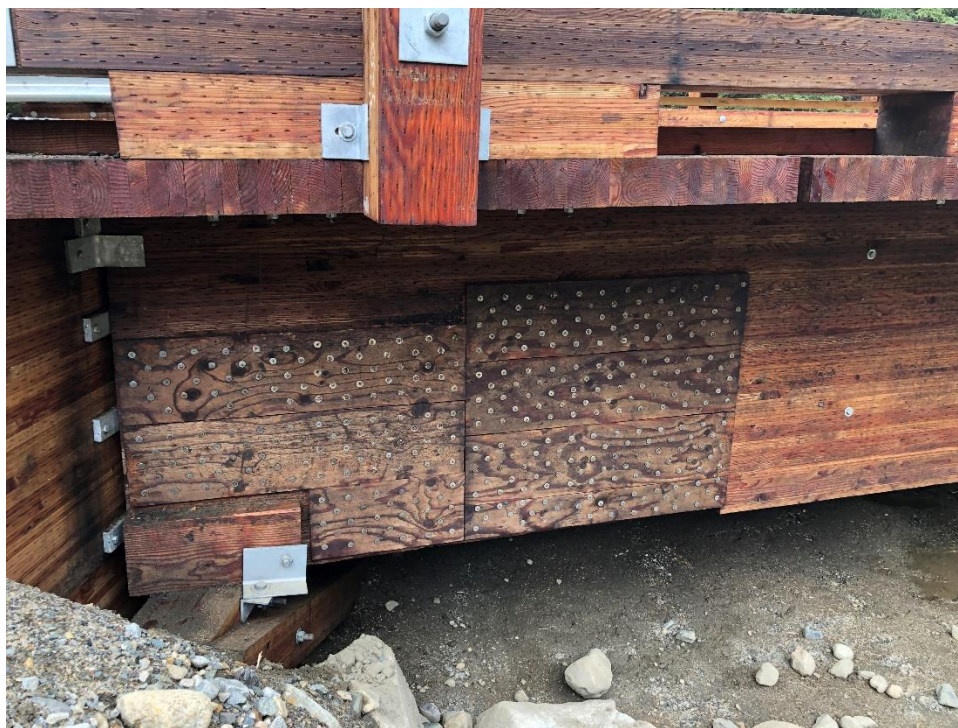
Figure 3-7: Fiber-reinforced shear panels on a forestry bridge in British Columbia.

Short-span elements are more likely to be controlled by shear capacity. Examples of shear-controlled elements might include stringers in a railroad trestle or caps in a pile bent. FRP reinforcing can provide extra shear capacity without requiring larger timber elements. Shear reinforcement might consist of FRP panels or fabrics bonded to the vertical faces of the beam or FRP rods embedded inside the beam.

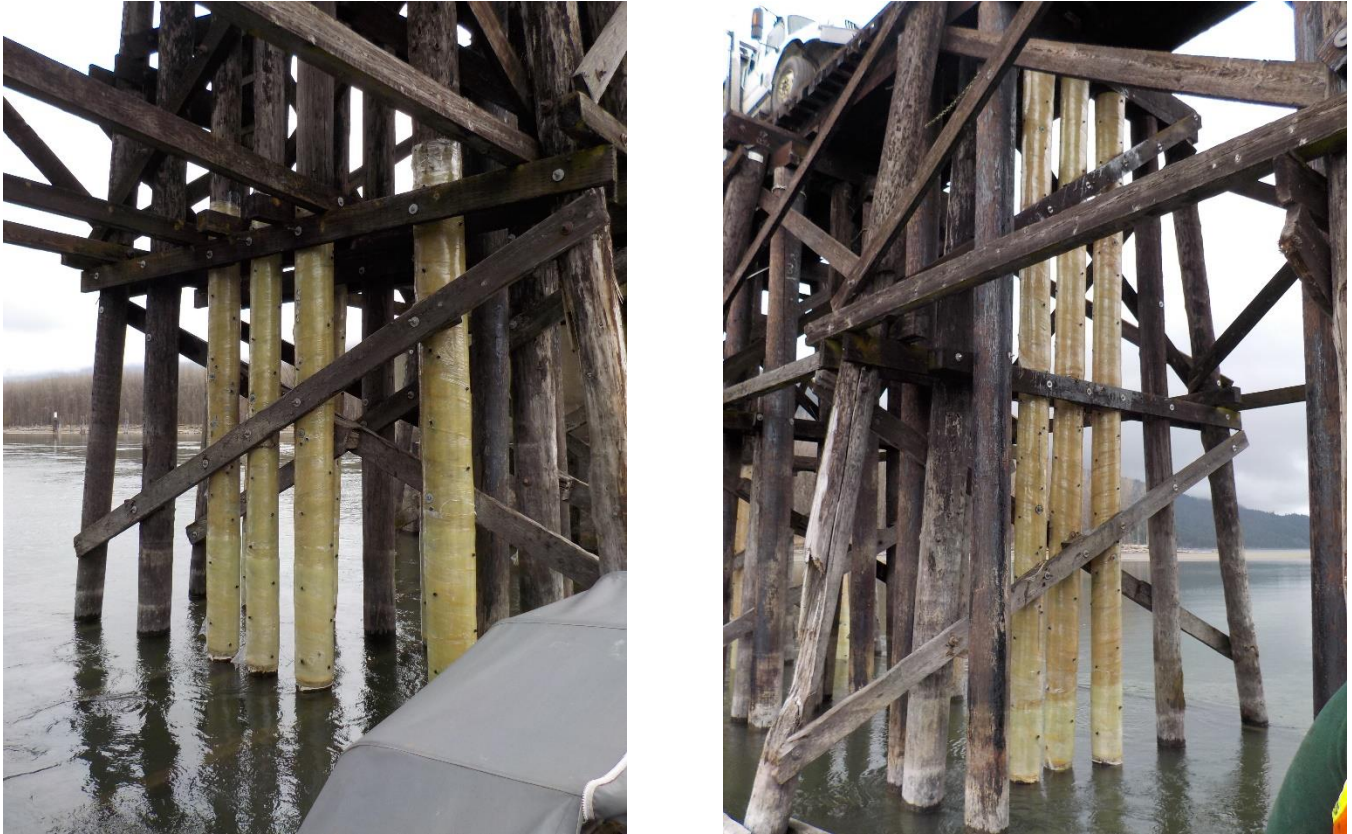
Figure 3-8: High-strength fibre pile wraps on a railroad trestle in British Columbia. Traditional repair methods would have been impractical on this structure. Driving new piles would have been cost prohibitive and would have required extended bridge closures, and posting multiple piles within a single bent is not recommended, as lateral resistances is significantly reduced.

Due to the difficulty of replacing a deteriorated pile, FRP wraps can be a very advantageous strategy for repairing an existing structure. In the case of an existing, cavitated pile, these wraps would be paired with epoxy injection to fill the cavities; this is important to prevent inward buckling of the pile annulus.

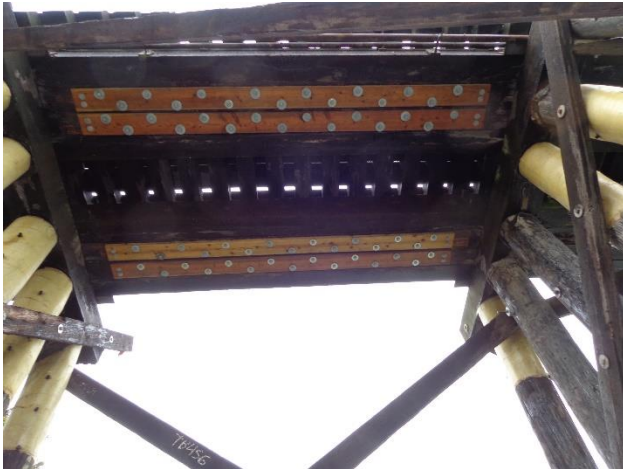
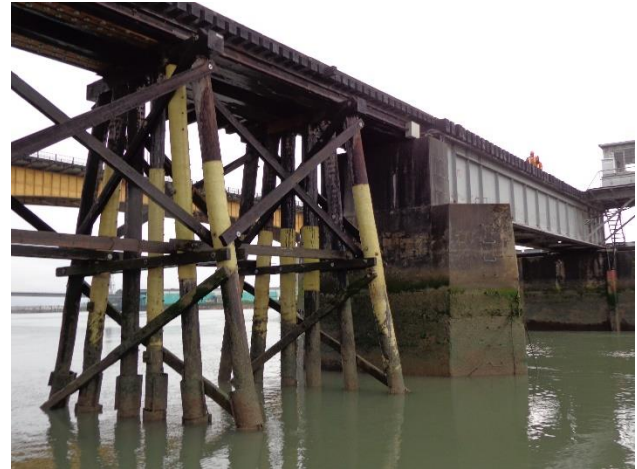
Figure 3-9: High-strength fibre retrofits on a railroad bridge, including tension reinforcement and pile wraps. These targeted retrofits were designed to reinforce deteriorated elements to restore the capacity of the structure. The retrofits could be installed while the bridge remained in service without interrupting rail traffic.

Alternatively, FRP reinforcing may be used to make targeted, in-situ repairs of elements that have become degraded by decay or other damage. Often, these FRP retrofits can be installed while the bridge remains in service. This can provide significant cost savings compared to kind-for-kind replacement strategies by avoiding costly demolition work, temporary structures, and detours. When combined with advanced inspection and preservation strategies, FRP retrofits can significantly extend the useful life of a structure that might otherwise be slated for replacement.

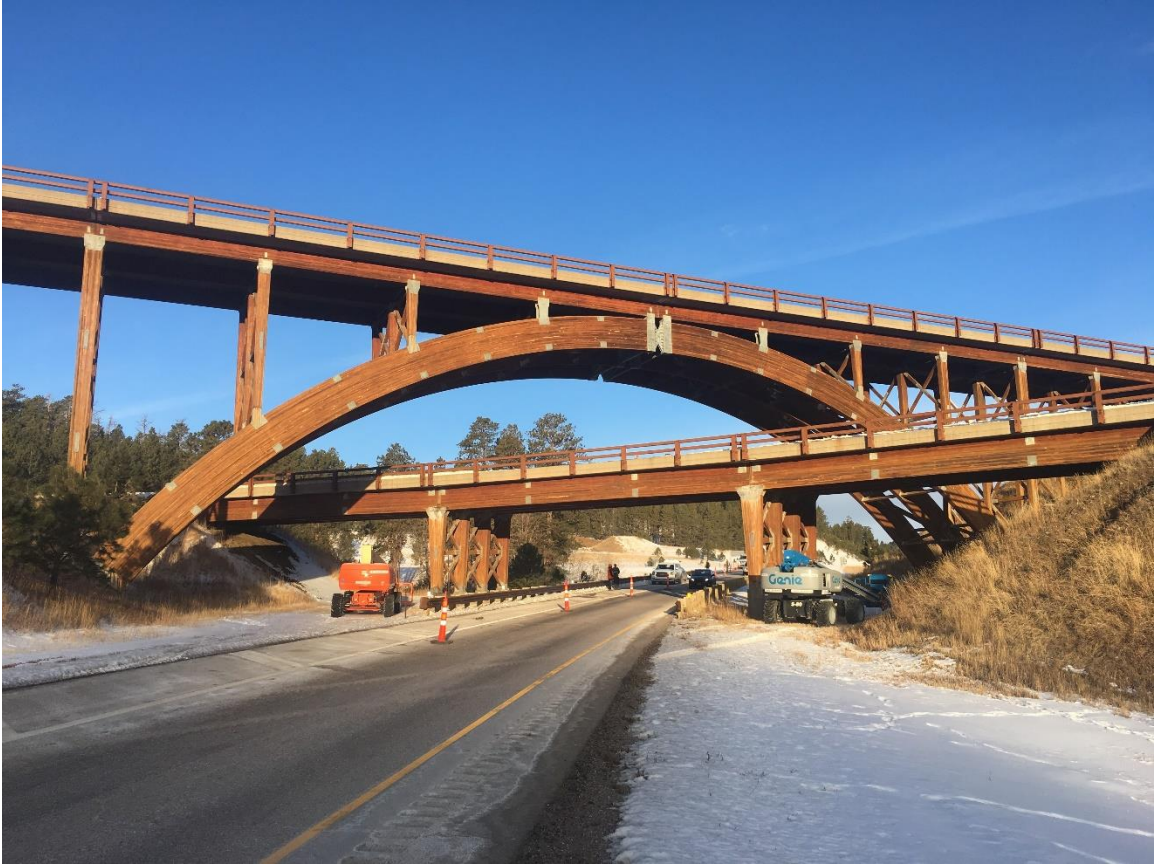
Figure 5-1: The Keystone Wye Bridges in South Dakota were recently inspected after more than 50 years in service, and were found to be in good condition; only minor repairs and routine maintenance were recommended to extend the longevity of the structures.

An in-depth inspection of the structures, including non-destructive testing, was conducted in 2018 by Wood Research and Development, after the bridges had been in service for over 50 years. The inspection report found both structures to be in good condition, and recommended only routine maintenance to extend the life of the structures.

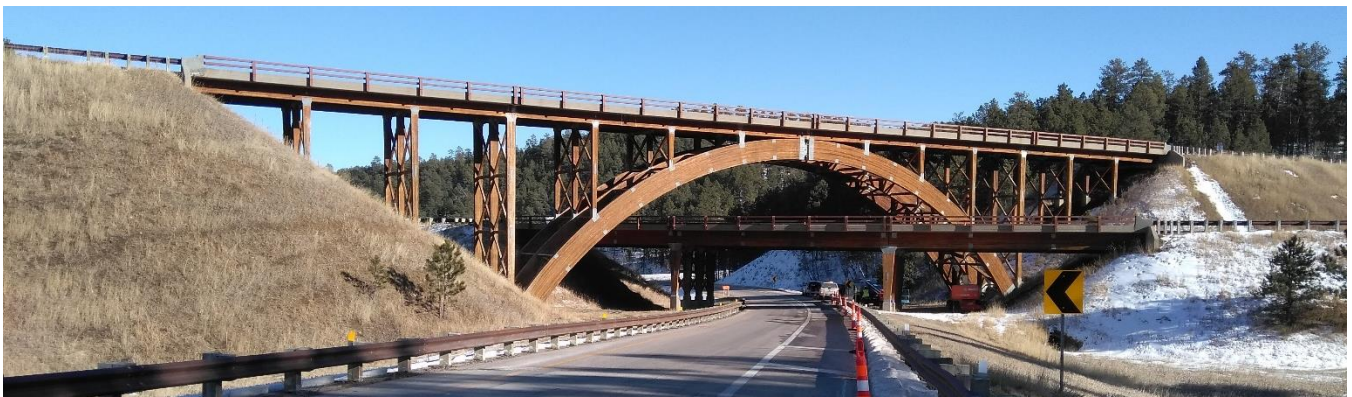
Figure 5-2: The wye includes an upper bridge supported on three-pinned glulam arches, and a lower three-span bridge supported by glulam girders.

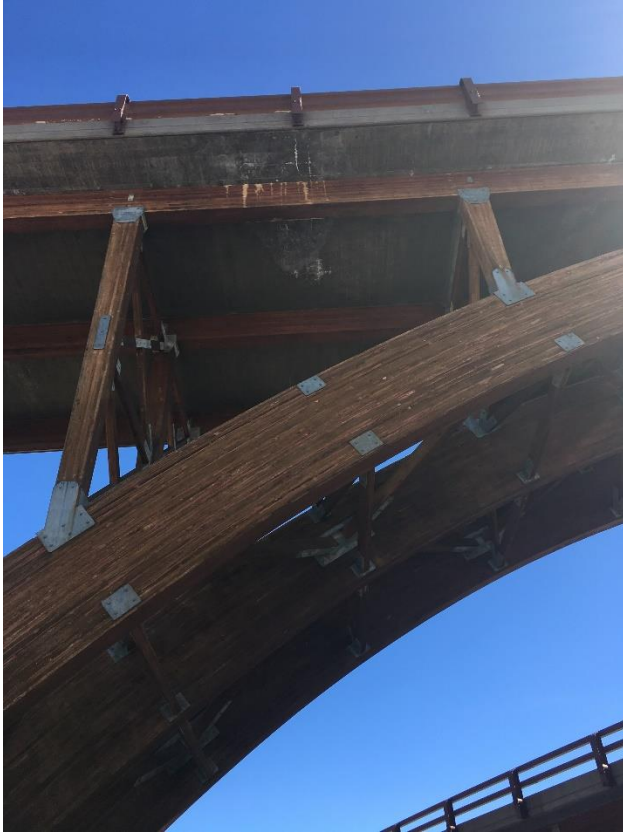
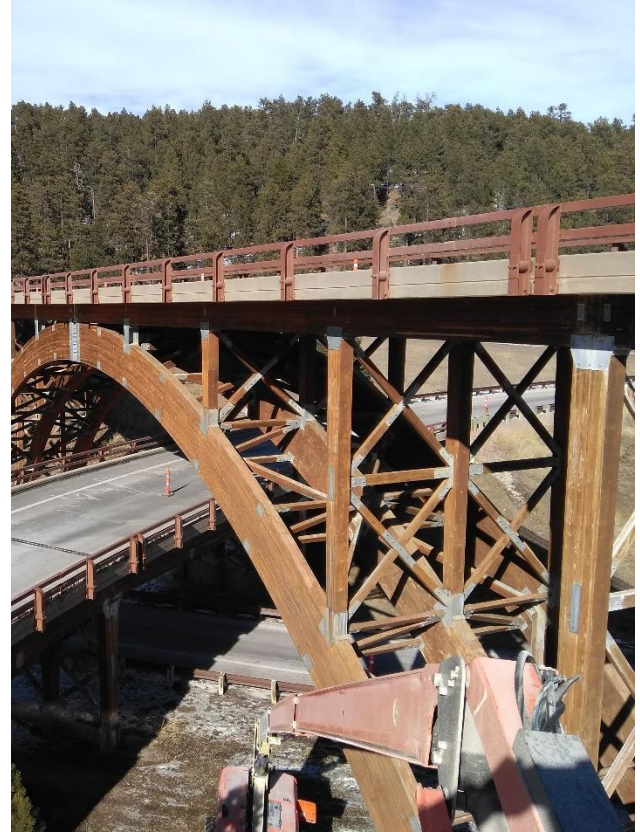
Figure 5-3: The upper bridge is supported by glulam arches.

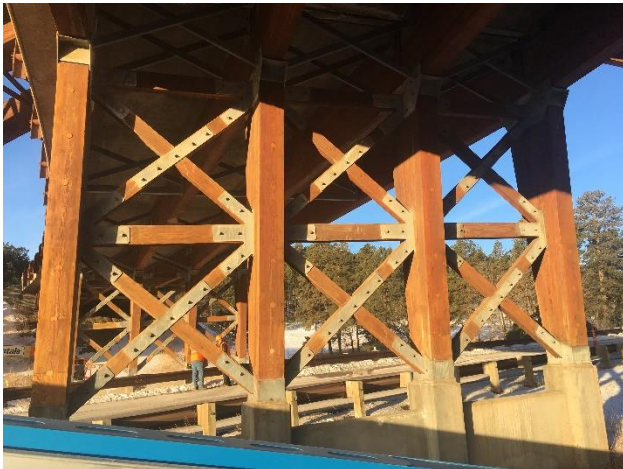
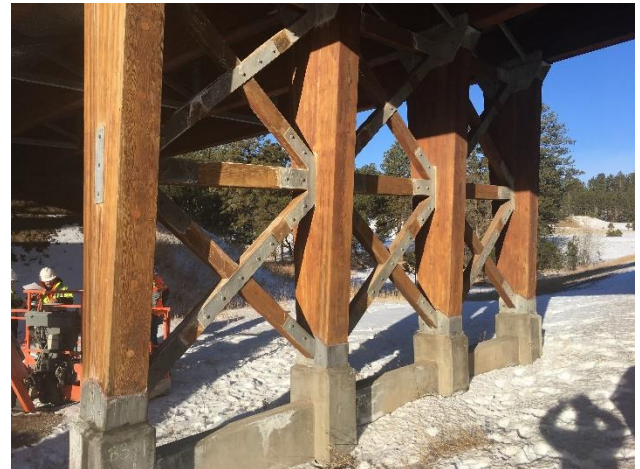
Figure 5-4: The substructure of the lower bridge consists of glulam timber frame bents.

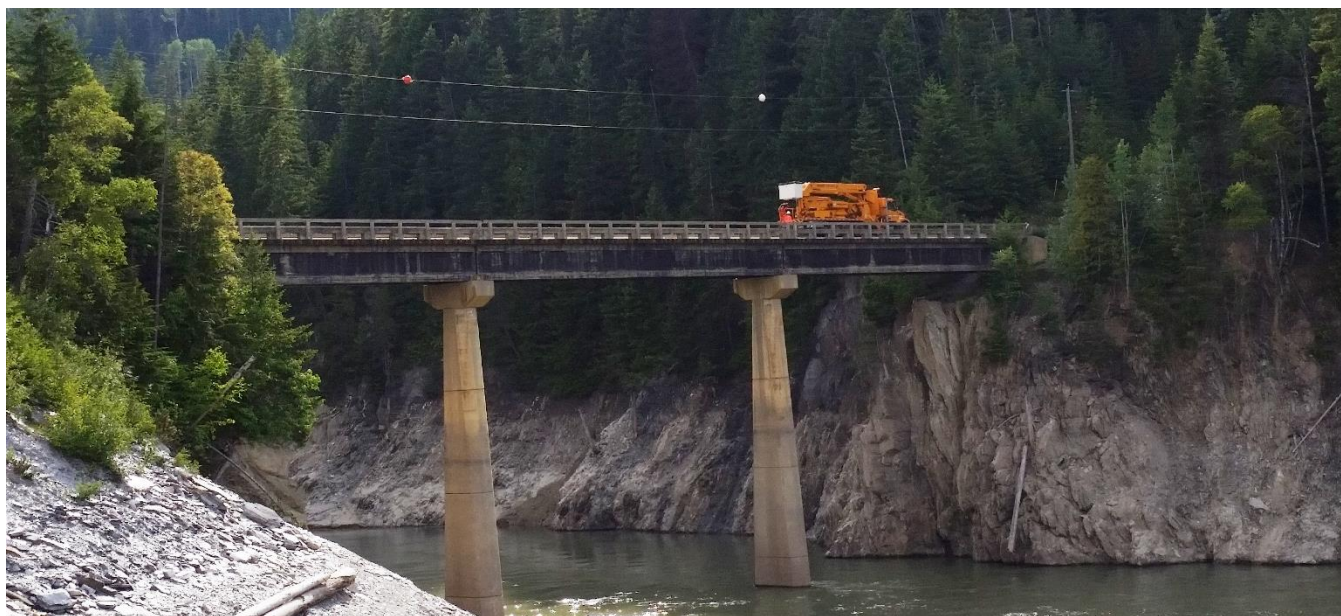
Figure 5-5: Golden Bridge, in British Columbia is a 3-span glulam timber bridge, totaling 82m (270 ft.) in length.

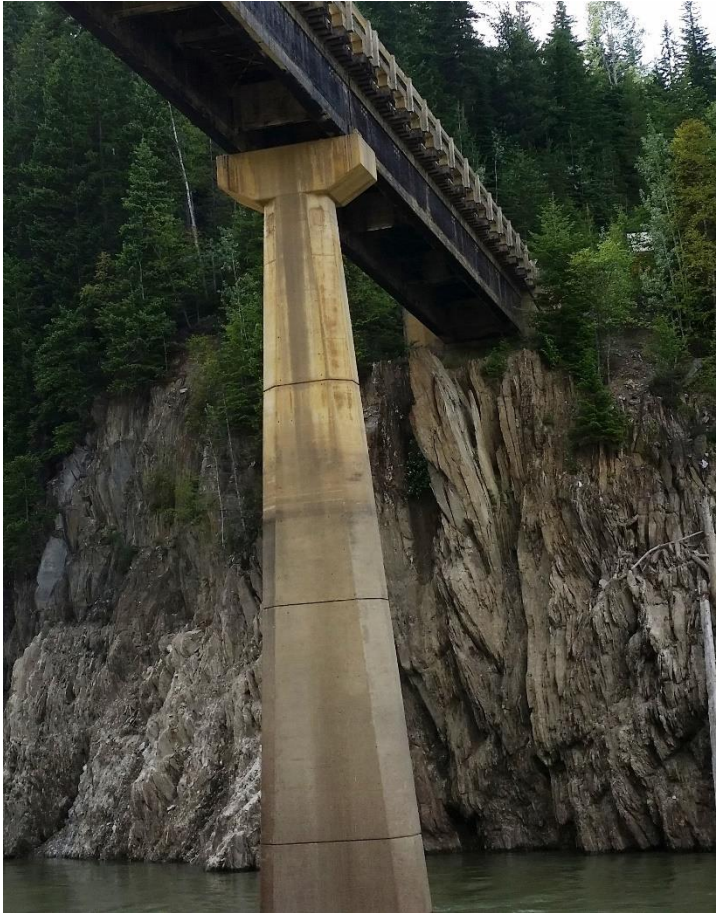
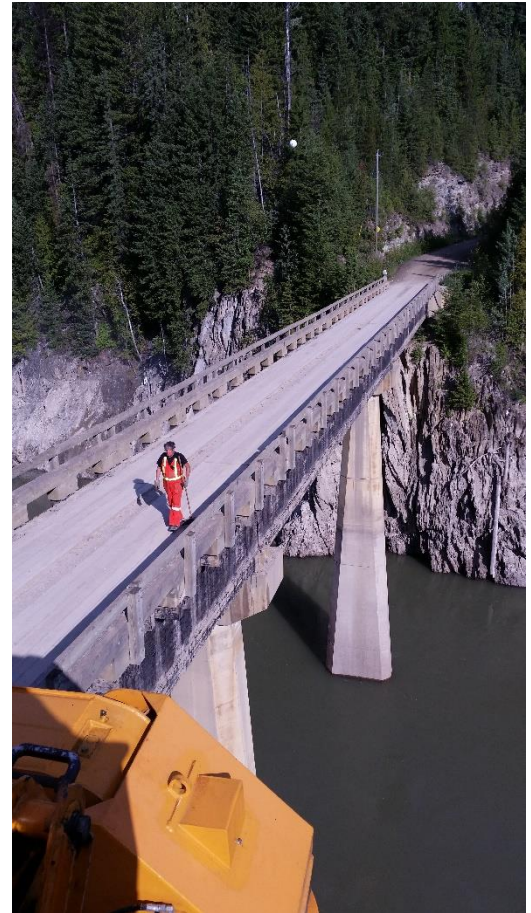
Figure 5-6: Each 27m (90 ft.) span consists of two glulam I-Beams which support transverse bearers. The deck and wear surface are made up of longitudinal planks.

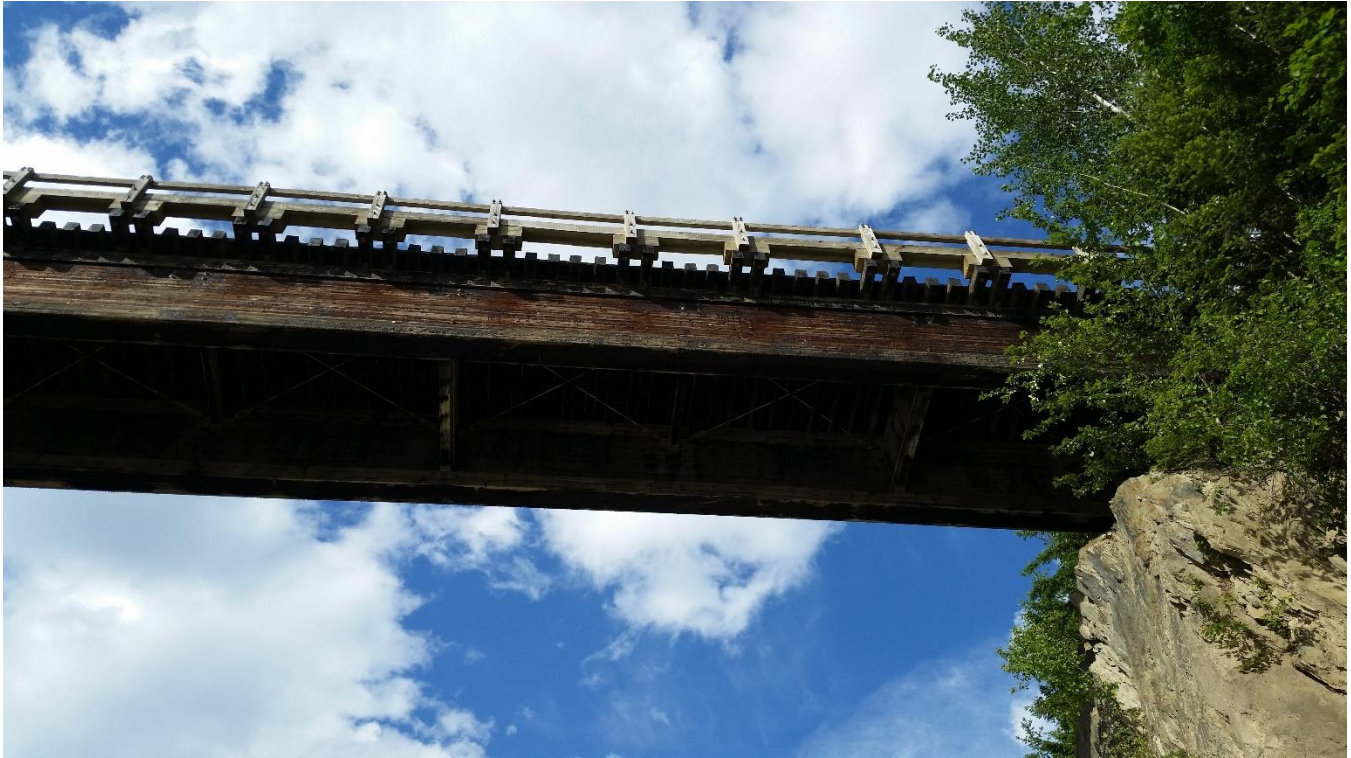
Figure 5-7: A recent inspection of the bridge found it to be in fair condition overall. The only significant deficiencies found were in the deck system as a result of vertical fasteners allowing water to penetrate into the timber elements. Even with these deficiencies, the bridge can maintain an L100 load rating. Recommendations were given for repairs and maintenance that could extend the life of the bridge for as much as 80 more years.

However, the inspection did reveal some deficiencies in the deck, primarily due to the use of vertical fasteners which have allowed moisture to penetrate into the timber elements. It was recommended that the deck be upgraded to a system that avoids the use of vertical fasteners. The Department of Forestry in British Columbia reports over 2,800 timber bridges in inventory. The Ministry of Transport reports a similar number in operation for a total approaching 5,700 timber bridges in British Columbia.

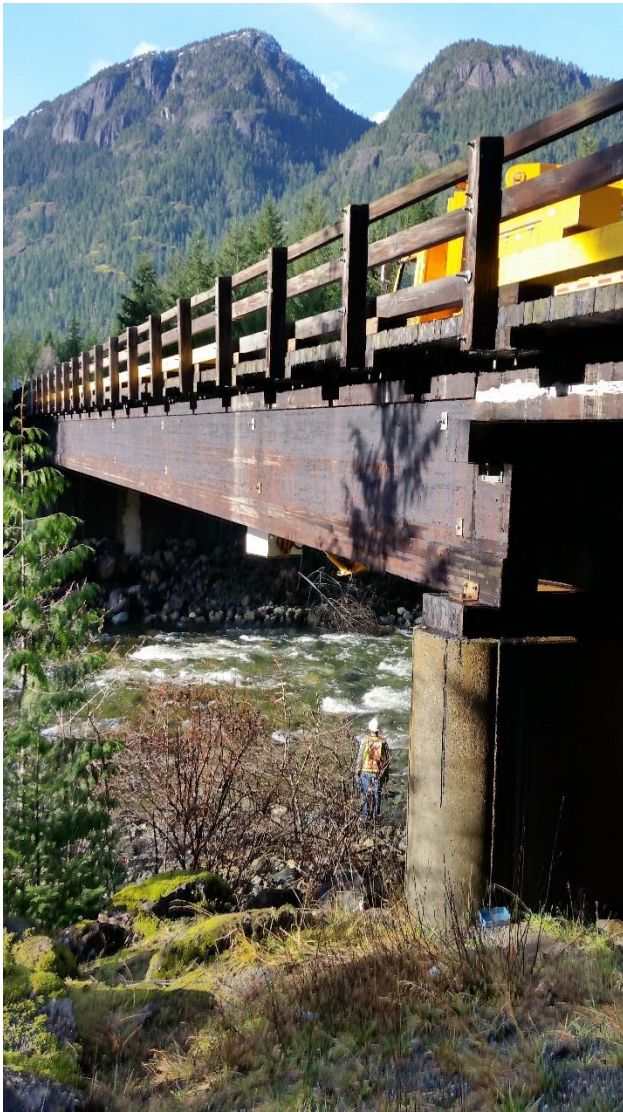
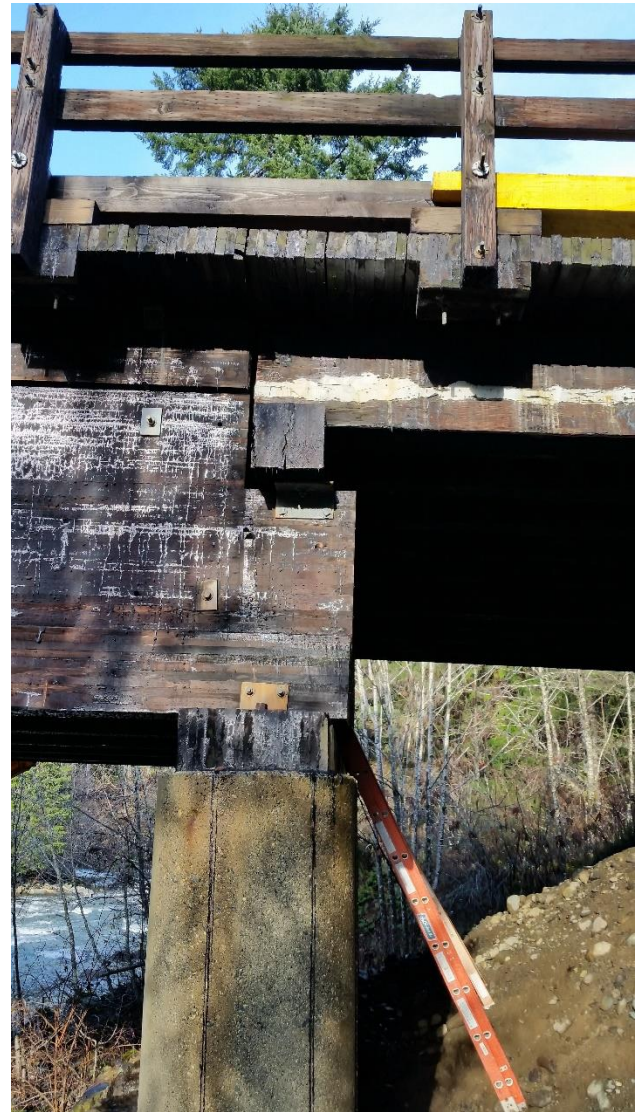
Figure 5-8: Elk River Bridge consists of six glulam I-beams spanning 35m; at each end is an approach span of approximately 8m made up of solid sawn girders. The deck is transverse nail-laminated timber.
