Timber Bridge Best Practices and the State of the Industry in Atlantic Canada

PREPARED AND PRESENTED BY:

Christopher Legg, Timber Structures Designer, Senior CAD Technician

Wood Research and Development

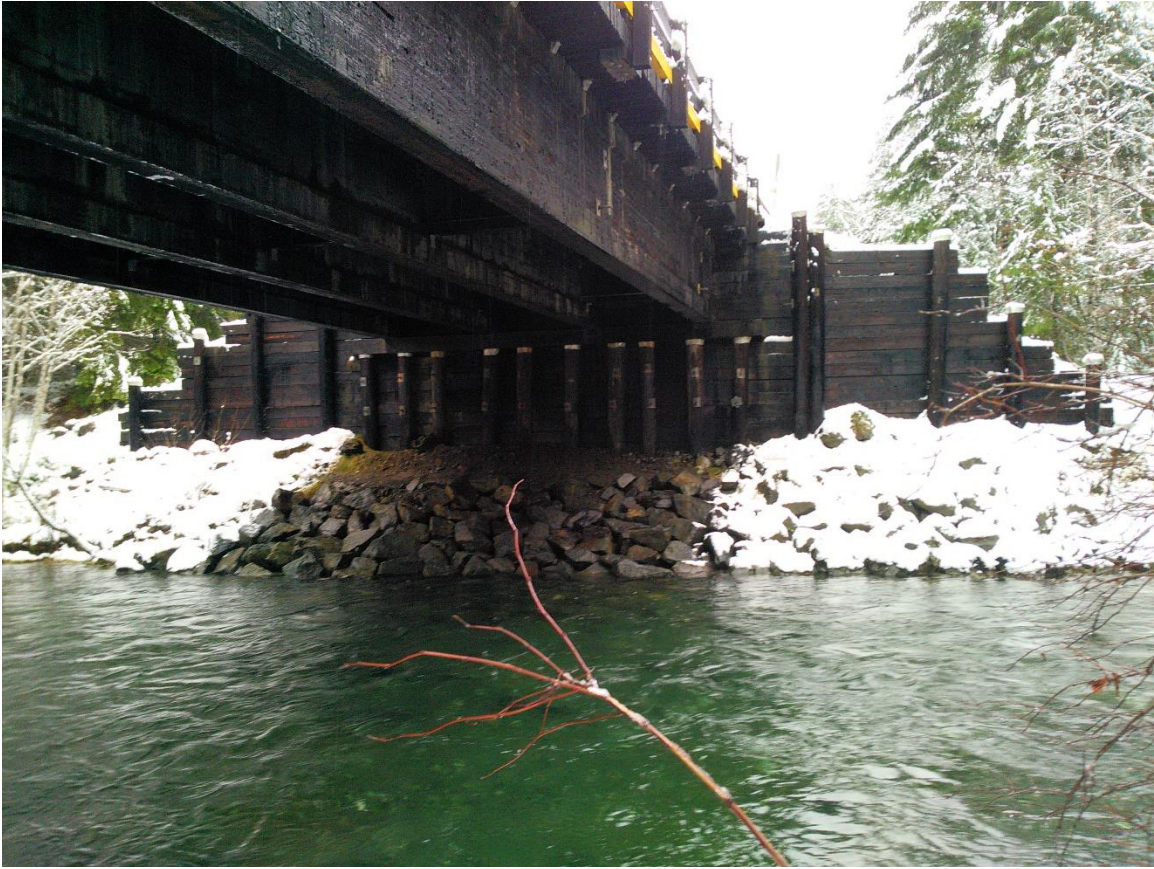
Figure 5-9: Cervus Creek Bridge is a 25m (82ft) single-span bridge consisting of four glulam I-beams with a transverse nail-laminated deck.

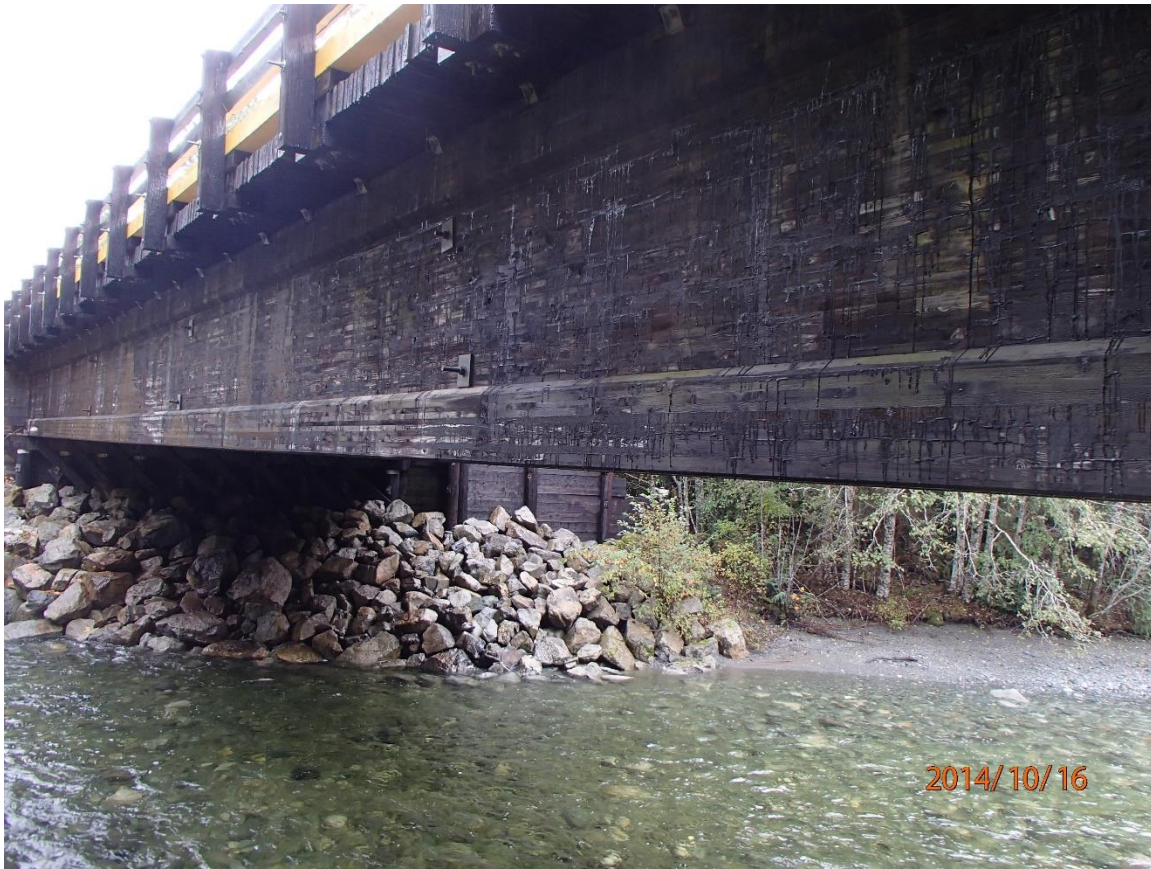
Figure 5-10: Heber River Bridge is a single-span, 34.5m (113ft) long consisting of four glulam I-beams and a transverse nail-laminated deck.

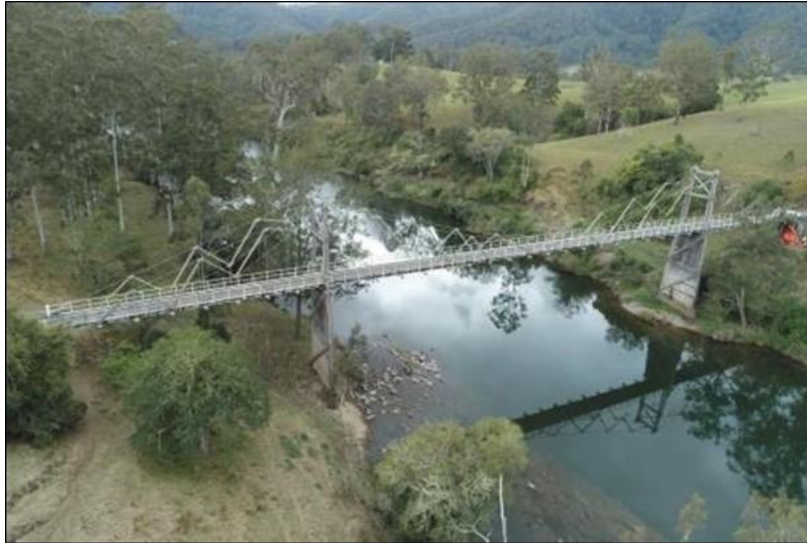
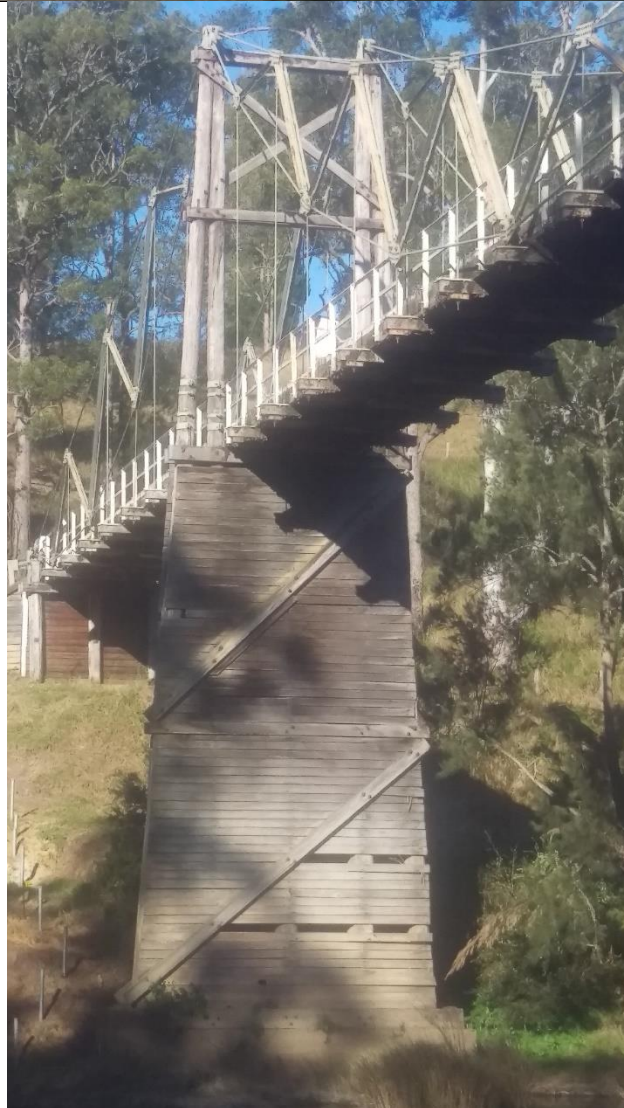
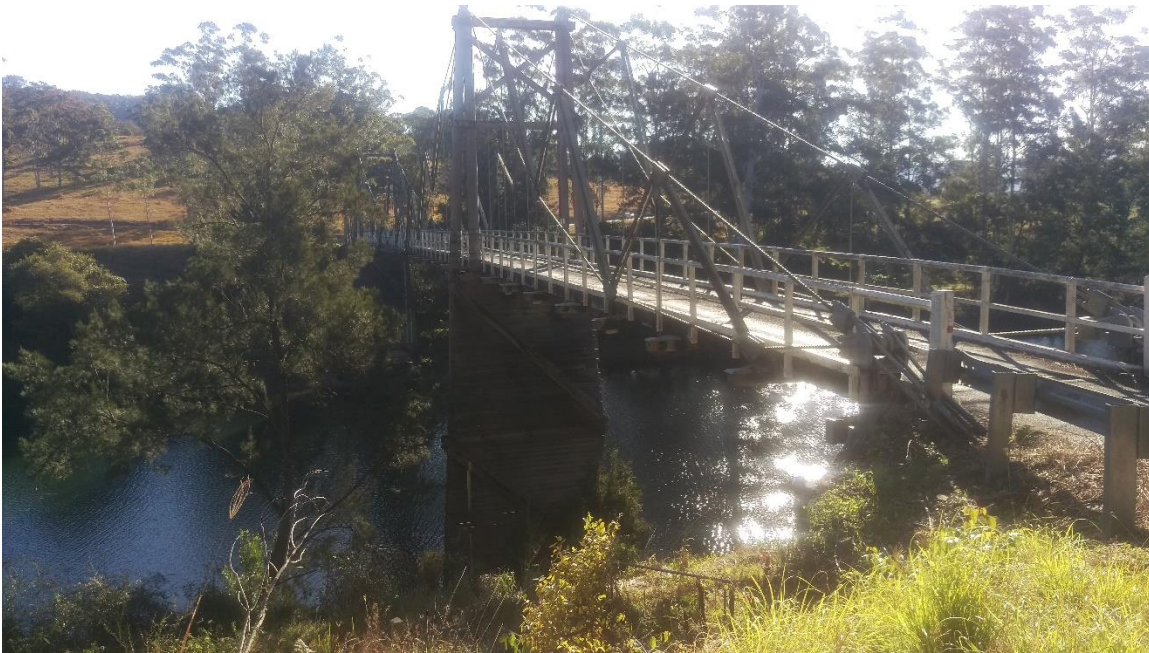
Figure 5-11: Kindee Suspension Bridge.

The longest timber suspension bridge in Australia still in service is the Kindee Bridge. See Figures below. Kindee Suspension Bridge over the Hastings River at Kindee comprises of three spans; 26.8m, 67.1m and 26.8m respectively. The timber deck is supported from the trussed cables with a panel length (longitudinally along the bridge) of 3.35m. The bridge has a camber of 0.915m and the clearance height above the highest known flood is 1.830 m at the center of the bridge. The center span truss is an inverted three hinged arch with the side spans acting as a simply supported truss to carry loads on the span itself whilst also acting as a back stay to support the horizontal tension in the center spans truss when loaded. The bridge is over 84 years old.

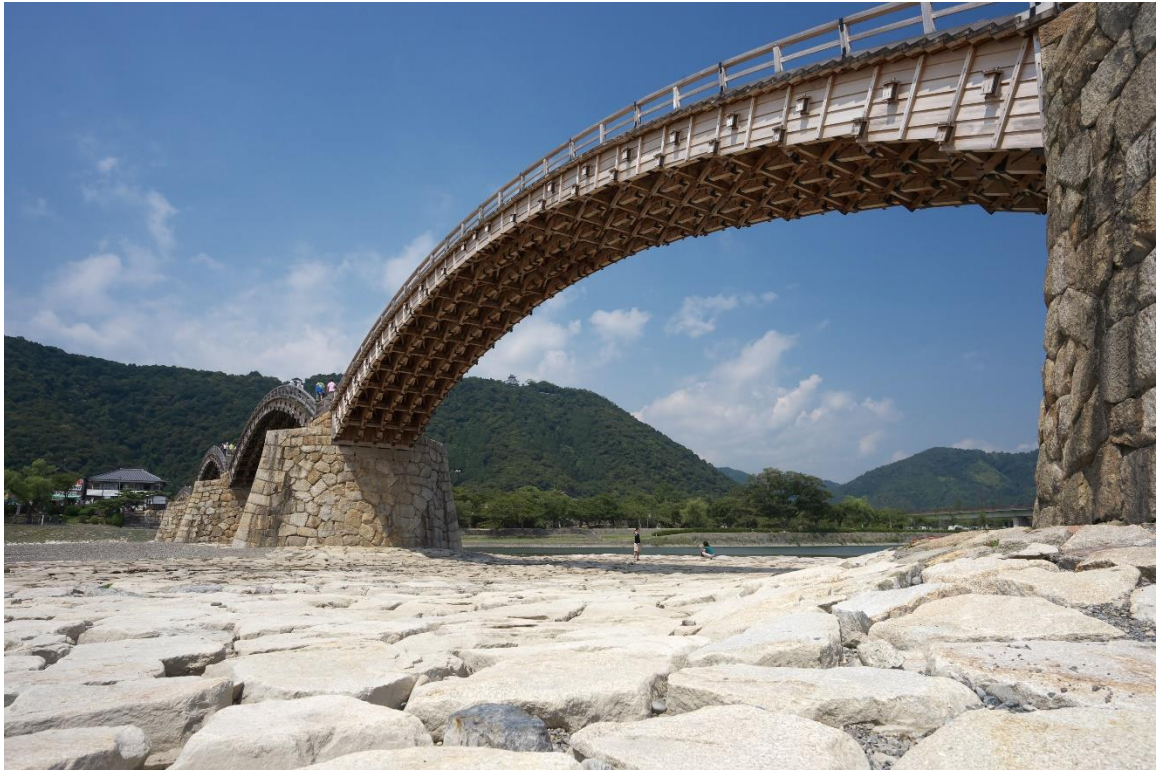
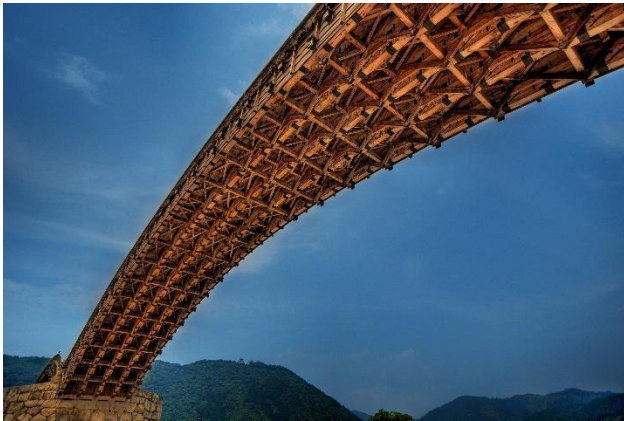
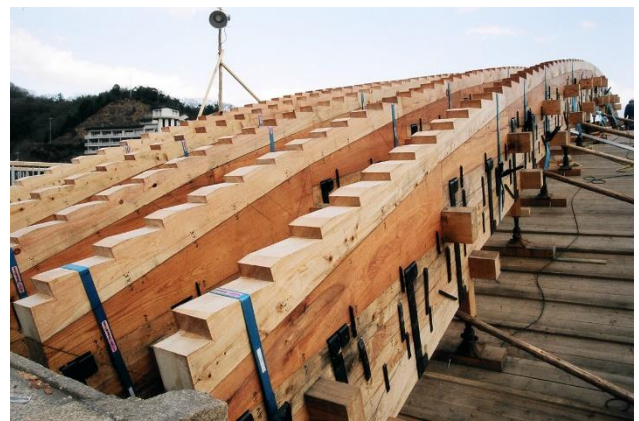
The Kintai Bridge was originally constructed in 1673 spanning the Nishiki River in Japan, and has been restored and rebuilt a number of times since then. The bridge is made up of five wooden arches, each spanning approximately 35m (115ft). The arches consist of a unique leaf-spring style design, with multiple layers of timber joined together with iron straps.

Figure 5-12: Kintai Bridge, spanning the Nishiki River in Japan, was originally constructed in 1673

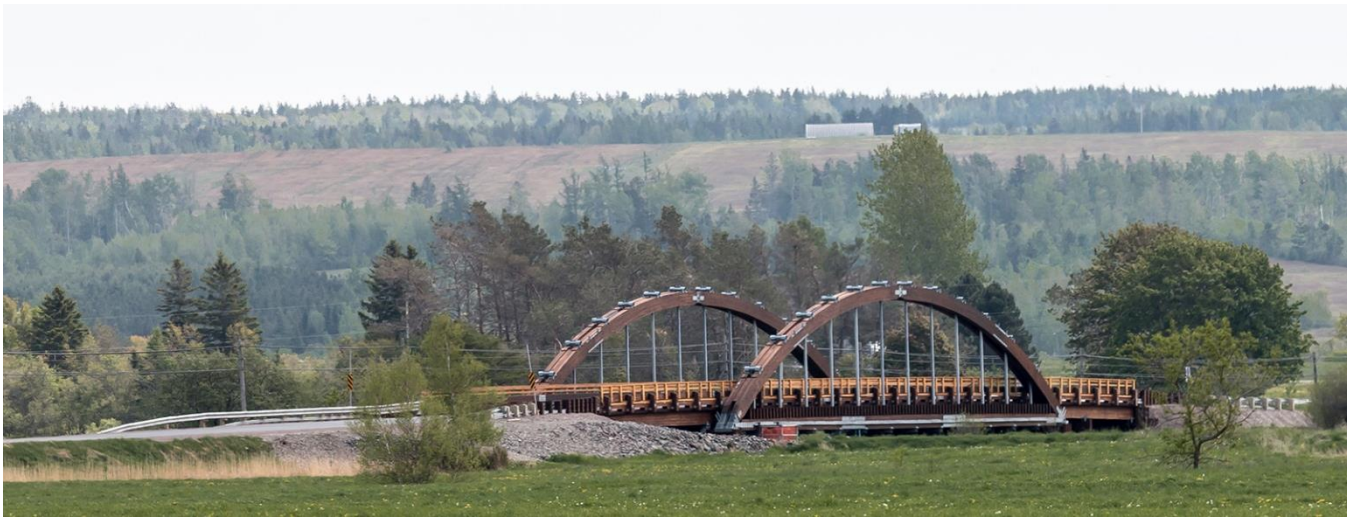
Figure 5-13: Roger Bacon Bridge in Nappan, N.S. consists of glulam arches spanning 39.5m and girder-under approach spans spanning 12m at each end.

Located in Nappan, Nova Scotia, the bridge replaced an existing steel arch bridge which had failed and was taken out of service. The existing timber piles remained in good condition, and the new bridge was built on these piles with only minor repairs needed.

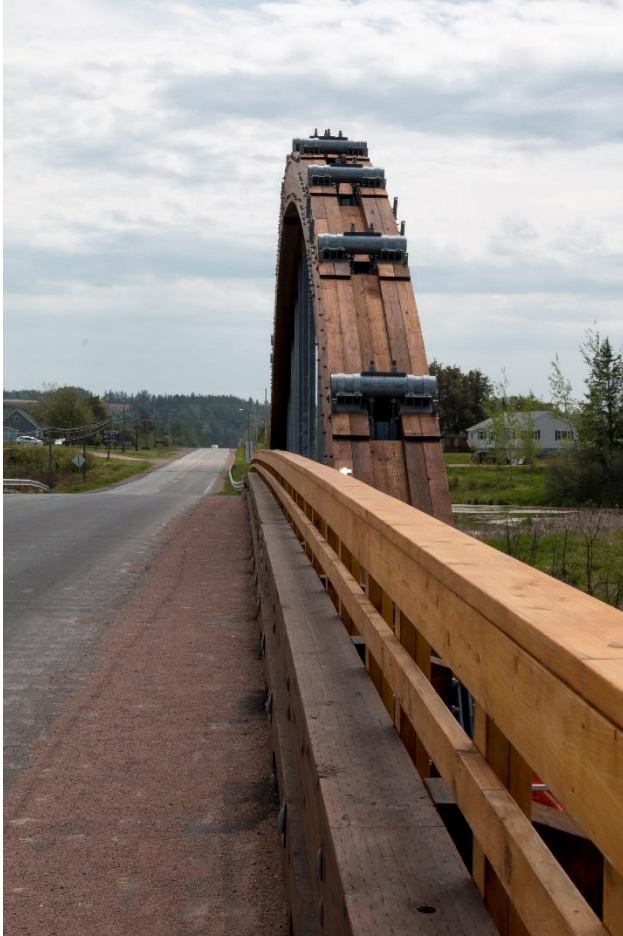
Figure 5-14: The main arches are made up of four layers of glulam beams with spacer blocks between. These arches support steel hangers, which carry the transverse glulam deck system.

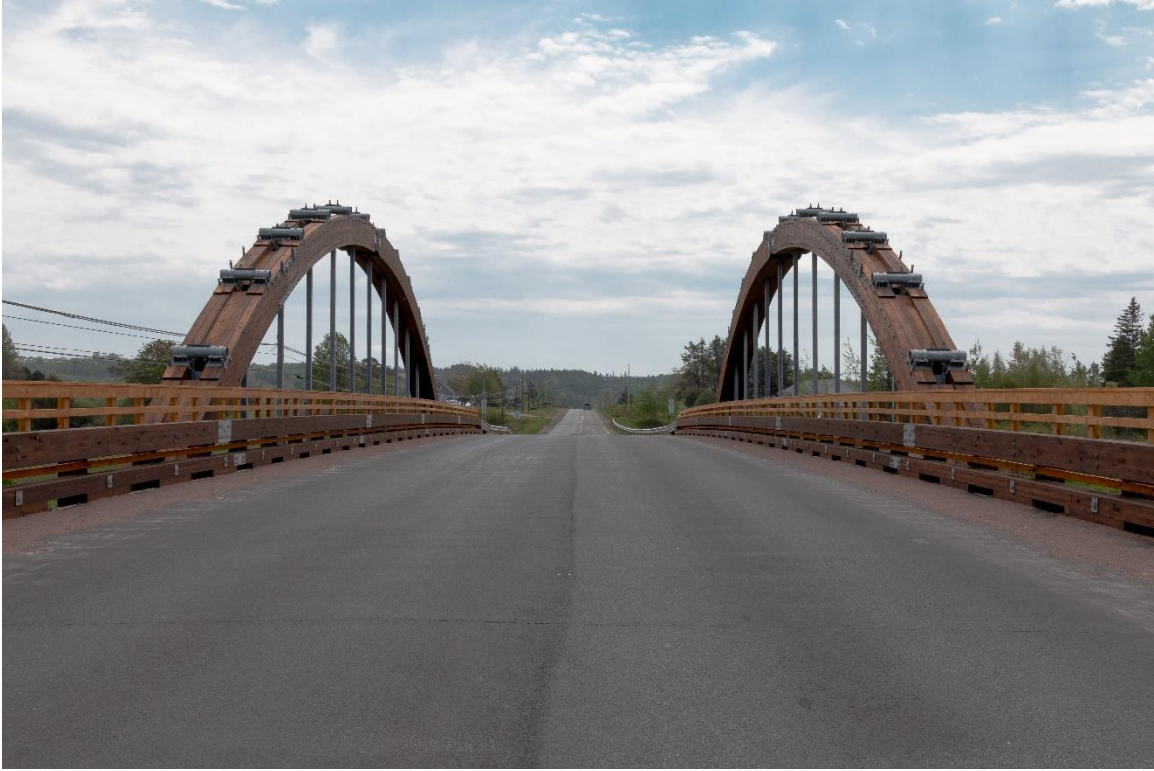
Figure 5-15: The bridge carries a two-lane highway with wide shoulders; the design allows the bridge to safely carry up to three lanes of traffic.

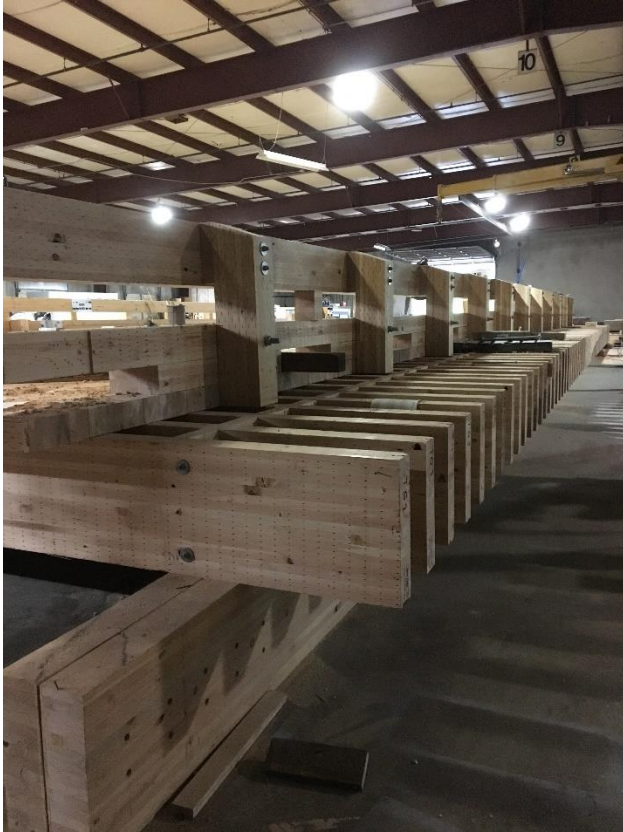
Figure 5-16: The timber components were preassembled prior to preservative treatment to ensure a proper fit and minimize on-site modifications.

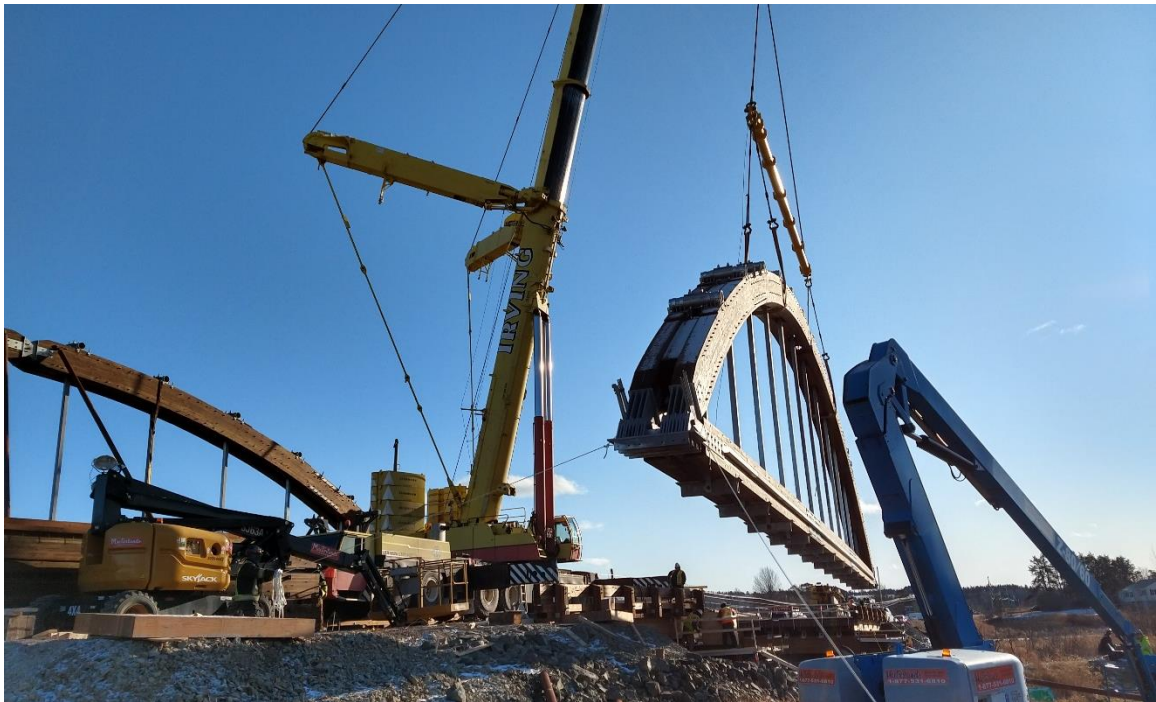
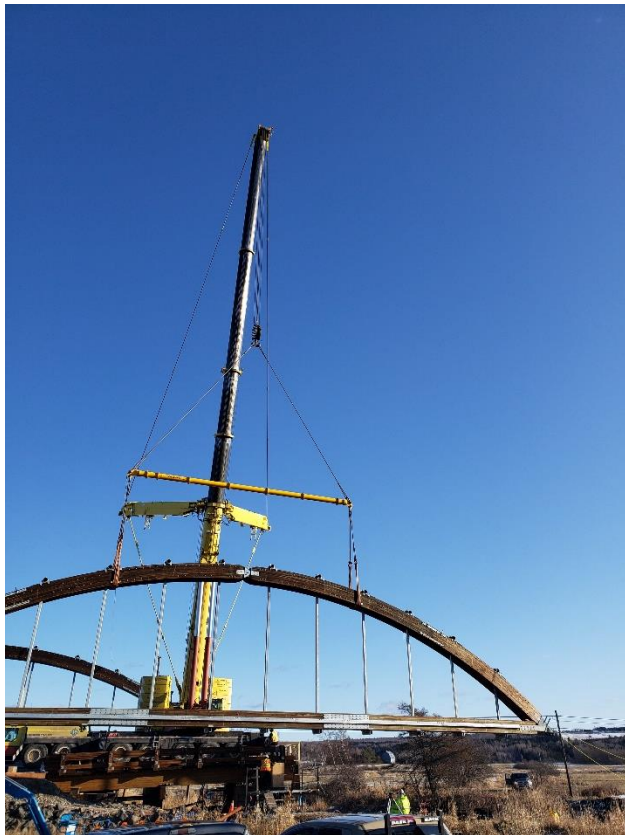
Figure 5-17: The arches were assembled alongside the road, on shore, and then flown into position by crane.

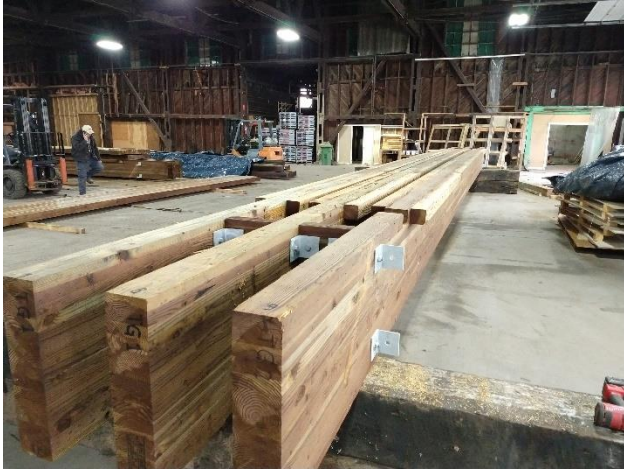
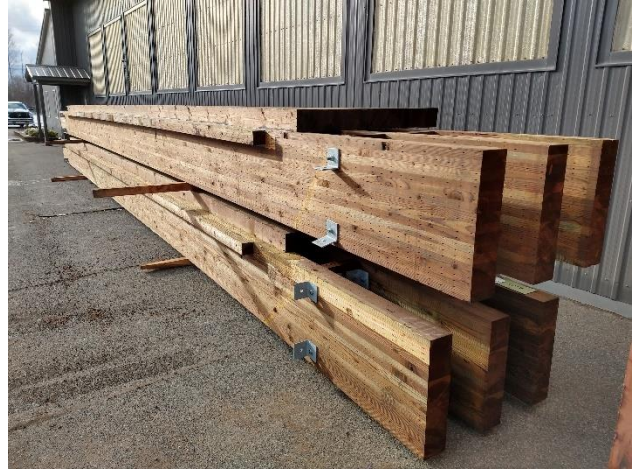
Figure 5-18: The deck in the main arch span consists of transverse “Triple-T” panels. These panels are made up from glulam three transverse floor beams with a glulam deck panel glued to the top. The beams and panels are bonded with structural epoxy adhesive to act as a composite section. Each panel laps over the previous beam and is field glued, so that the entire deck acts as a continuous diaphragm.

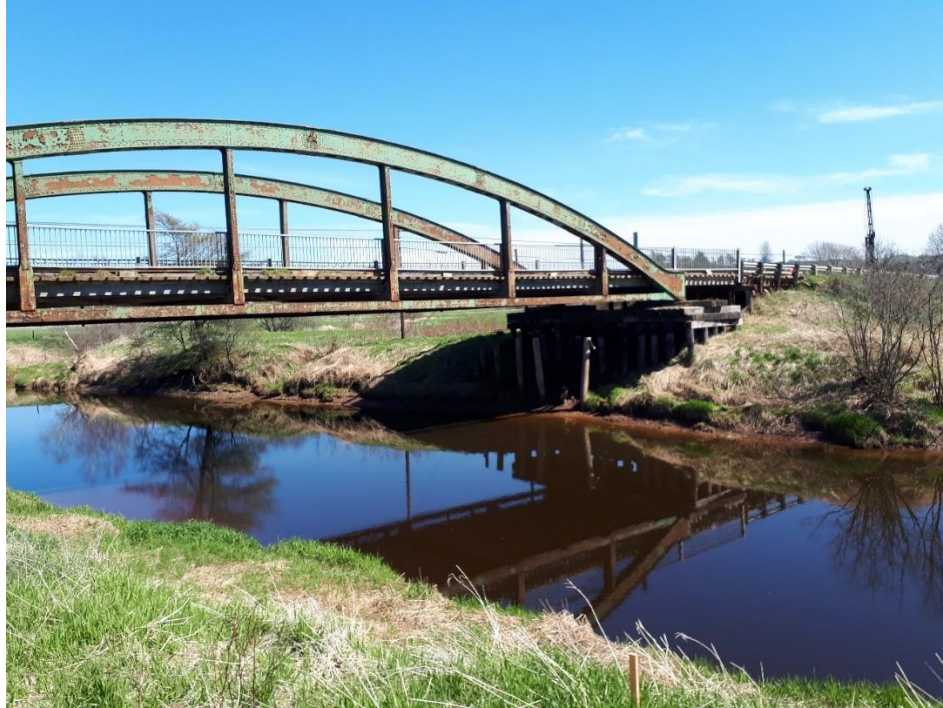
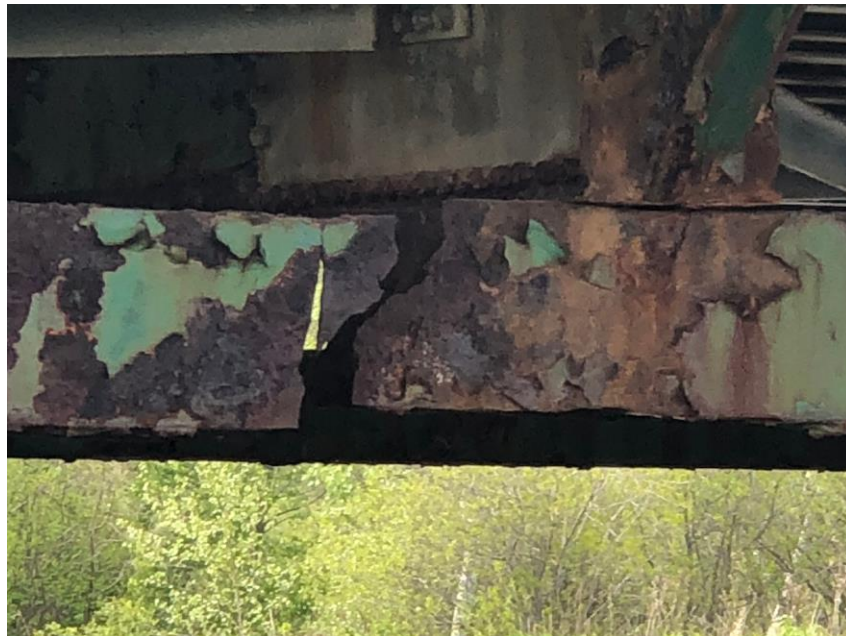
Figure 5-19: The existing steel arch span that was replaced by the new timber structure. Note in the lower photo the failed tension cord having rusted through and failed. The bridge is located in the highest embedded and exposed corrosion zone in Canada. Wood is the best option. The bridge was first built in wood on wood piles 100 years ago. The steel bridge was built on the old piles with more piles added to accommodate the dead weight less than 50 years ago. Now after a short life (less than 50 years) the steel bridge is replaced with wood, the best option in this case!! Lower cost and better design life.

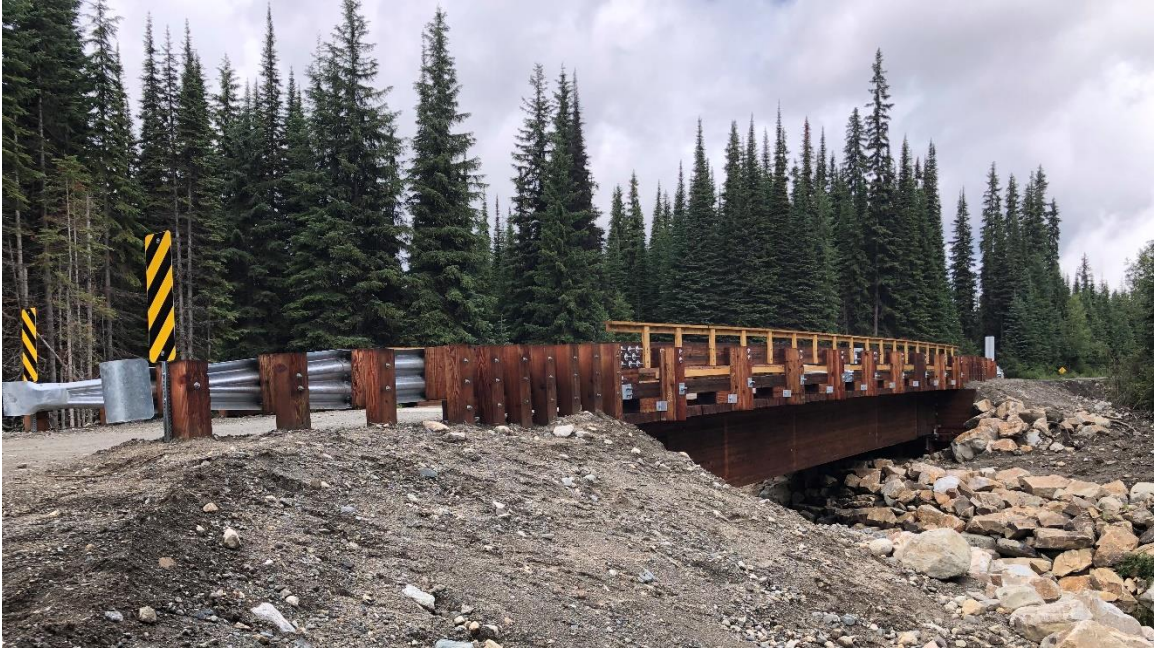
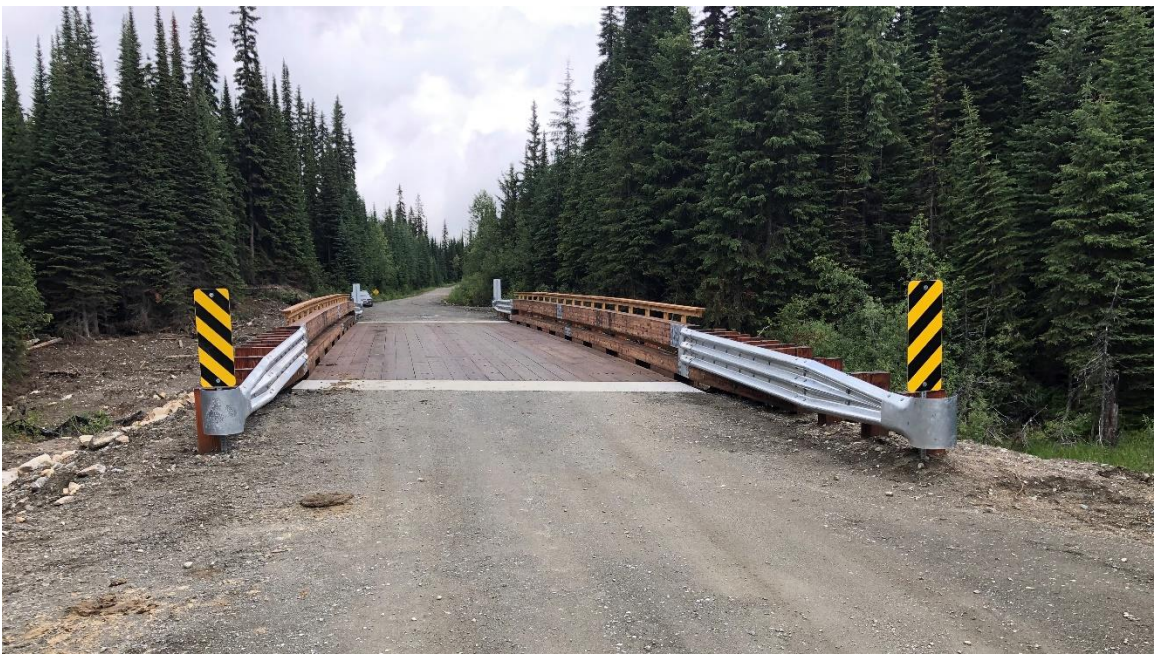
Figure 5-20: McGillivray Bridge is a 21m fibre-reinforced glulam bridge on a forestry road in British Columbia.

McGillivray Bridge was developed for the BC Ministry of Forests Lands and Natural Resource Operations as a proof of concept demonstrating the use of timber structures on forestry roads. The 21m (70 ft.), single-span bridge consists of five fibre-reinforced glulam girders and a transverse glulam deck and is supported by glulam frame bents. The bridge is designed to support L100 loading – a BC standard design load representing off-highway logging equipment.

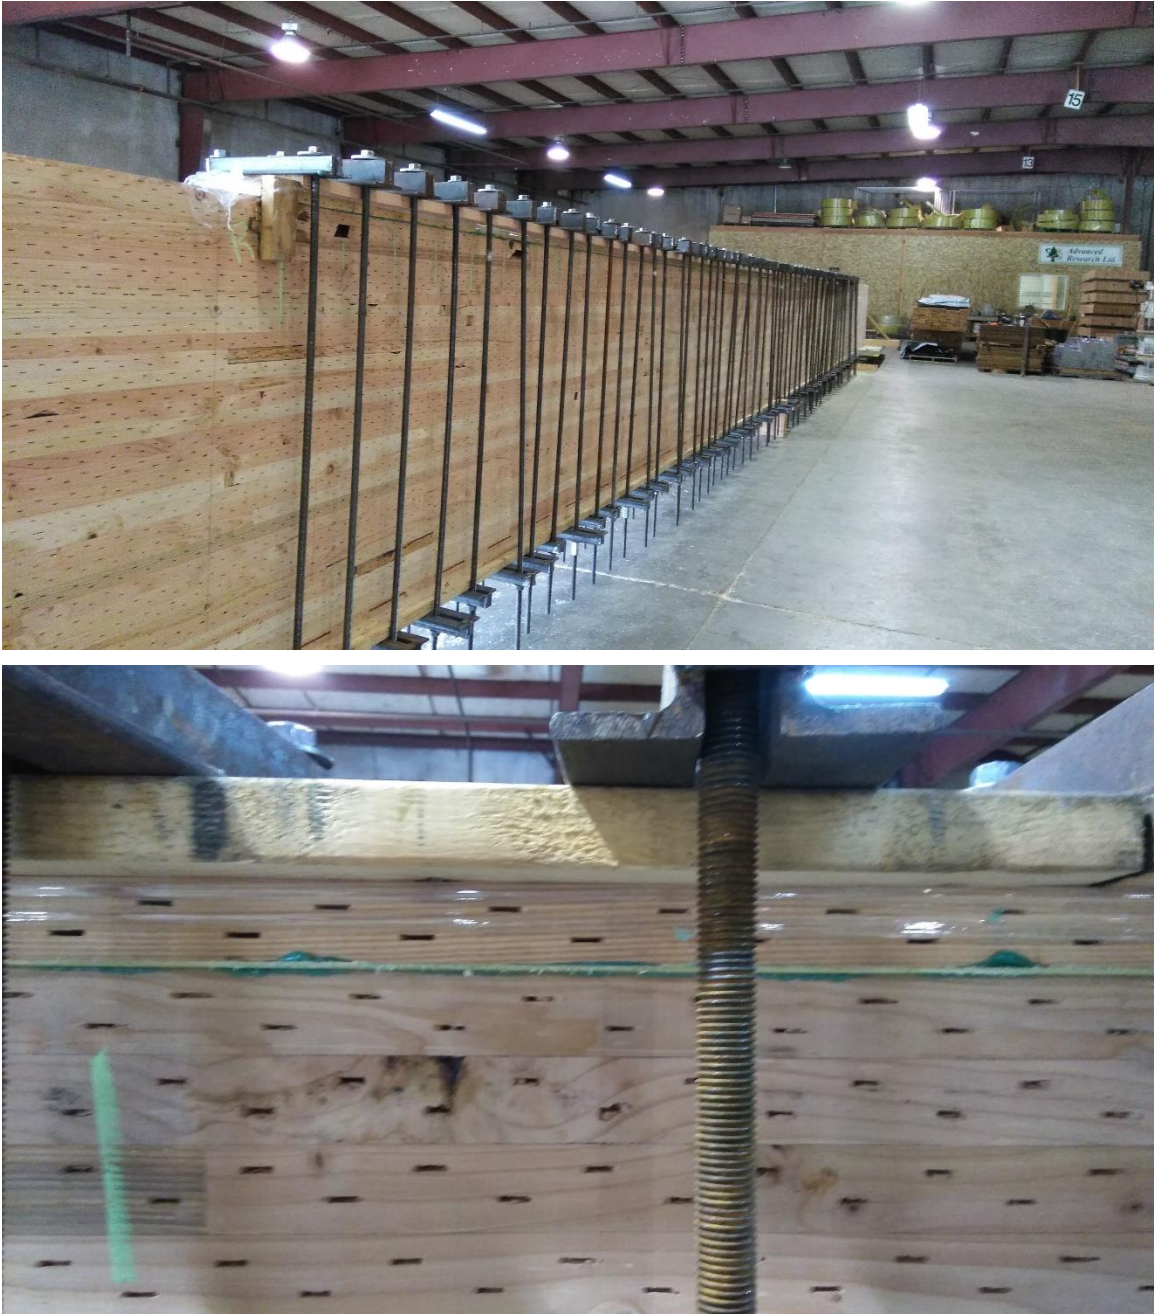
Figure 5-21: The glulam girders are reinforced with high-strength fibre on the tension face. This fibre-reinforcing is installed in the shop prior to assembling the structure.

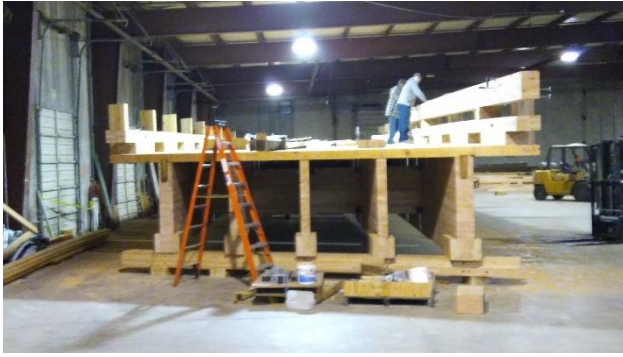
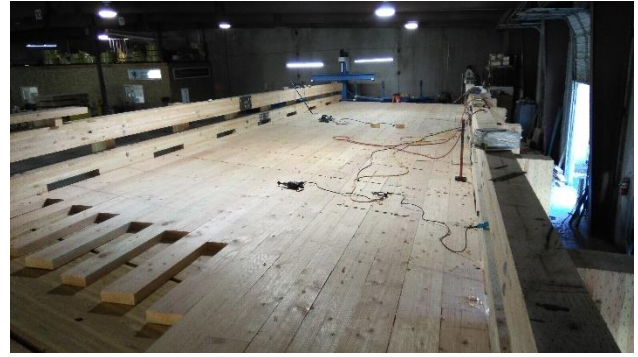
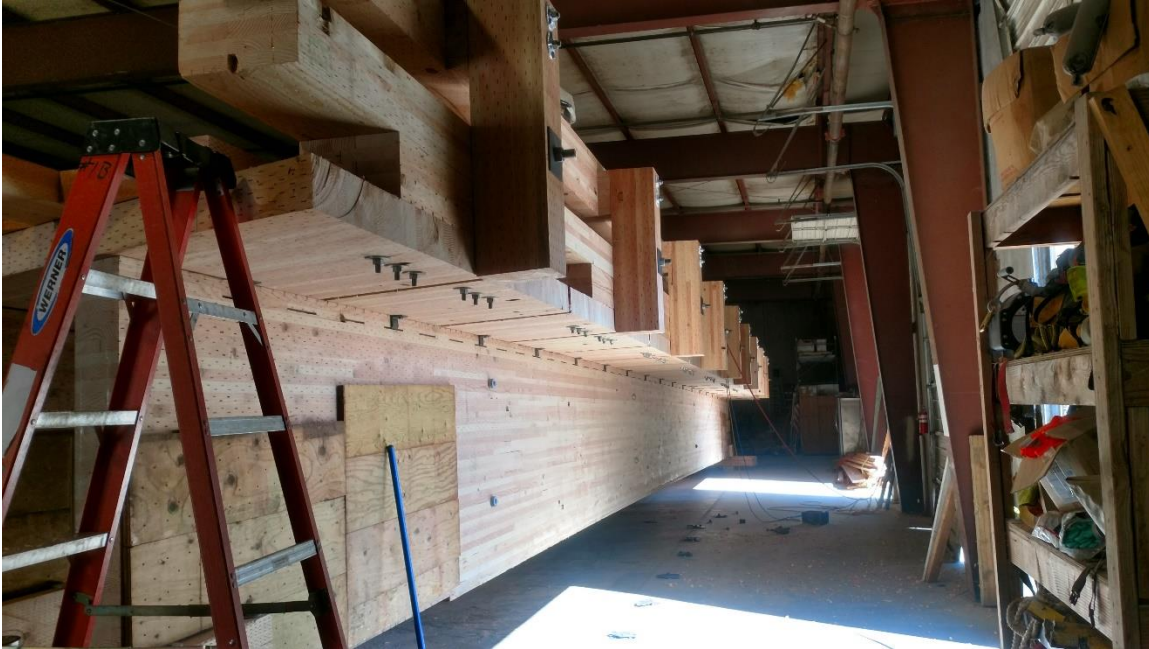
Figure 5-22: All timber components are fabricated and pre-assembled in the shop prior to preservative treatment. This dry-fit process helps avoid any field modifications that might compromise the preservative treatment layer. The bridge is then disassembled and the components are pressure-treated before being shipped to the site for assembly.

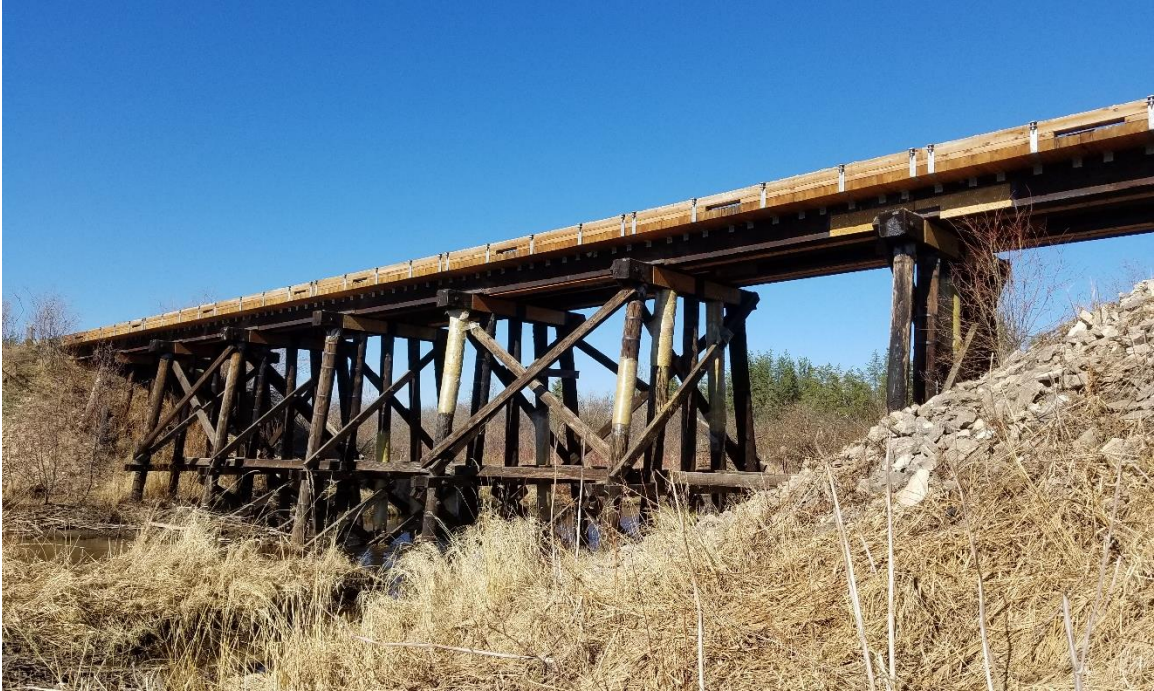
Figure 5-23: Meadow Lake Bridge is a conversion of a decommissioned railroad trestle to be used as a forestry bridge.

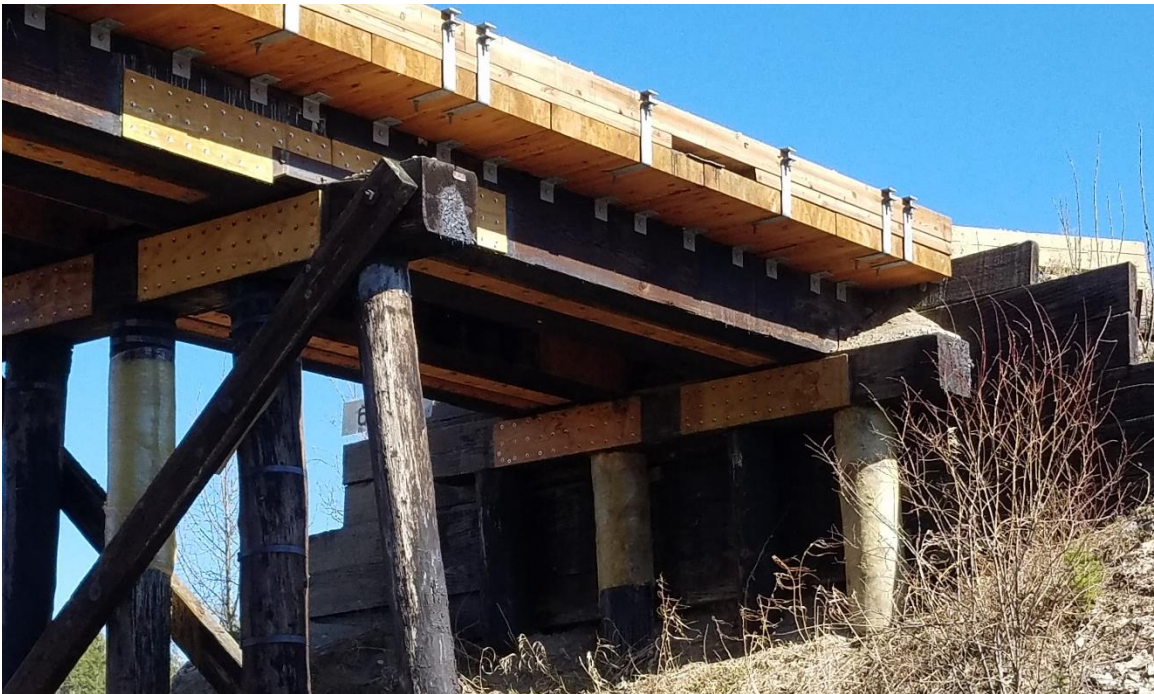
Figure 5-24: The Existing piles, caps, and chords were reinforced with high-strength fibre to restore capacity that had been lost due to decay. The old deck was removed and replaced with a new transverse glulam timber deck and curb.

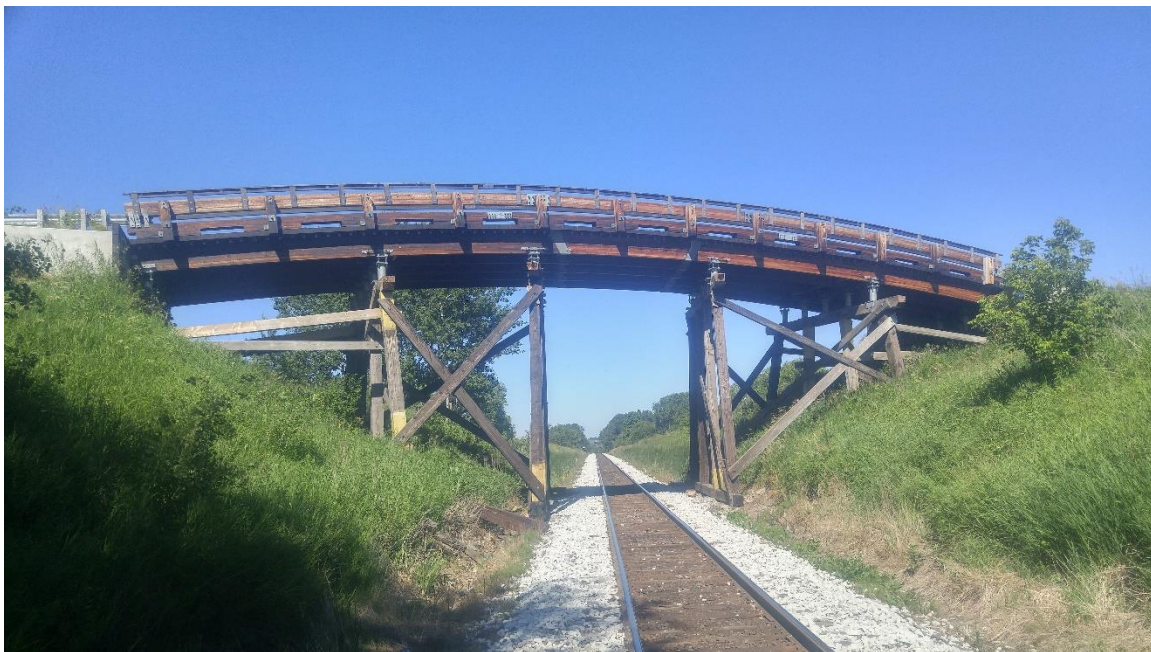
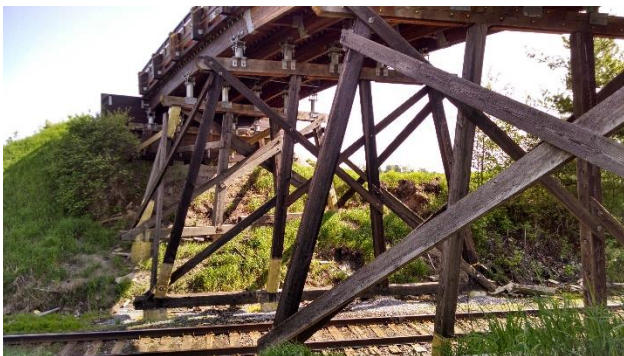
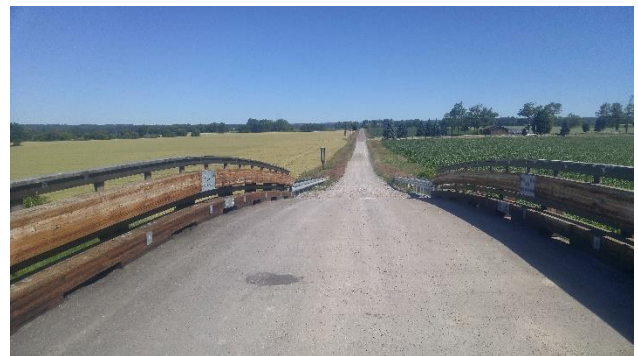
Figure 5-25: Providence Road Bridge in Clarington, ON consists of five lines of glulam girders supporting a transverse timber deck. The existing solid sawn frame bents were restored, including the addition of high-strength fibre reinforcing in some locations to restore capacity that had been lost due to decay. An asphalt wear surface was installed on top of the transverse timber deck. The timber guard rail is crash-tested to TL-4 specifications.

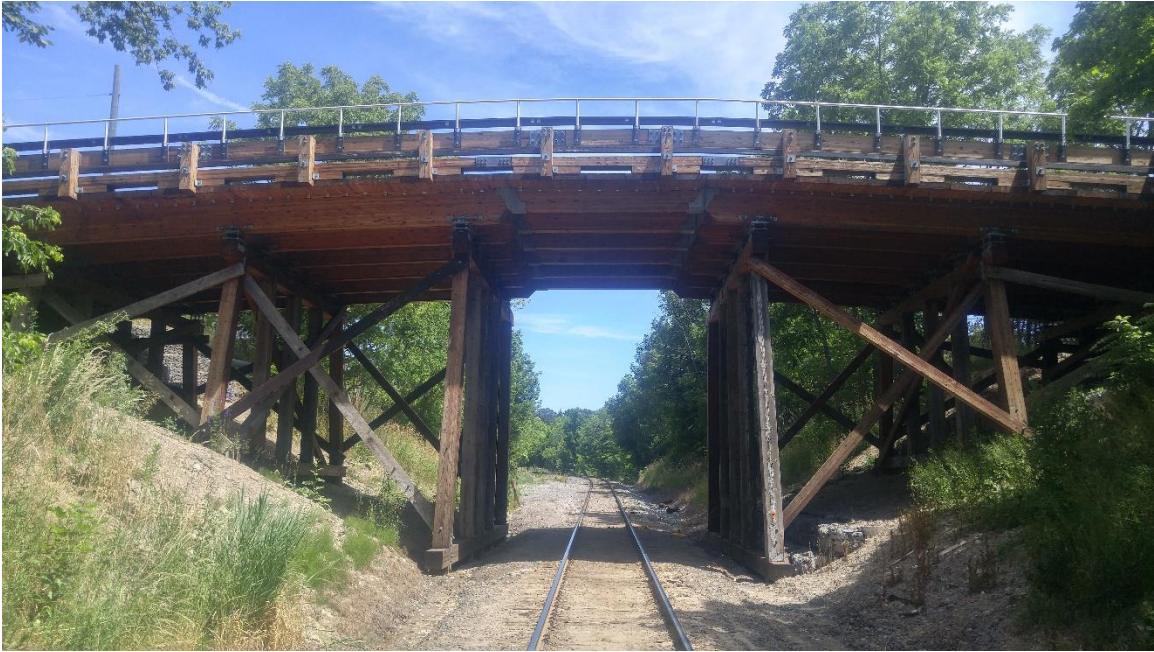
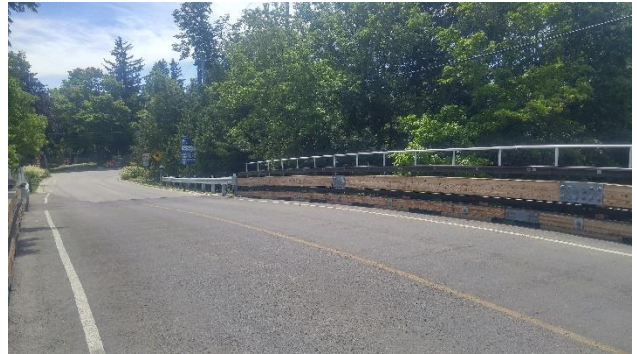
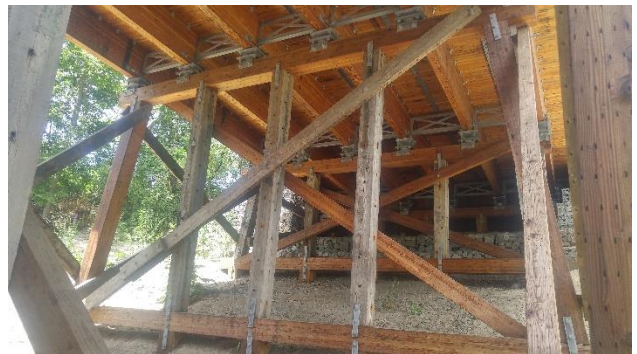
Figure 5-26: Snake Road Bridge, on the border between Hamilton and Burlington, Ontario, consists of six glulam girder lines. The substructure was completely rebuilt; however, much of the material from the original structure was salvaged for use in the new bridge.

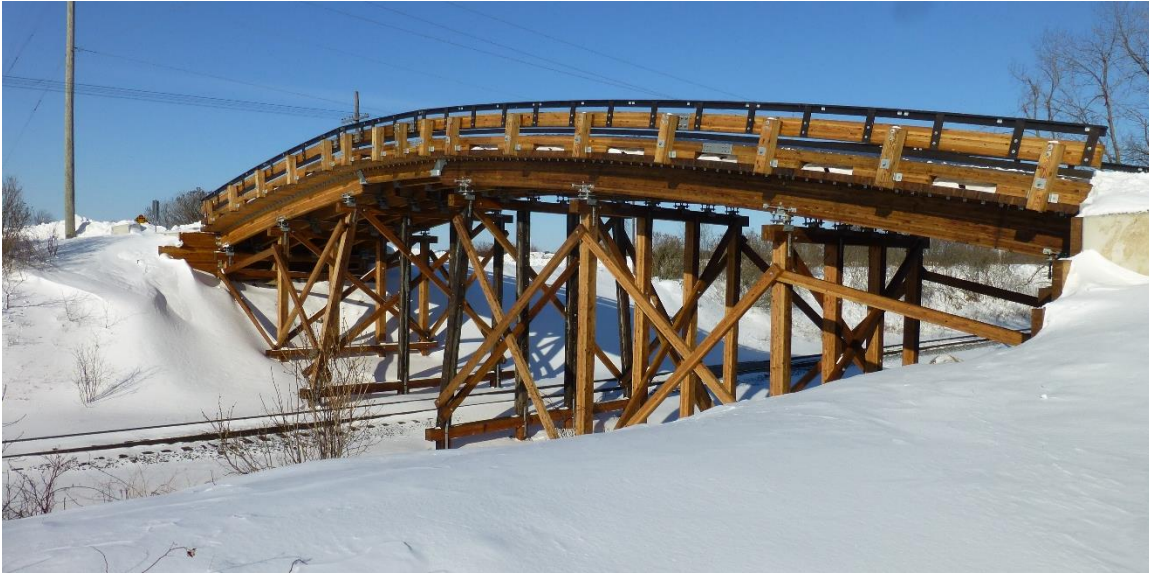
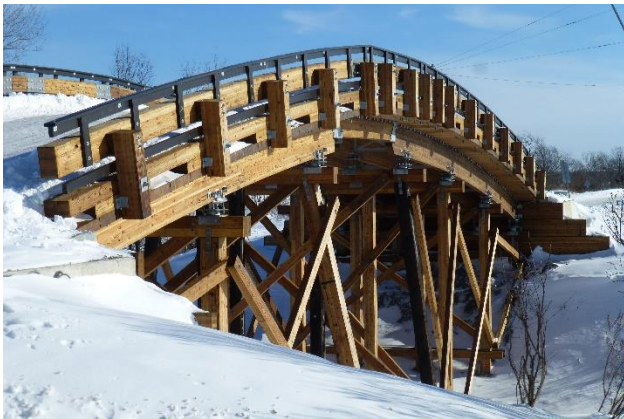
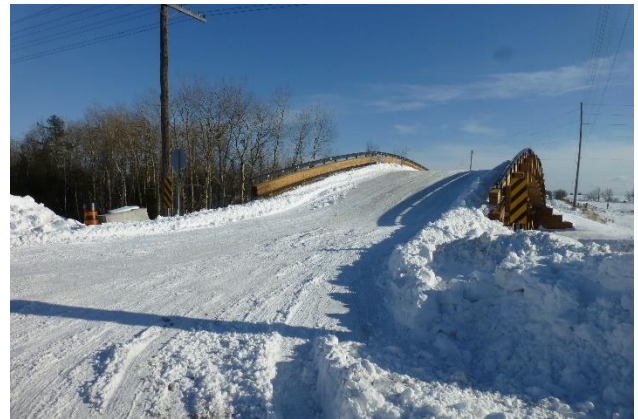
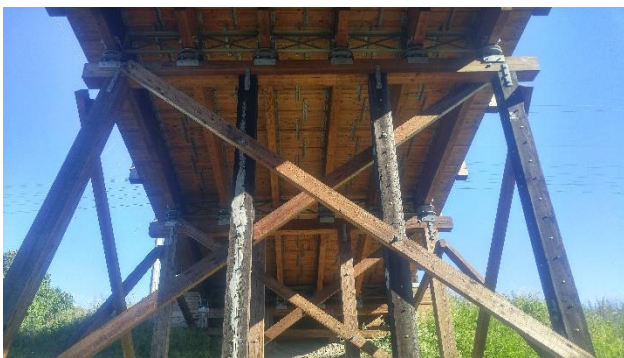
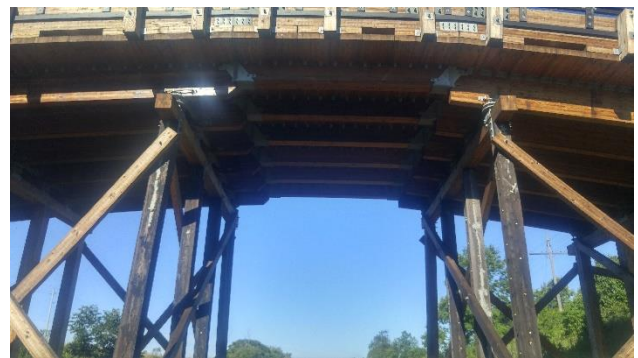
Figure 5-27: Dickinson Road Bridge, in Port Hope, Ontario consists of six glulam girder lines. The substructure was completely rebuilt; however, much of the material from the original structure was salvaged for use in the new bridge.
