Timber Bridge Best Practices and the State of the Industry in Atlantic Canada

PREPARED AND PRESENTED BY:

Christopher Legg, Timber Structures Designer, Senior CAD Technician

Wood Research and Development

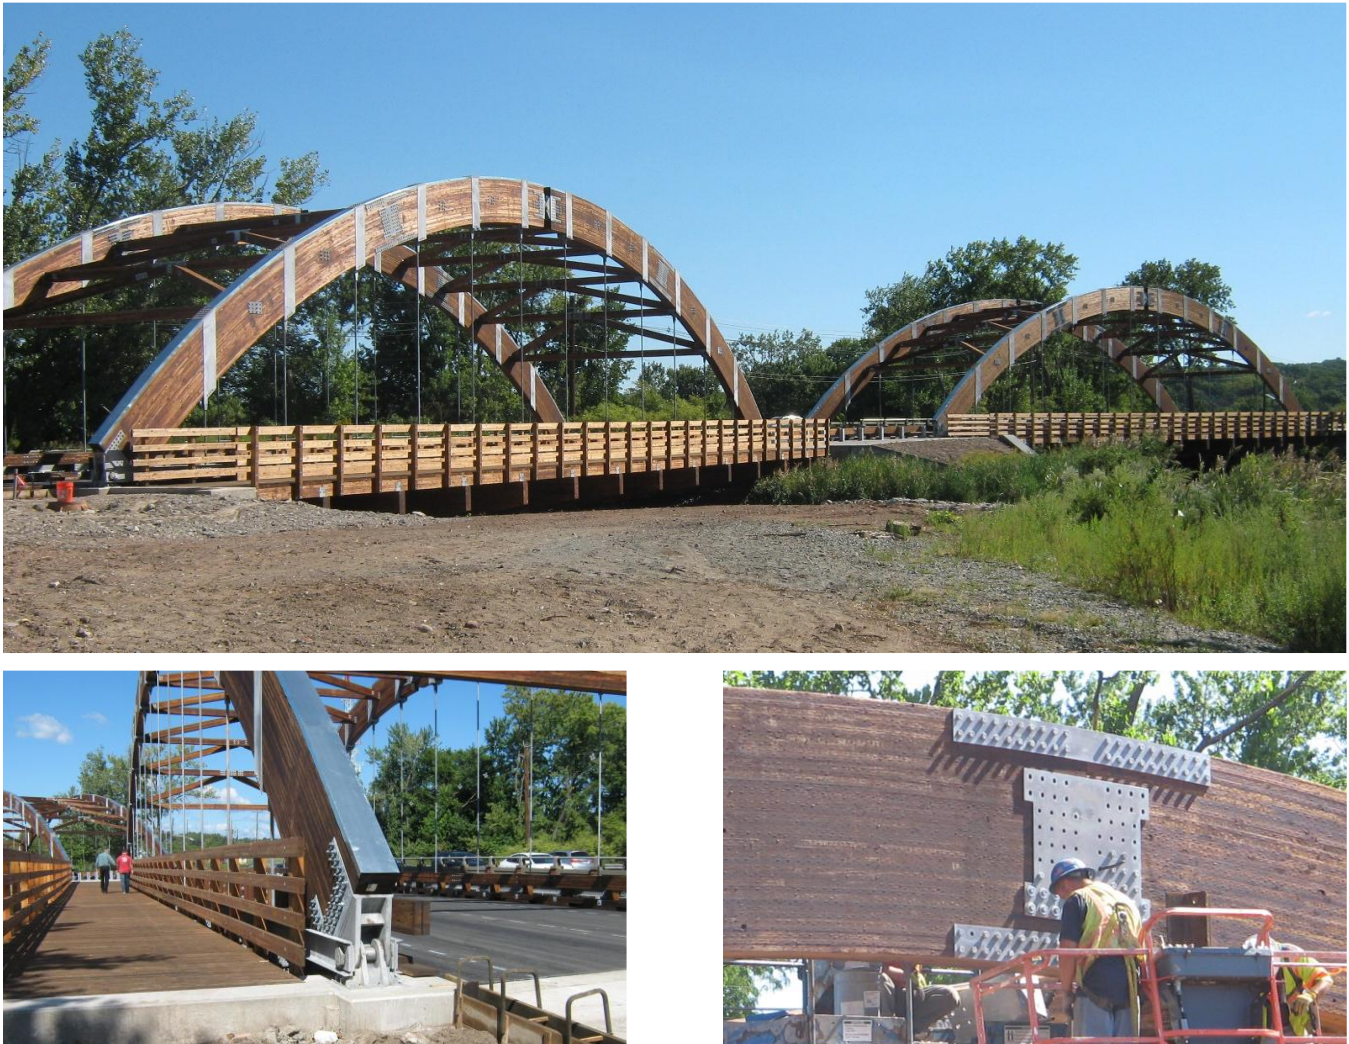
Figure 5-28: Overpeck Park Bridges, by Western Wood Structures, are a pair of two identical through-arch bridges. Each bridge spans 43m (140ft) and carries two lanes of traffic and a pedestrian walkway. The arches are three-pin arches, with a hinge at mid-span; to reduce the size of the individual members, each arch segment is broken into two pieces with a moment splice at its midpoint.

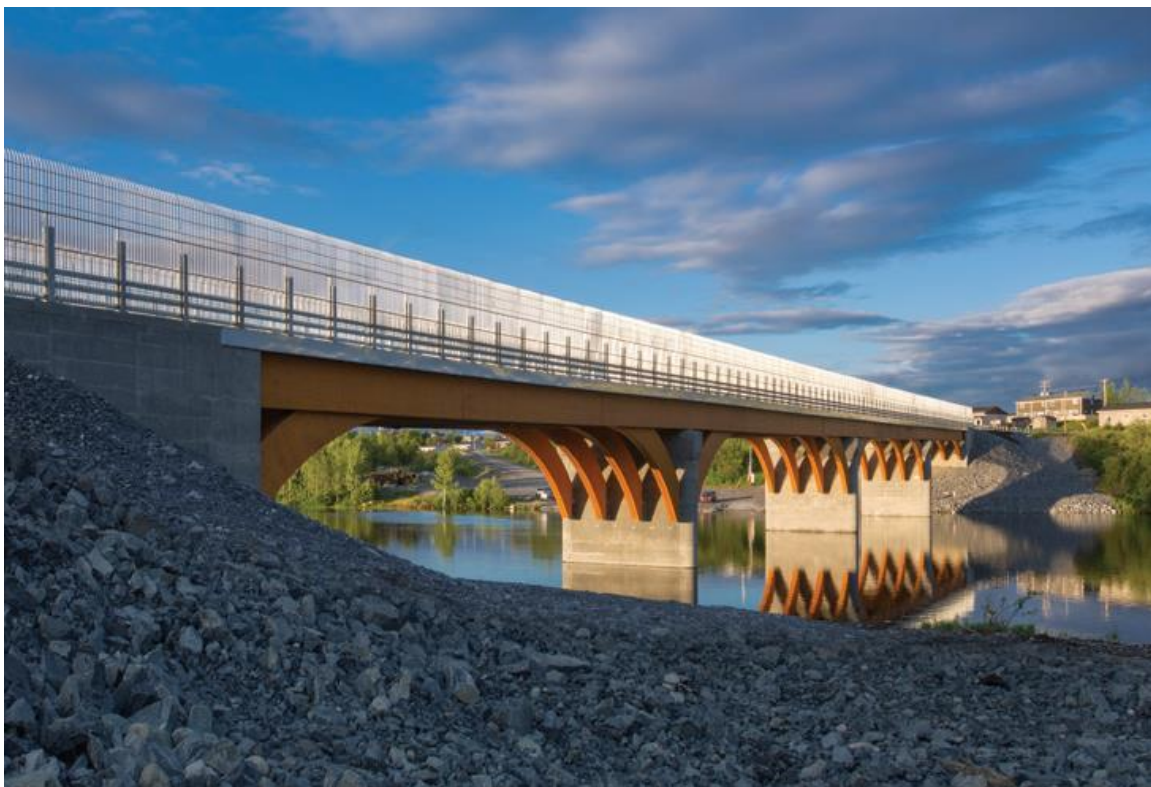
Figure 5-29: Mistissini Bridge is a 4-span bridge totaling 160m (525ft) long. The bridge is 9.25m (30ft) carrying two lanes of traffic, plus a pedestrian walkway on one side. It consists of glulam girders and arched knee-braces supporting a glulam deck with an asphalt wear-surface. (Forestry Nordic, 2015)

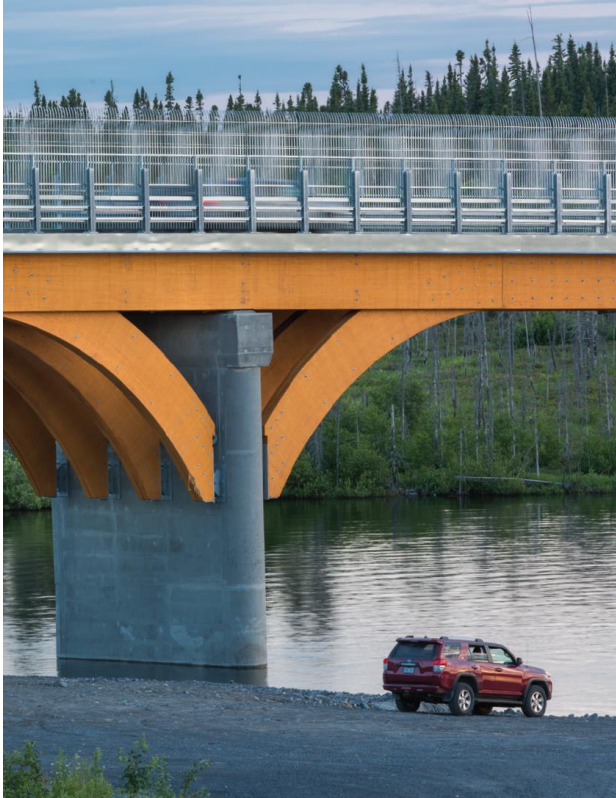
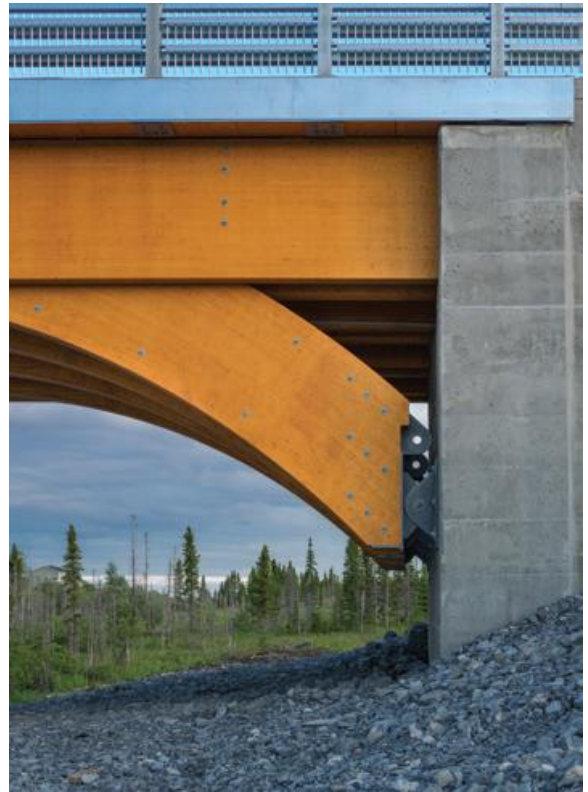
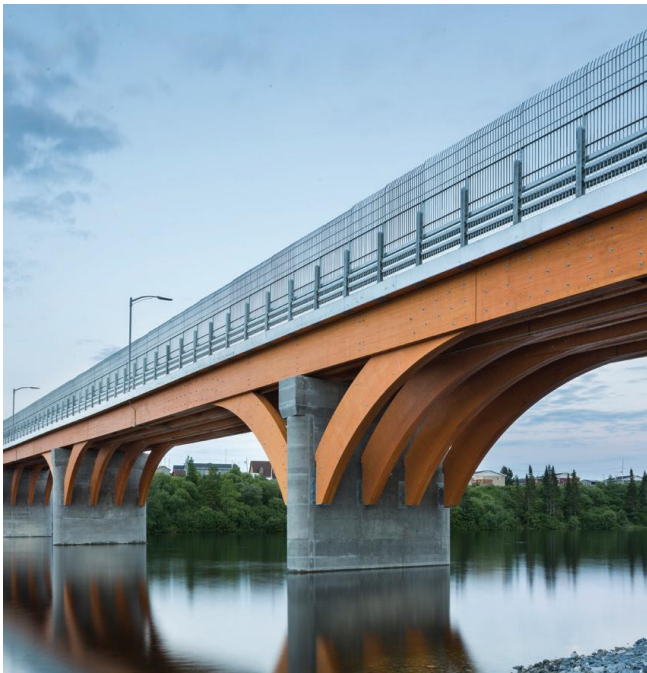
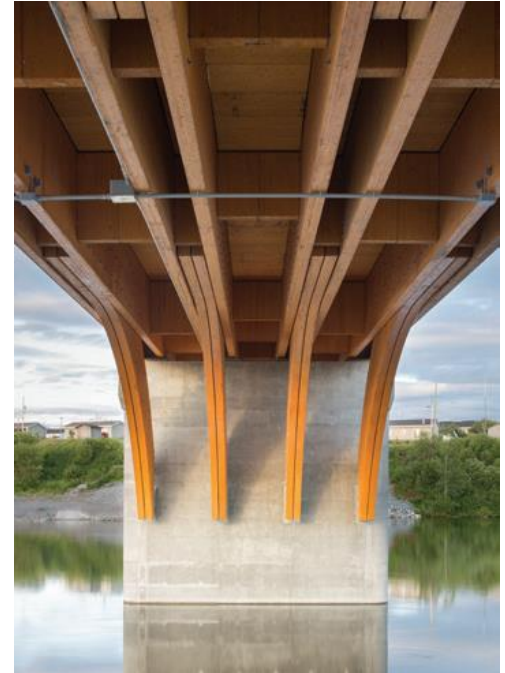
Figure 5-30: The arched braces are connected to the piers with pinned connections. The connection between the arches and the girders serves to both support the girder ends and to create a moment-resisting splice in the girders. This forms a continuous structure with no deck joints, which will help avoid cracking of the asphalt and maintain a waterproof surface. (Forestrie Nordic, 2015)

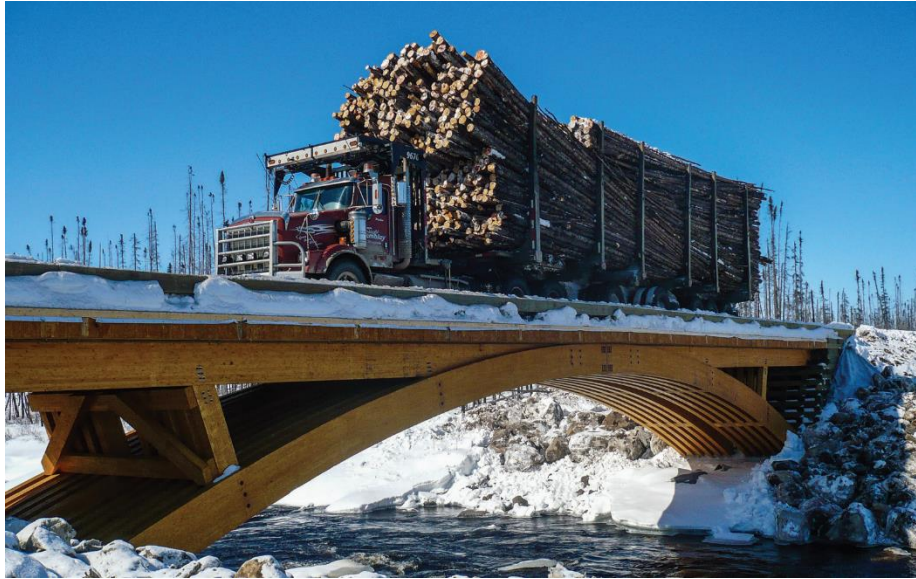
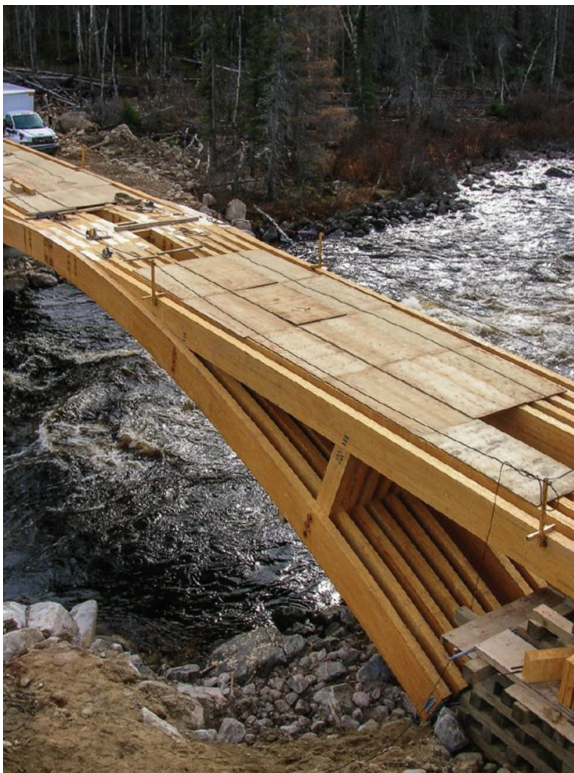
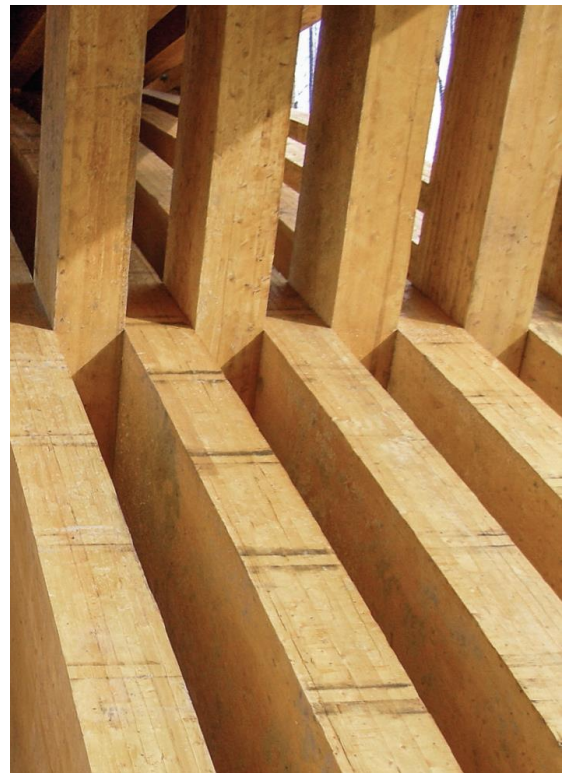
Figure 5-31: Tamiscame River Bridge, by Nordic Structures, consists of 12 glulam arches spanning 30m (98ft) which support 10 glulam girders and a transvers glulam deck. (Forestrie Nordic, 2015)

Built in 2009 by Nordic Structures, Tamiscame River Bridge is a forestry bridge in Quebec supported by a glulam arch-under system. The arches span 30m (98ft) and the total deck length is 34m (112ft). (Forestrie Nordic, 2015)

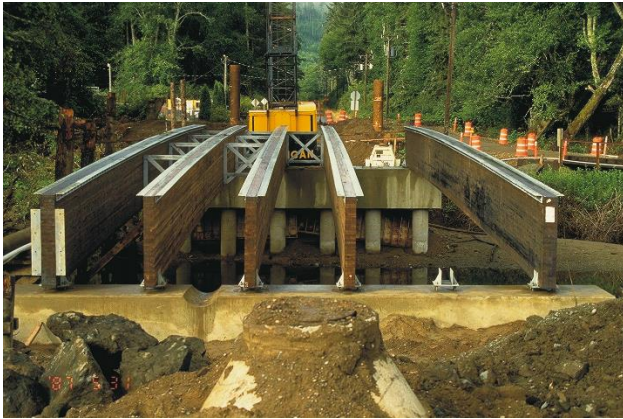
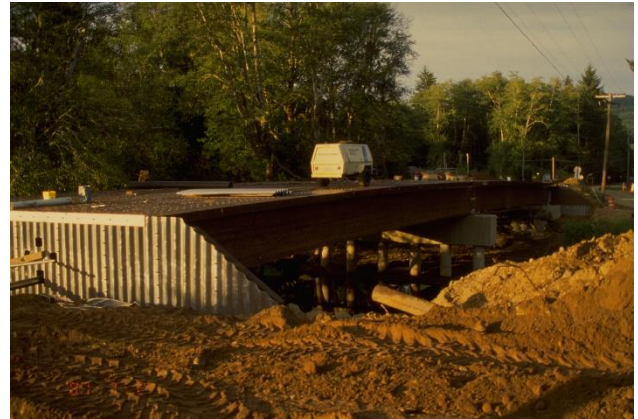
Figure 5-32: The Lighthouse Bridge, under construction in Clallam Bay, Washington. The bridge consists of six fibre-reinforced glulam girders in each span.

The Lighthouse Bridge near Clallam Bay, Washington is a 2-span, 50m (160ft) bridge consisting of fibre-reinforced glulam girders and a transverse glulam deck. Constructed in 1995, the Lighthouse Bridge was the first vehicular bridge designed for heavy loading (HS25-44) to utilize FRP reinforcing in the United States (Tingley & Gai, 1998).

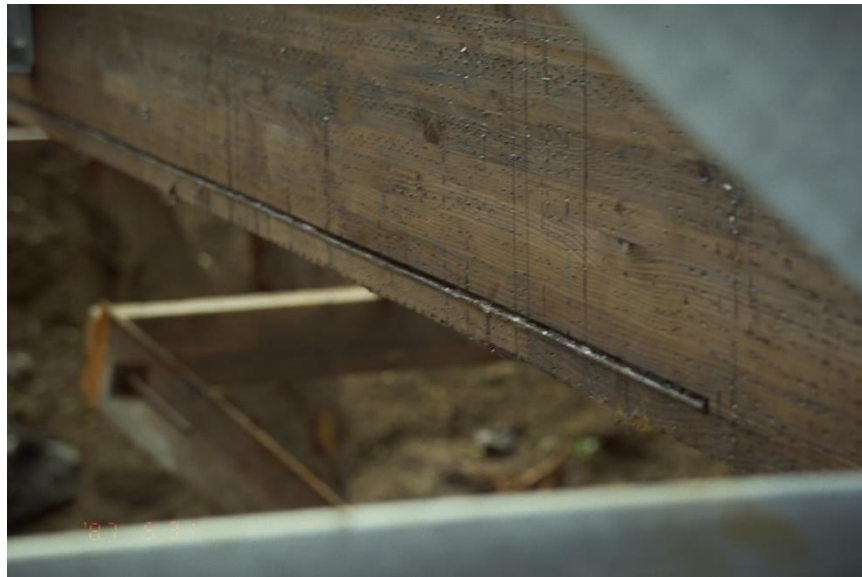
Figure 5-33: The glulam girders are reinforced with a layer of fibre-reinforced plastic (FRP) which permitted a significant reduction in the volume of wood required compared to an unreinforced bridge.

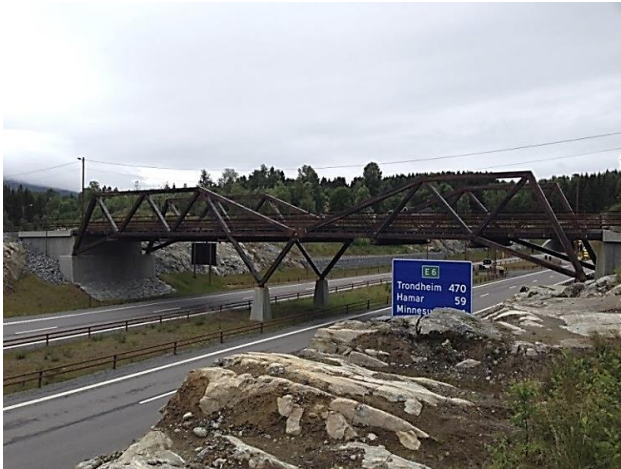
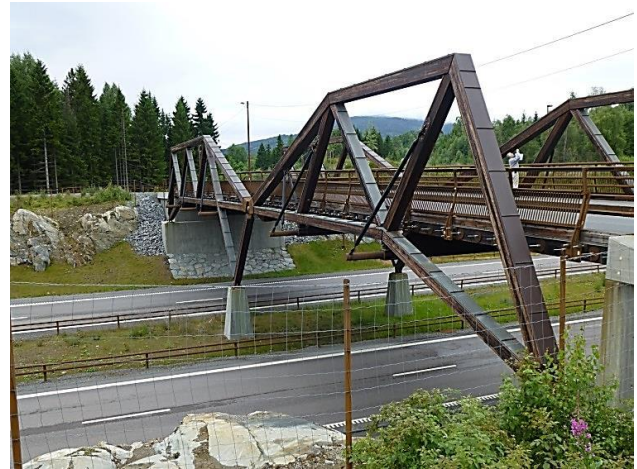
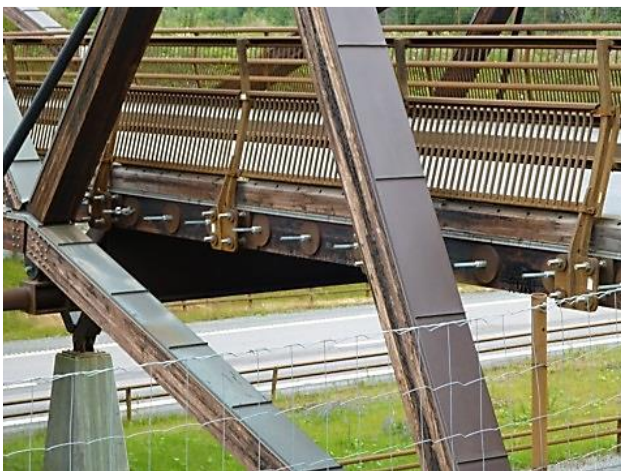
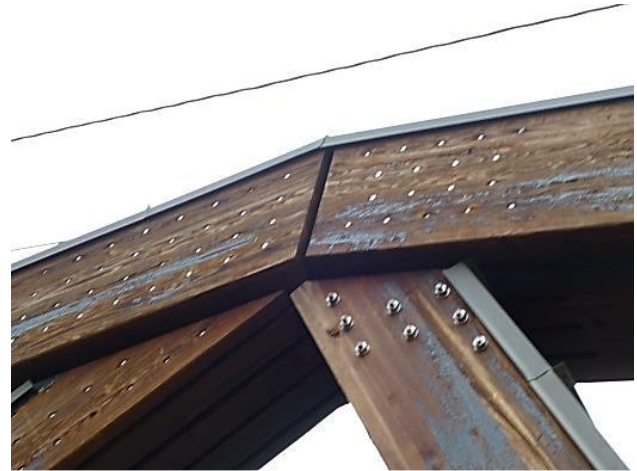
Figure 5-34: Sletta Bridge in Eidsvoll, Norway. The structure consists of asymmetrical glulam trusses which carry steel crossbeams and a stress laminated deck. In addition to being dual preservative treated (with a copper-based preservative and creosote) the main elements are sheltered from moisture using metal flashing.

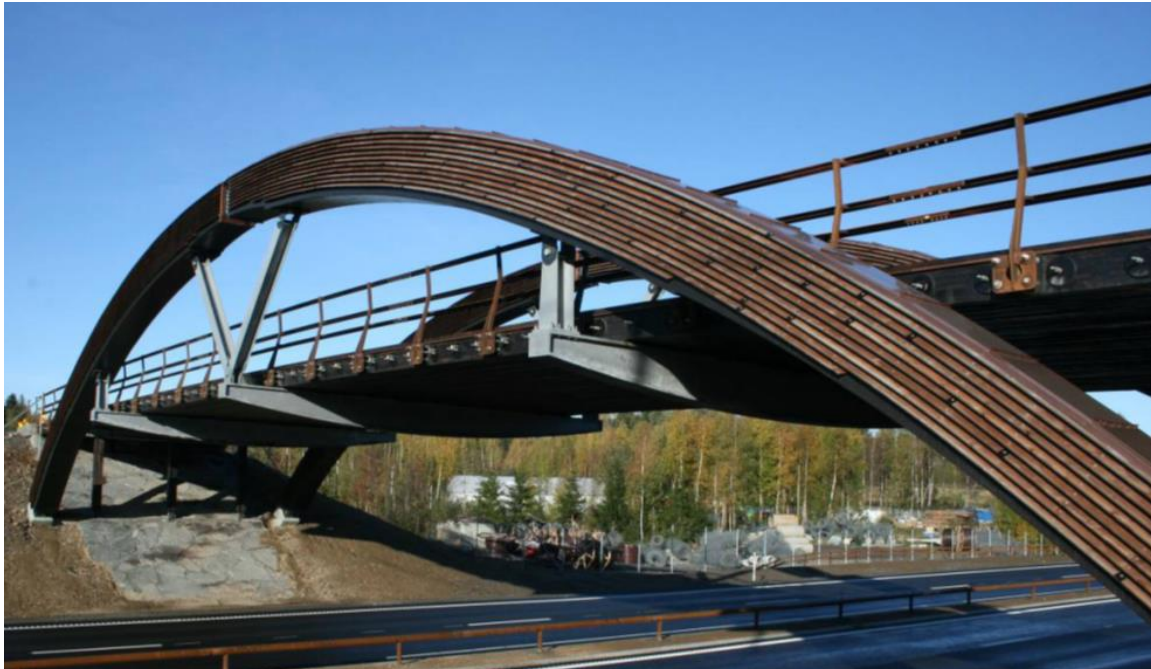
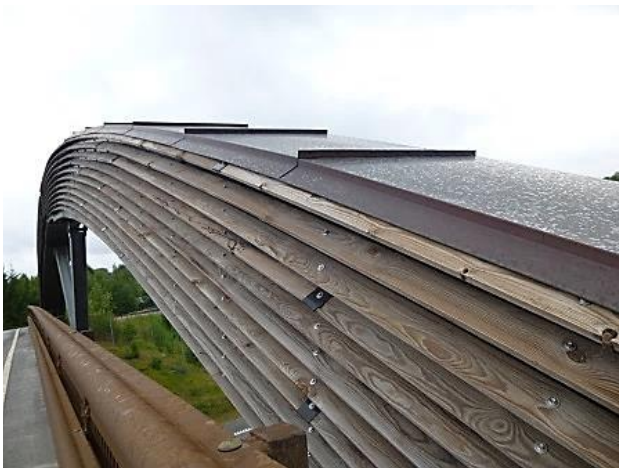
Figure 5-35: Skogsrud Bridge in Tangen, Norway consists of two glulam arches and a stress-laminated deck. The arches are protected with metal flashing on top and wood louvers on the vertical faces. This shelters the elements from rain while still allowing sufficient air flow to keep the moisture content of the wood low.

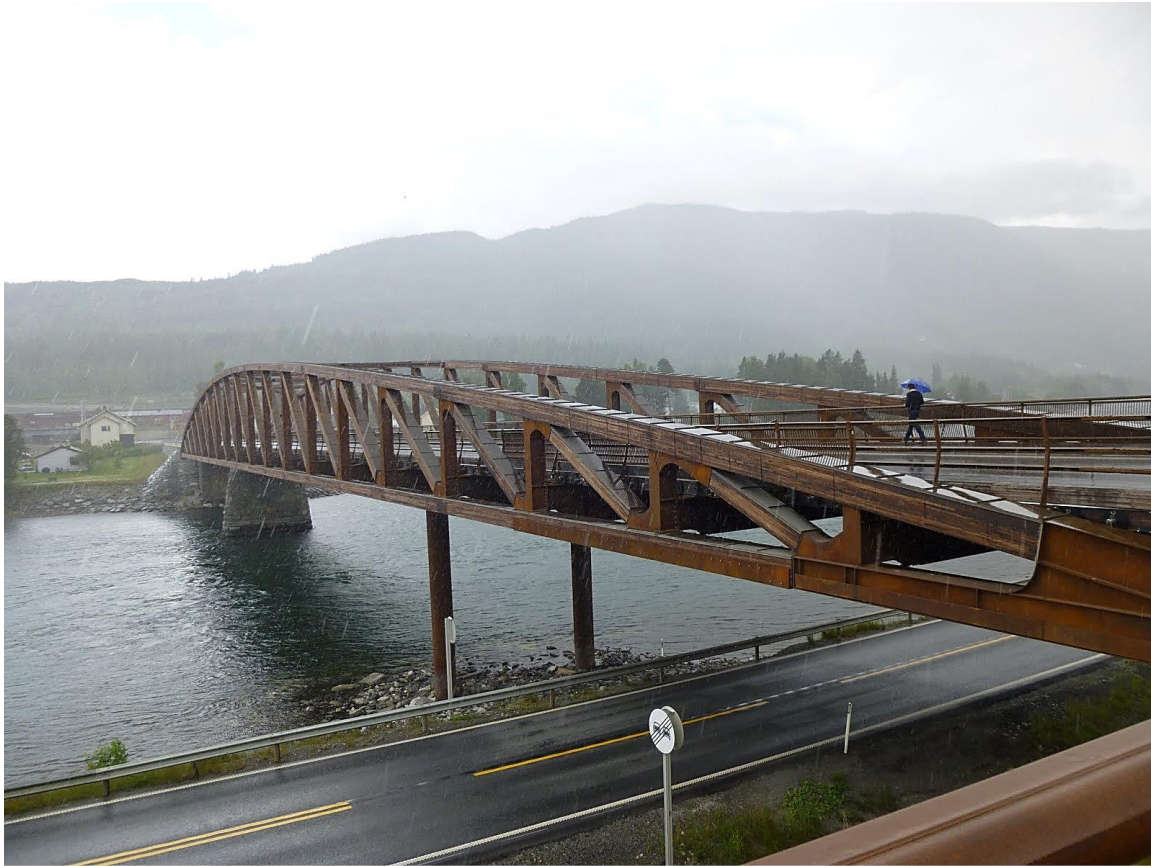
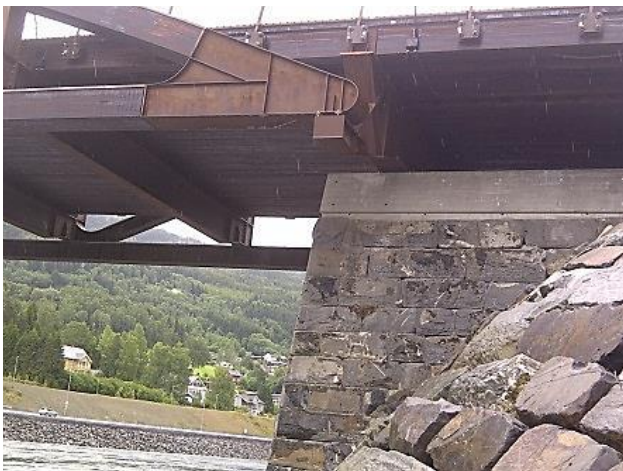
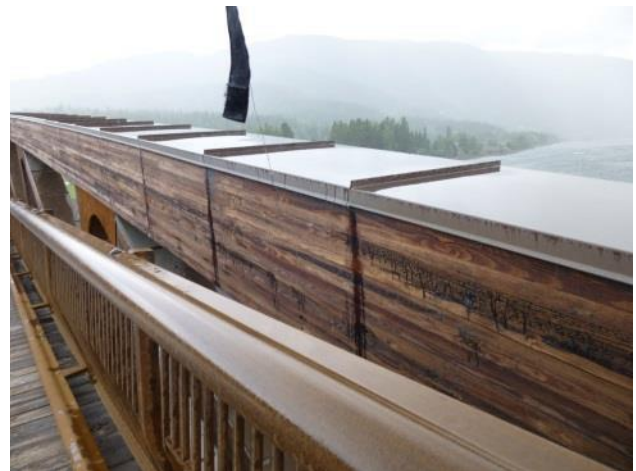
Figure 5-36: Tretten Bridge is a continuous truss across three spans. The truss is a hybrid truss made primarily from glulam timbers with steel vertical web members and steel shoes at the nodes. Corten weathering steel was used for the steel elements.

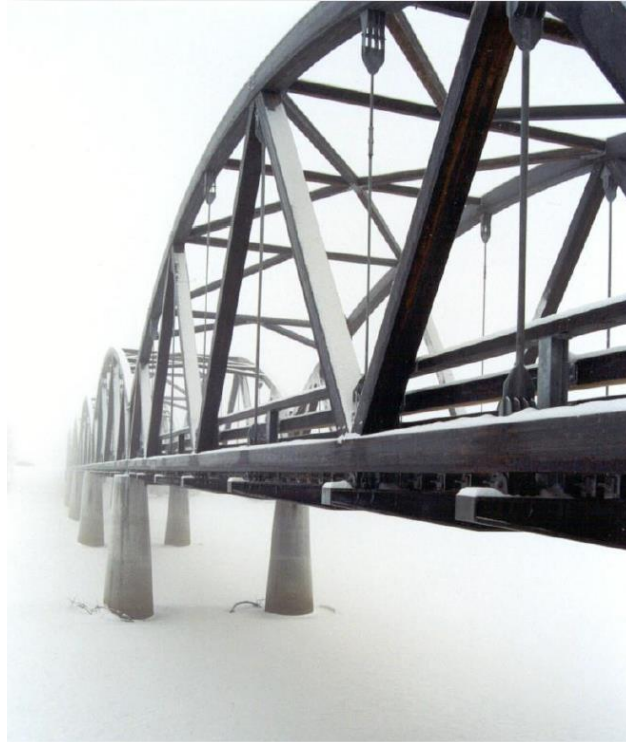
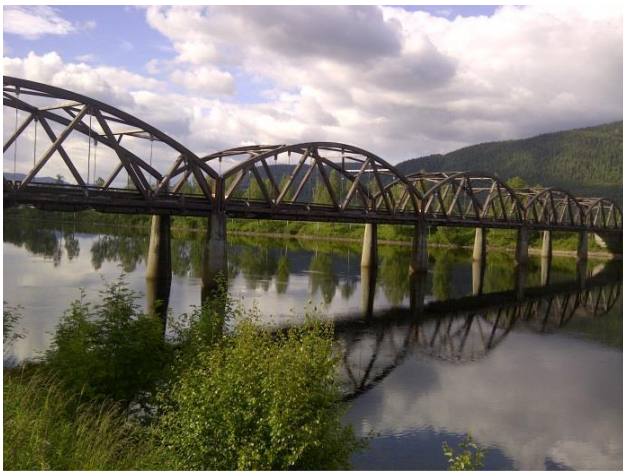
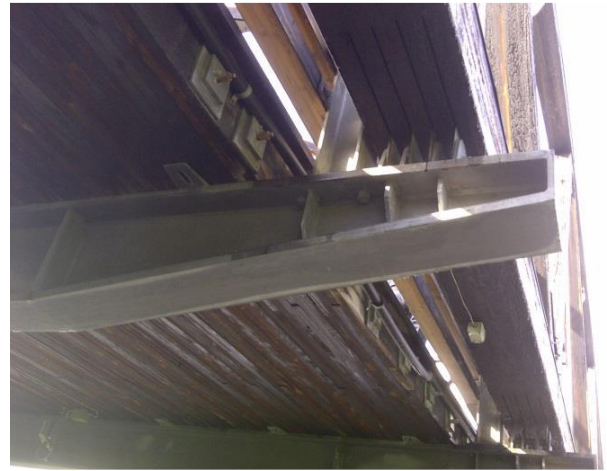
Figure 5-37: Evenstad Bridge is made up of five glulam truss spans, each 36m (118ft) long. The trusses support steel cross beams and a stress-laminated deck.

Evenstad Bridge is a five-span, 180m (590ft) bridge. Each 36m (118ft) span consists of a pair of arched glulam trusses. These trusses carry steel crossbeams and a longitudinal stress-laminated deck.

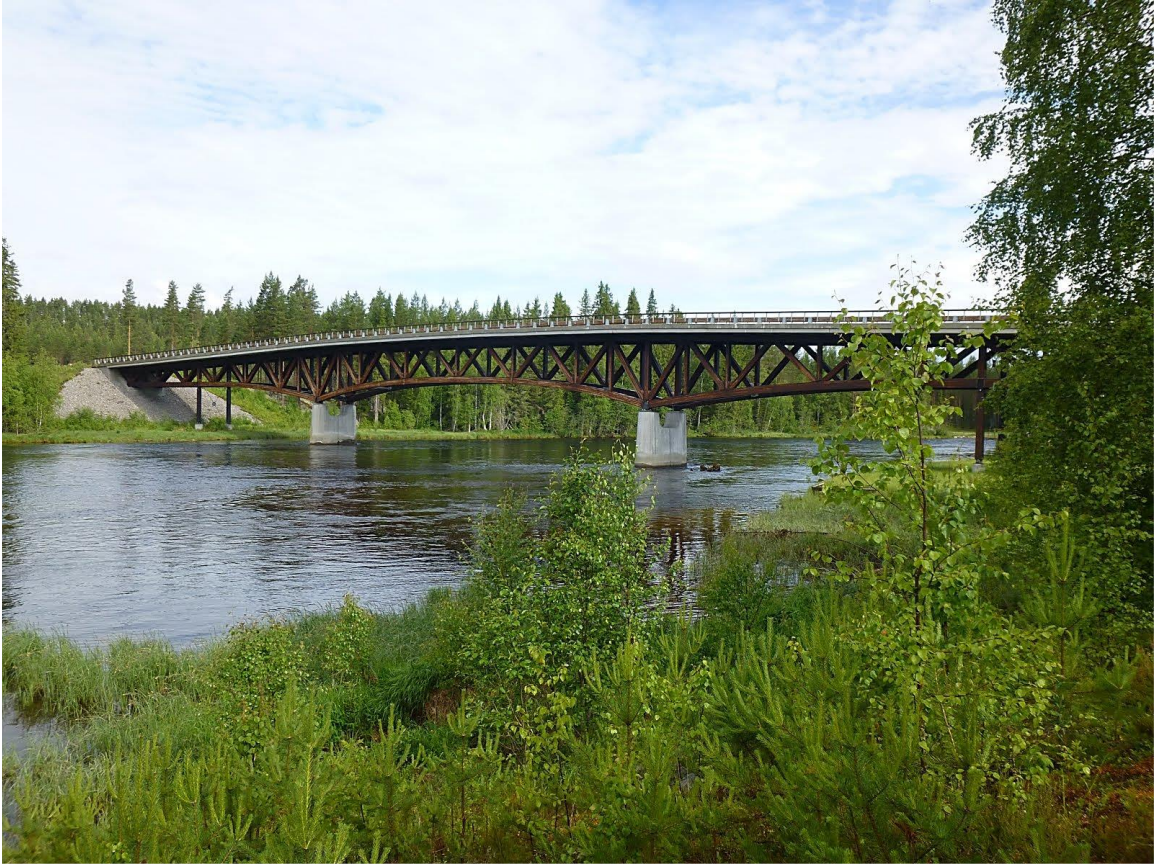
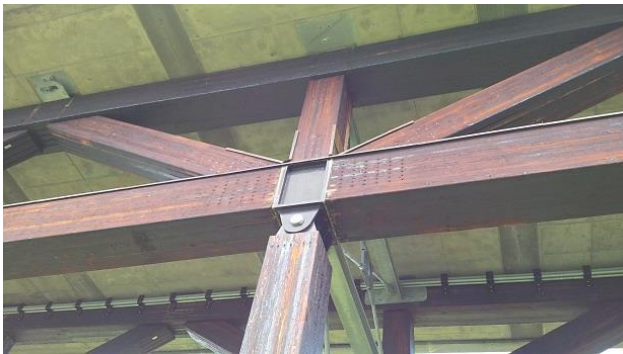
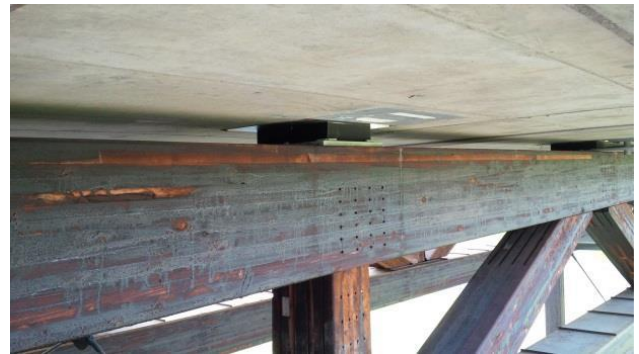
Figure 5-38: Kjølssæter Bridge consists of a continuous glulam truss with a total length of 145m (476ft) and a maximum span of 36m (118ft). The glulam truss supports a concrete slab deck.

Kjølssæter Bridge, in Rena, is five-span, 145m (476ft) bridge with a maximum span of 45m (148ft). The structure consists of a continuous glulam truss carrying a concrete slab deck. The bridge is designed for heavy military loading of over 100 tons, making it the strongest timber bridge in Norway.

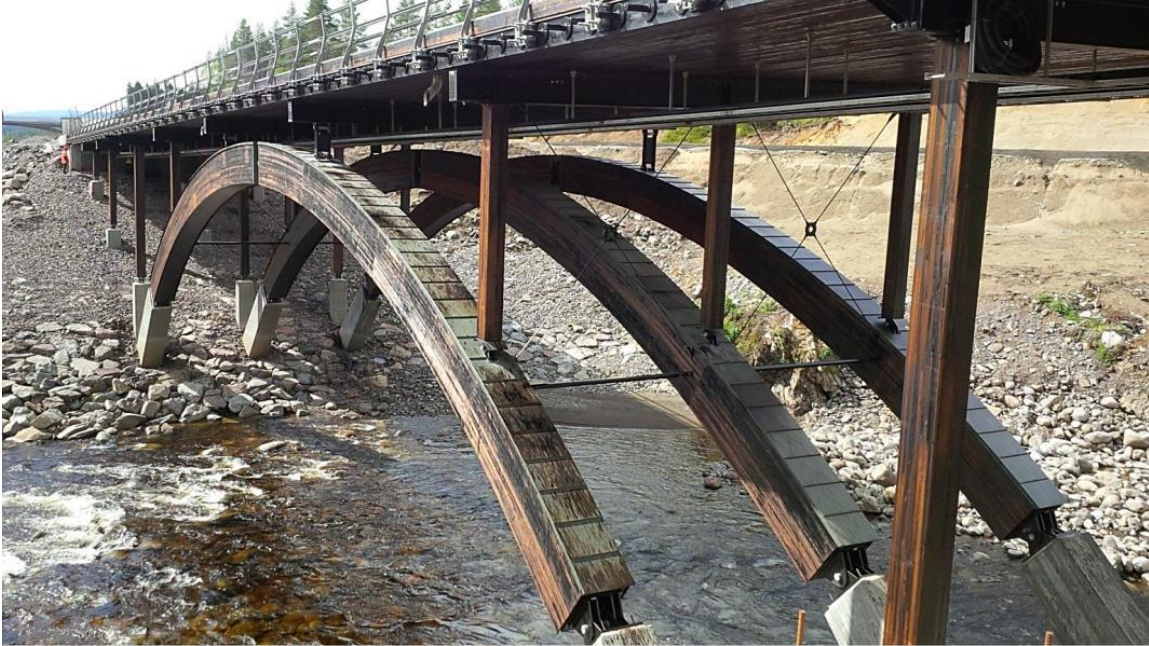
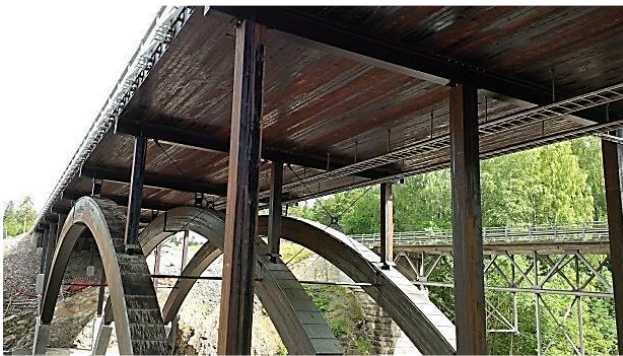
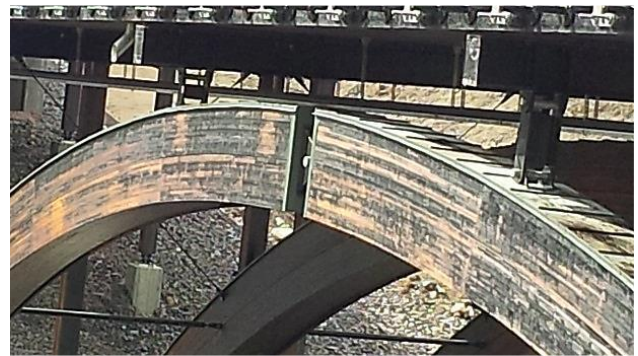
Figure 5-39: Asta Bridge is a stress laminated deck supported by glulam arches. The deck totals 96.6m (317ft), and the arches span 38.5m (126ft).

Asta Bridge, in Rena, is a longitudinal stress laminated deck supported on steel crossbeams. The deck totals 96.6m (317ft). The central span of 38.5m (126ft) is supported by glulam arches.

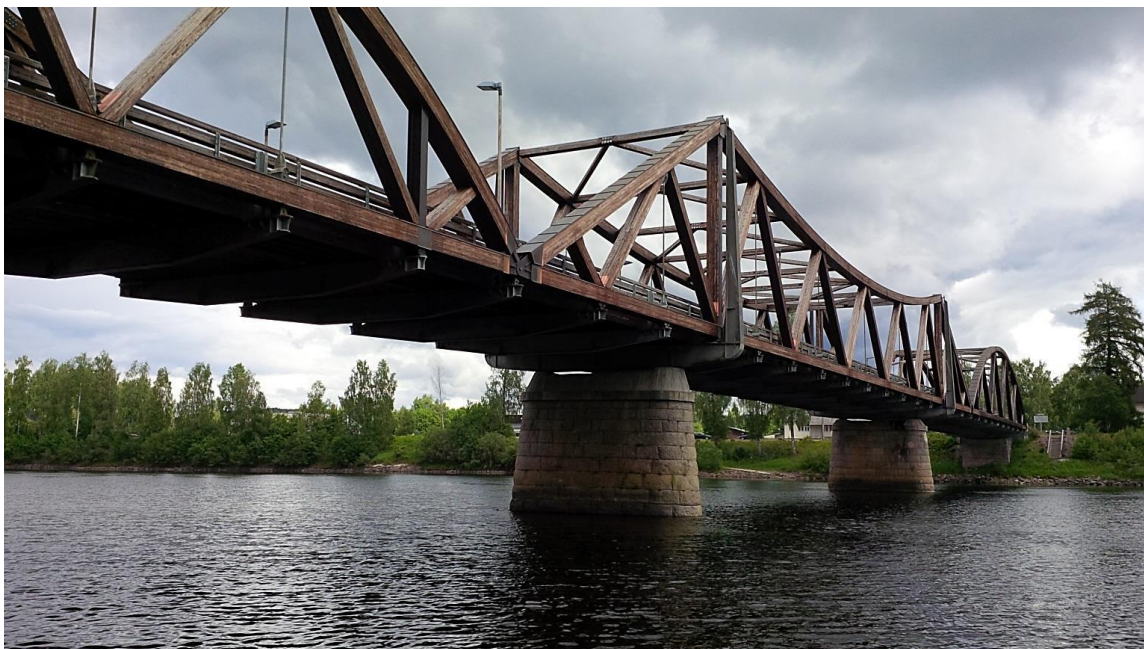
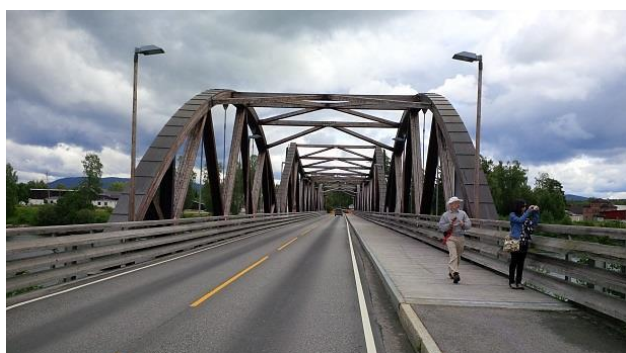
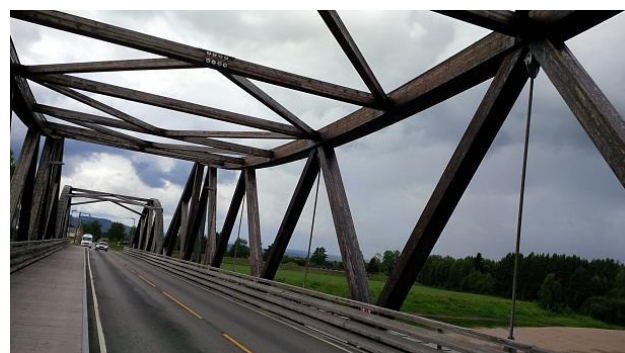
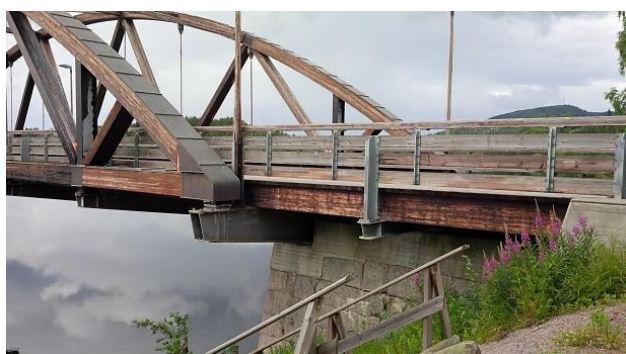
Figure 5-40: Flisa Bridge is a three-span glulam truss bridge totaling 196m (643ft) with a maximum span of 70m (230ft).

Flisa Bridge is a three-span glulam truss bridge totaling 196m (643ft) with a maximum span of 70m (230ft). The trusses carry steel cross beams and a stress laminated deck.

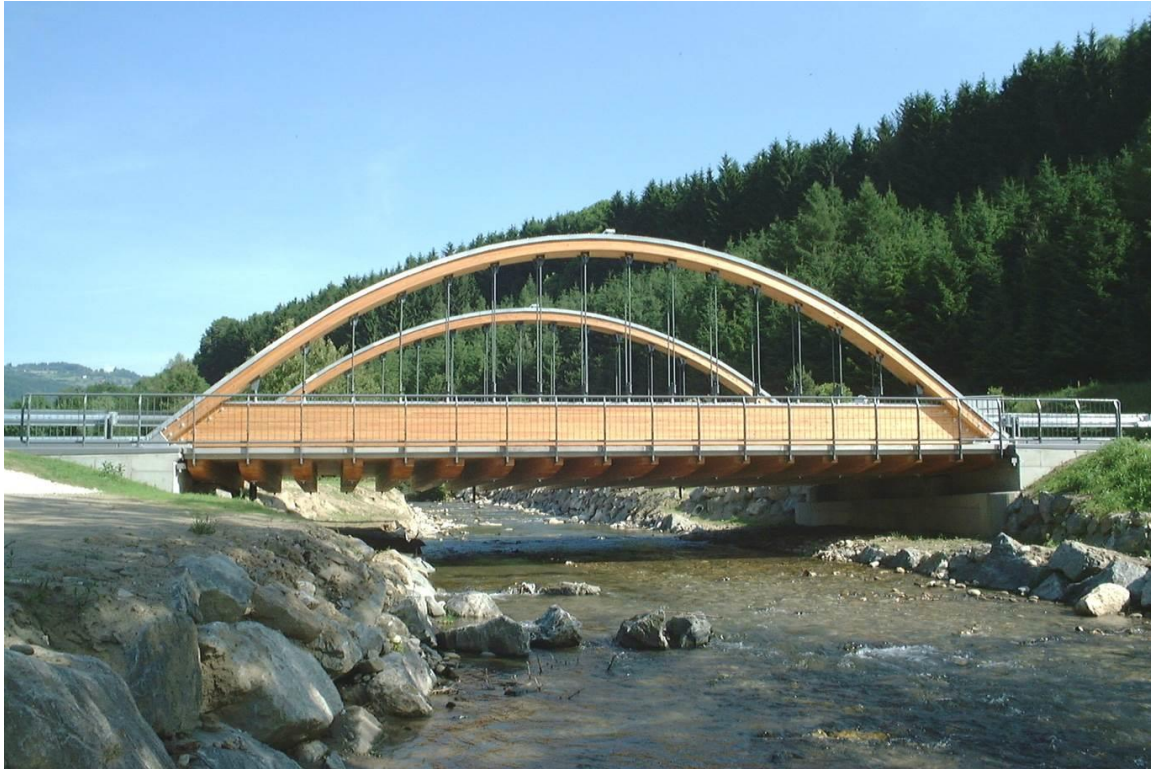
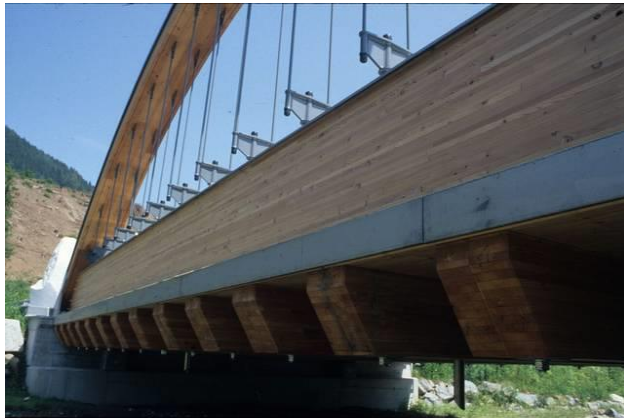
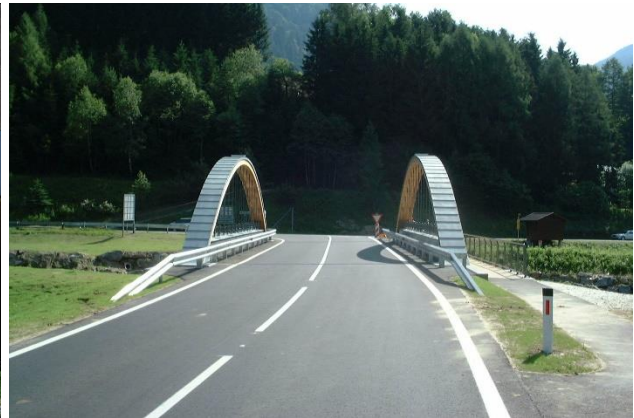
Figure 5-41: Krastalbrücke consists of two glulam tied-arches. These support steel hangers which carry the transverse glulam beams which, in turn, carry the deck.

Krastalbrücke is a tied-arch glulam bridge in Treffen, Austria. The arches carry transvers glulam beams which, in turn, support a cross-laminated timber deck. The bridge carries two lanes of traffic and a sidewalk and is designed for 60 ton vehicle loads.

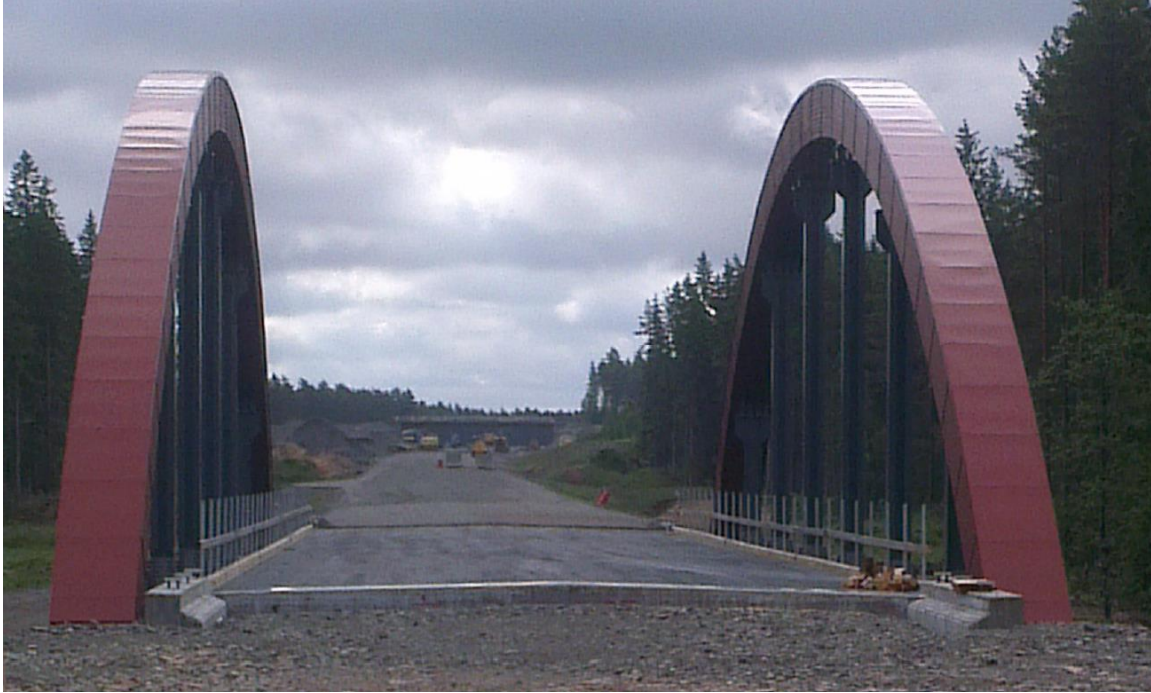
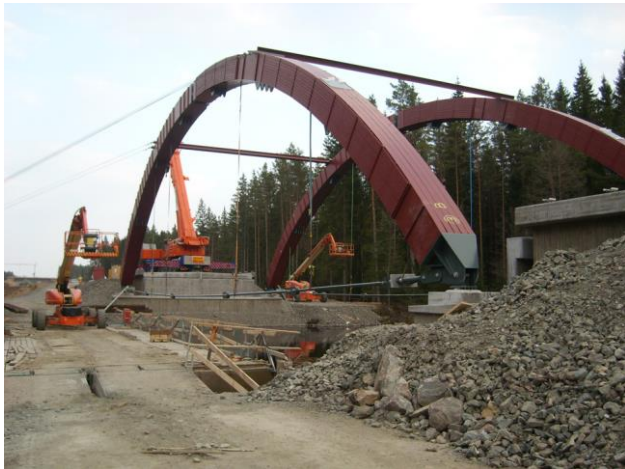
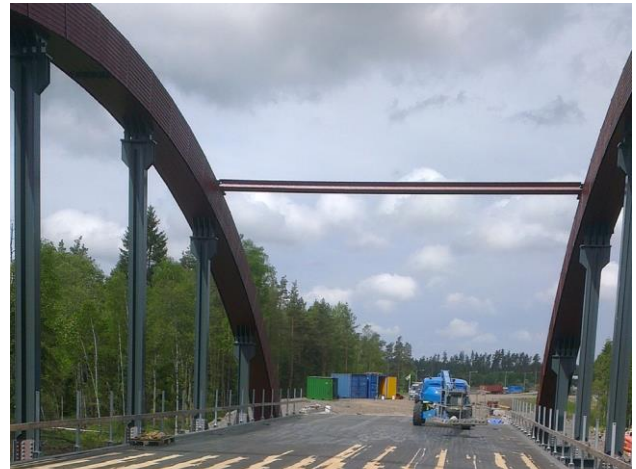
Figure 5-42: Nissan River Bridge spans 47.4m (155ft) and consists of two three-pinned arches. The arches carry steel hangers and crossbeams which in turn carry a stress-laminated deck. The glulam arches are sheltered by steel flashing on top and vented wood panels on the vertical faces.

At 47.4m (155ft) Nissan River Bridge is the longest single-span timber highway bridge in Sweden. It consists of two three-pinned arches which carry steel cross beams and a longitudinal stress-laminated deck. Lateral stability of the arches was achieved by using stiff steel hangers and moment resisting connections from the arch to the hangers and from the hangers to the crossbeams (Ekholm, Nilson, & Johansson, 2013).

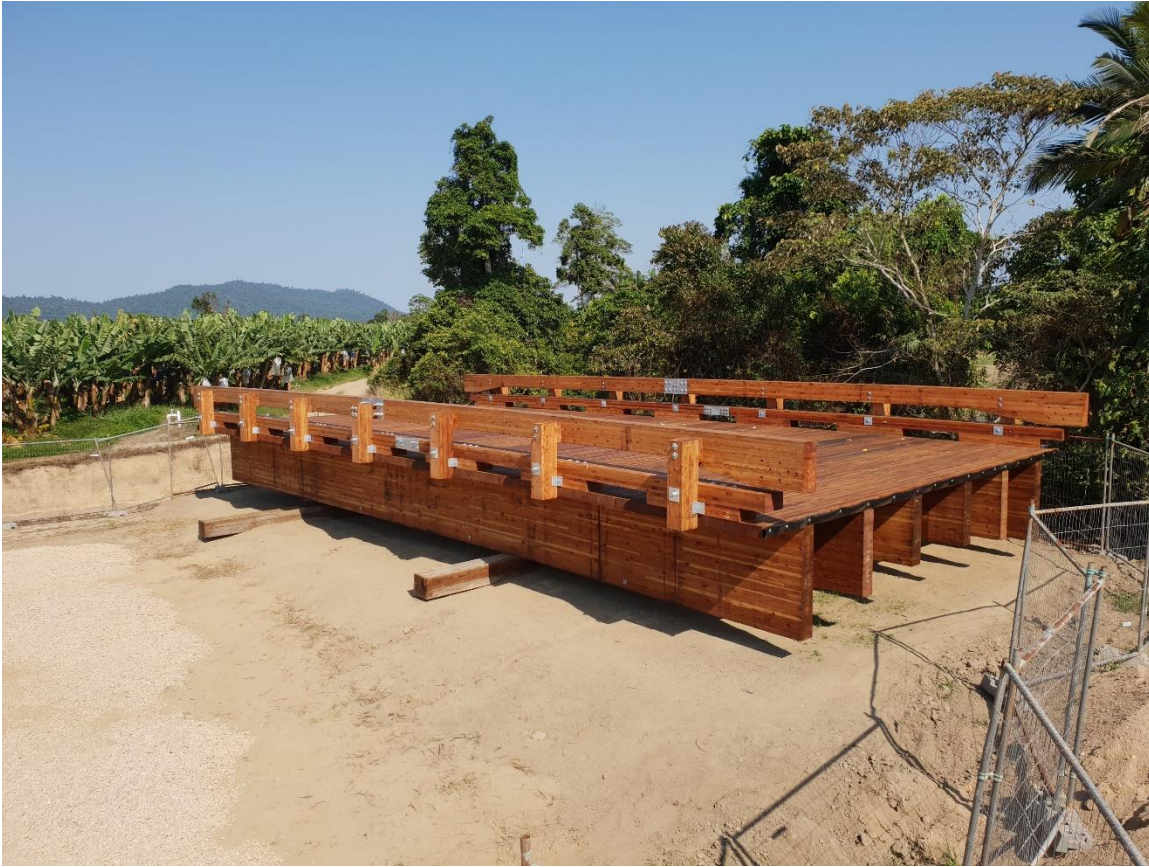
Figure 5-43: Cowley Creek Bridge, fully assembled and ready to be installed with one crane one lift. A concrete bridge of the same length and width could not have been lifted into place totally assembled.

foundation upgrades have been completed, the bridge will be lifted into place by crane, to limit the necessary road closures.

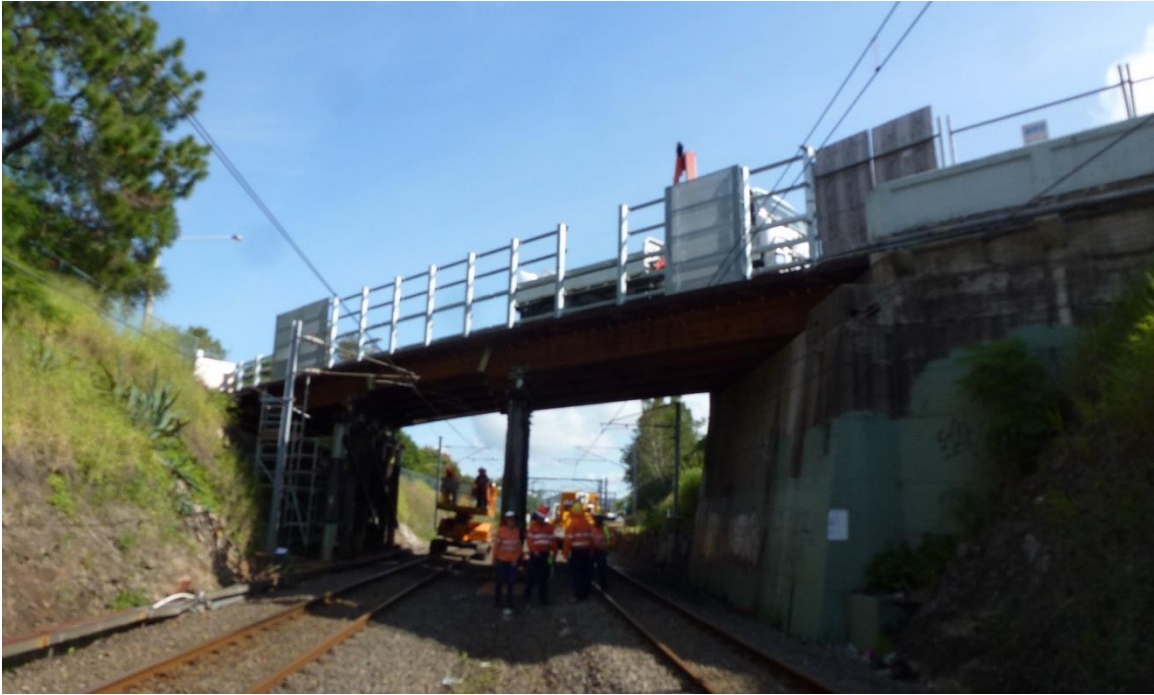
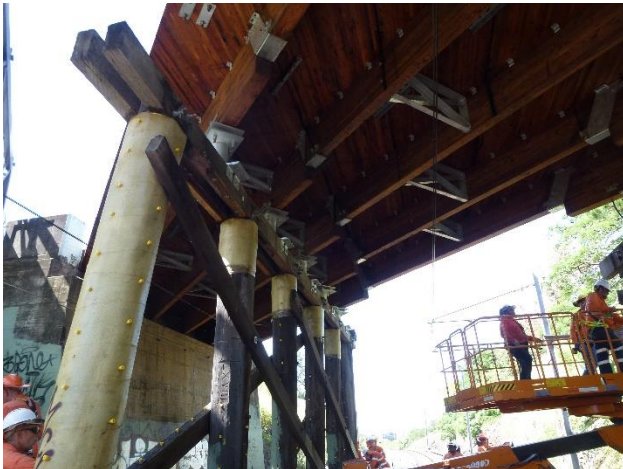
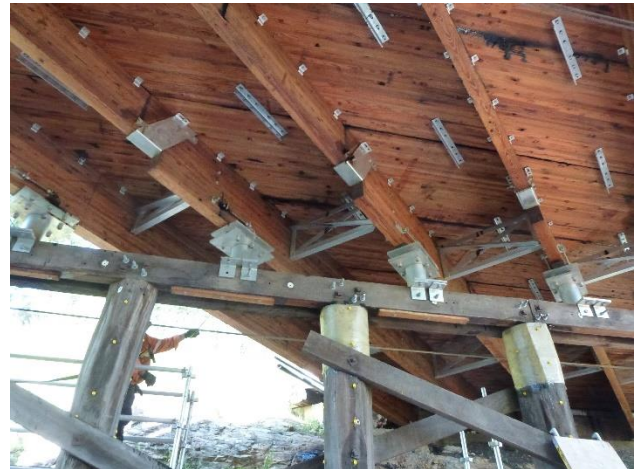
Figure 5-44: Alderley Avenue Bridge crosses a pair of Queensland Rail tracks. The new glulam superstructure and deck were installed on the existing substructure. Localized decay in the substructure was repaired using high-strength fibre wraps on the piles and tension reinforcement on the headstocks.
