Timber Bridge Best Practices and the State of the Industry in Atlantic Canada

PREPARED AND PRESENTED BY:

Christopher Legg, Timber Structures Designer, Senior CAD Technician

Wood Research and Development

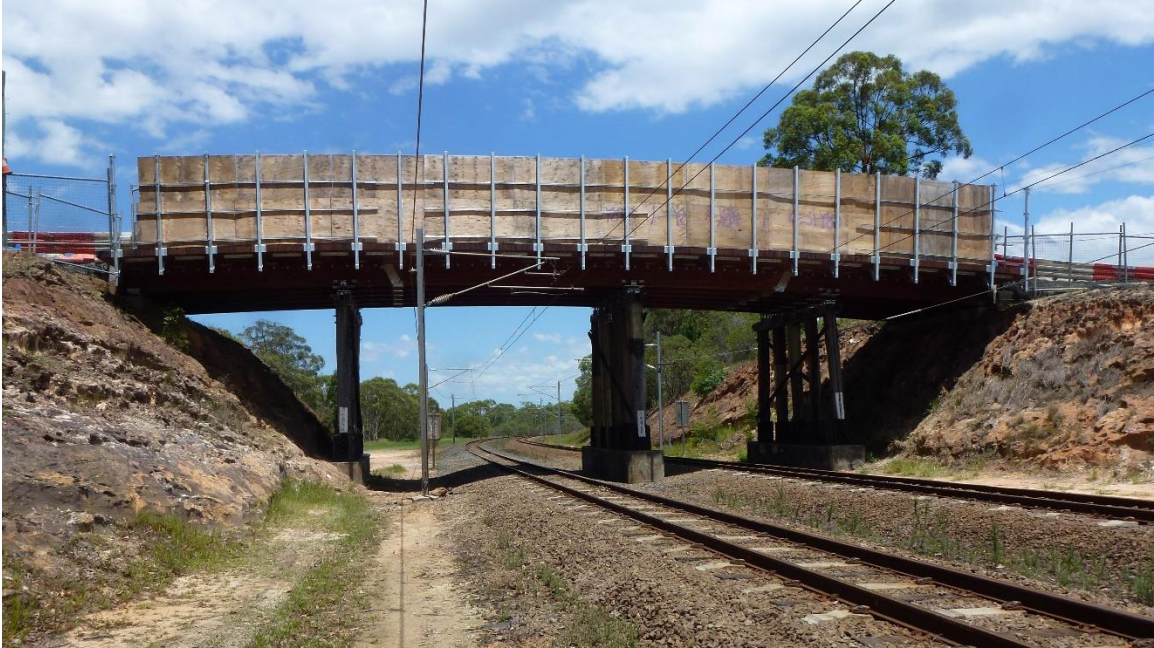
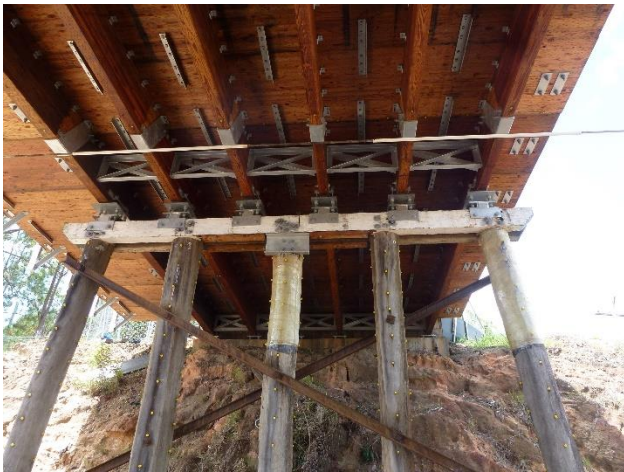
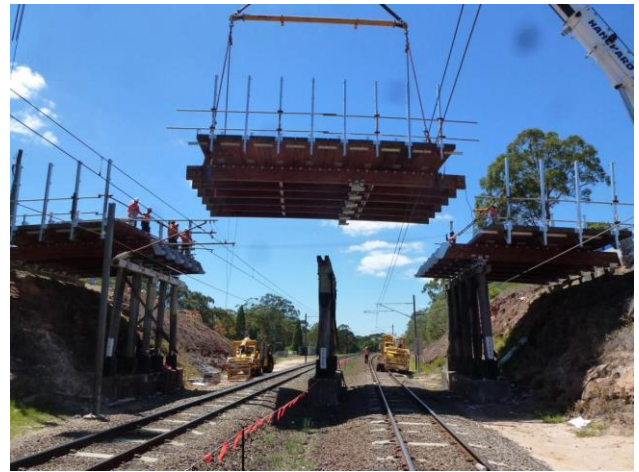
Figure 5-45: Boundary Road Bridge is a four-span overpass crossing a pair of Queensland Rail tracks. The light weight of the timber superstructure allowed each span to be preassembled alongside the road and lifted into place by crane. This limited the interruptions to rail traffic on the tracks below.

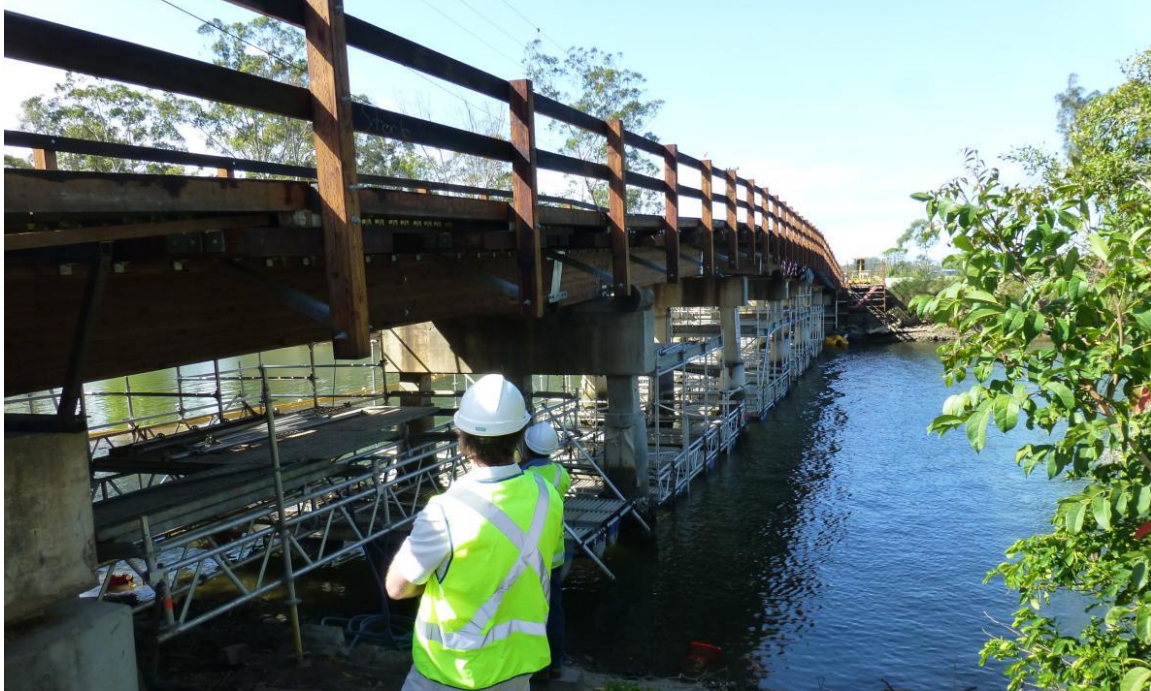
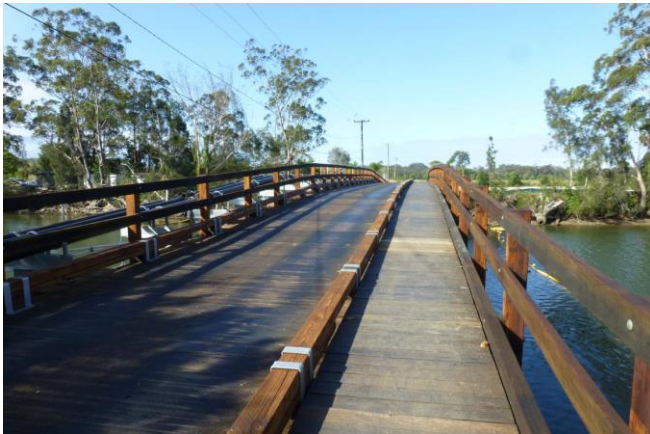
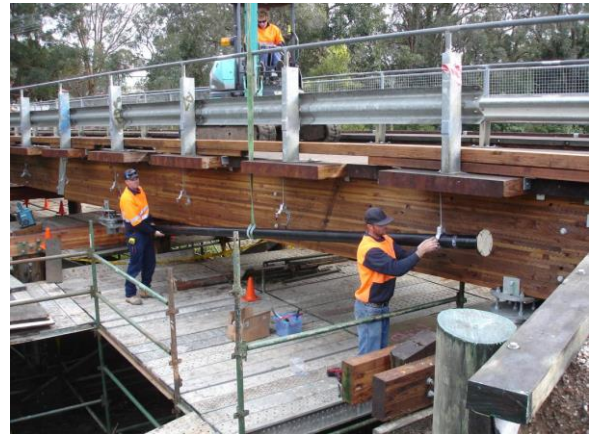
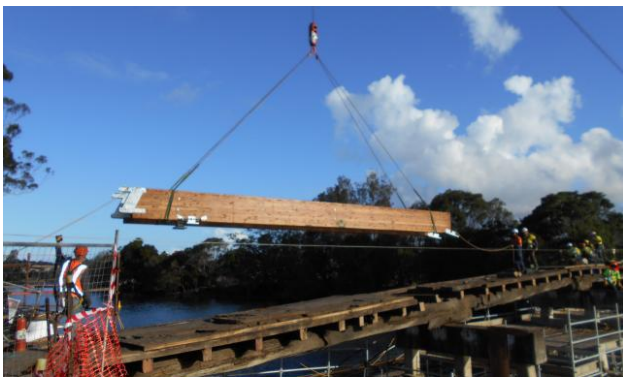
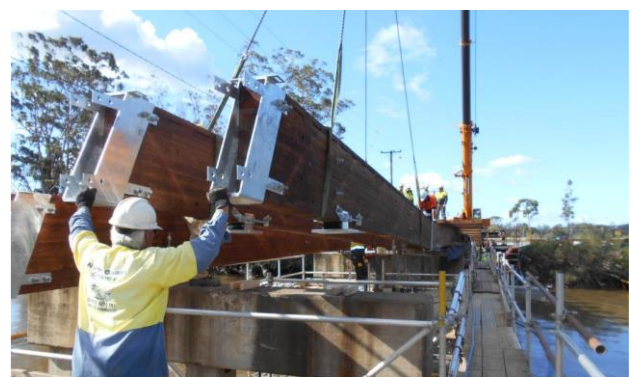
Figure 5-46: The new glulam superstructure and deck were installed on the existing substructure at Newry Island Bridge. Removal of the existing structure and installation of the new occurred in tandem to limit the road closure time.
