Fire safety summary: Fire research conducted for the project on midrise wood construction (Report to research consortium for wood and wood-hybrid mid-rise buildings)

Su, J.Z.; Lougheed, G.D.

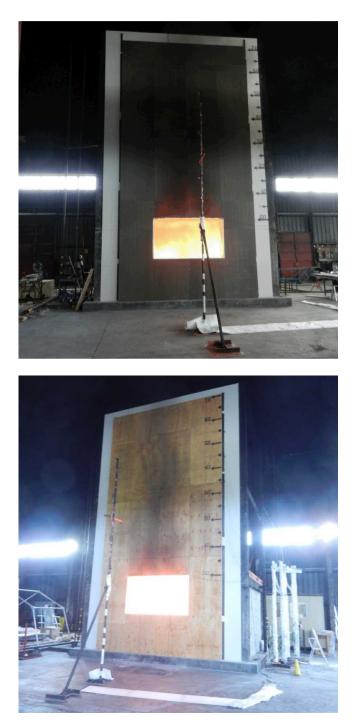
Figure 6. Tests of Exterior Wall Assemblies.

Each test assembly simulated a structural exterior wall system. However, no loads were applied to the wall. The objective of the test was to evaluate the performance of the assembly for exterior fire spread in conformance with CAN/ULC-S134. If, in practice, the exterior wall assembly also required a fire-resistance rating, it would need to be evaluated using CAN/ULC-S101 [20].

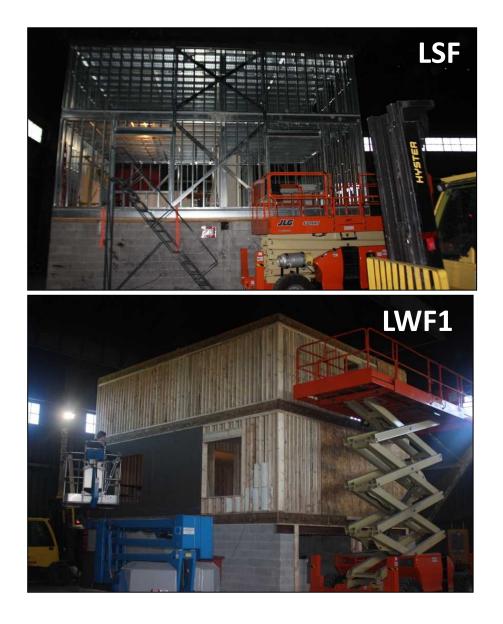
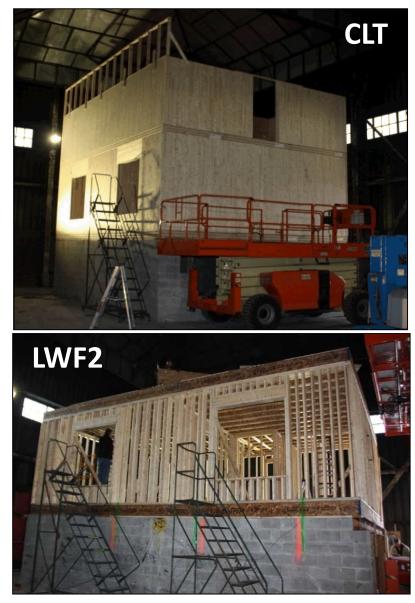
Figure 29. Large-scale apartment test structures under construction.

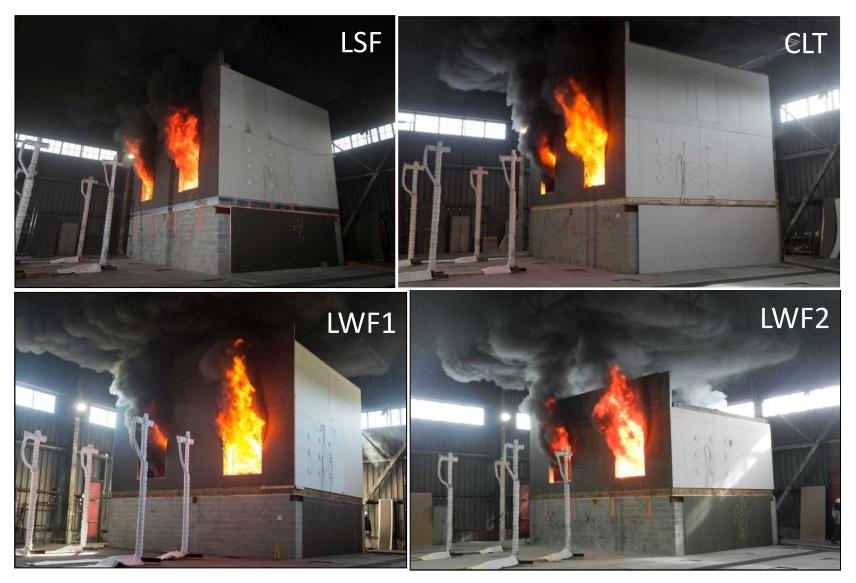
Figure 31. Flashover in both the bedroom and living room areas during large-scale apartment fire tests.

The furniture and contents as well as the hardwood flooring, the kitchen cabinets and counter tops in the fully furnished apartment produced high-intensity fast growing fires with similar initial fire development in all experiments. A smoke alarm was activated in less than 20 s. Flashover occurred in the bedroom at approximately 3 min and the door between the bedroom and the living room was fully breached at 5 min or earlier. Then the fire quickly developed in the living room area and subsequently progressed to the kitchen and entrance area. Localized flashover occurred in the living room/kitchen spaces – typically around 6 min in the living room area, and subsequently progressed to the kitchen area by 10 min and to the entry area by 19 min. Photographs taken after flashover in both the bedroom and living room area are shown in Figure 31.
